ADA Compliance Committee

Report to Port and Harbor Advisory Commission
May 23, 2018

Highlights of Northwest ADA Center Report on Homer Harbor

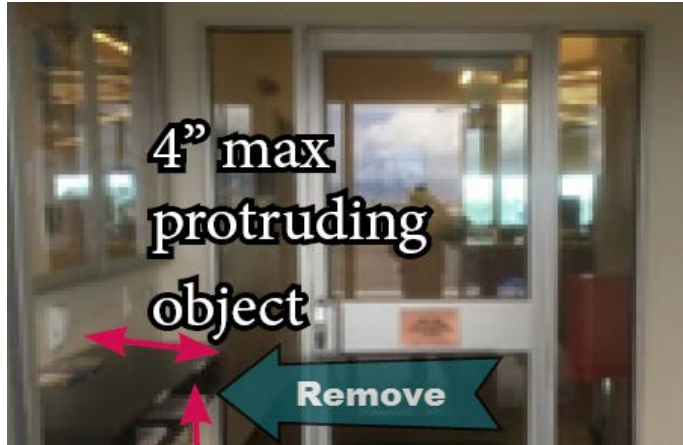
Harbormaster's Office

Protruding element 4" or greater at doorways or dominant path of travel.

Eliminate shelf to provide clear floor space to approach in opening the door.

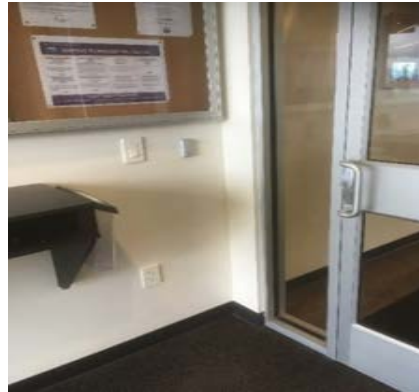
Harbormaster's Office

Exterior Notification Board: Too high for visibility for anyone using a wheelchair

For greater access, lower access to bottom edge of the information boards to 48" to 60" maximum.

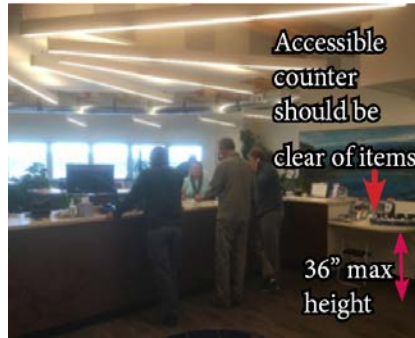
Harbormaster's Office

Accessible sales and service counter is clustered with multiple items rendering the purpose of its design moot.

- Provide clear surface counter that can be utilized by providing accessible counter with a surface area of 30" width in the dominant section of service counter.
- Provide a chair for patrons in case standing for longer period is a challenge.

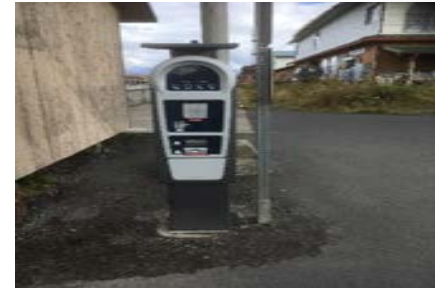
Clear floor space and asphalt-to-gravel transition issues. The clear floor space to use the automated parking meter that serves Ramp 3 parking lot can become uneven with foot-traffic use and ongoing weathering due to the asphalt-to-gravel transition.

- Accessible route or approach must be free of abrupt changes in surface level and should have a cross slope of less than 2% in all directions. This change-in-level barrier could be easily remedied and likely permanently maintained with a little additional asphalt around the base of the meter.
- In order to facilitate a smooth payment interchange create an even, stable, slip-resistant surface for a forward or side approach by someone using a wheelchair.
