**ADDENDUM NO. 1  
TO THE BID DOCUMENTS**

**Project:** Homer City Hall Roof Replacement 2019  
**Addendum Issue Date:** May 29, 2019  
**Bid Date:** June 6, 2019 @ 2:00 PM (Thursday)  
**Previous Addenda Issued:** None  
**Issued By:** Dan Gardner  
Public Works Supt.  
City of Homer  
Homer, AK 99603  
[dgardner@ci.homer.ak.us](mailto:dgardner@ci.homer.ak.us)

# Hazardous Building Materials Survey

## City Hall Roofs

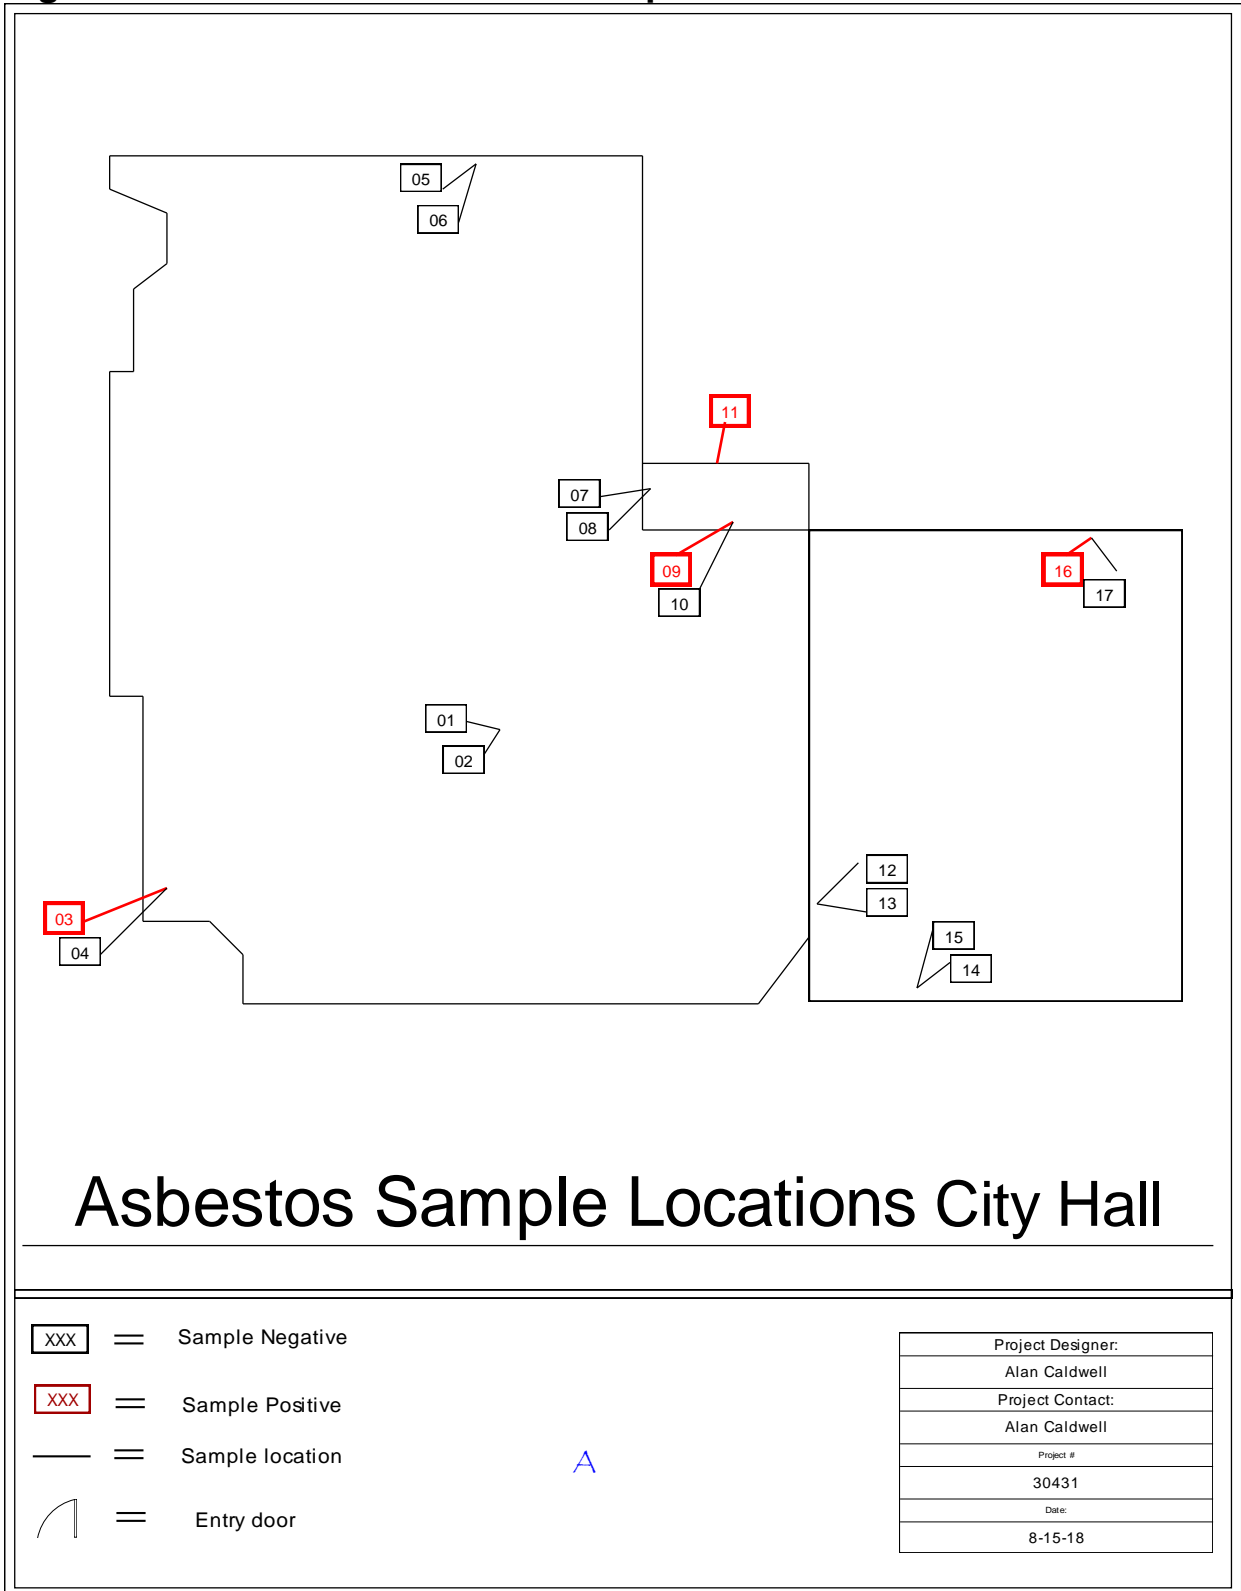
**Figure 4.1-1 Asbestos Sample Locations**

A total of 17 samples with 26 layers were taken during the survey. The results of the laboratory tests showed that the silver covering on the roof tested > 1% for asbestos on all three roof levels. Multiple samples for the same silver cover tested at <1% for asbestos.

Figure 4.1-1 identifies the locations of where asbestos samples were taken. Appendix B contains the asbestos sample results.

Review of results from the asbestos inspection revealed the top layer silver lining is ACM. We recommend that the removal and disposal of all asbestos containing materials (ACM) be completed by an accredited abatement contractor in accordance with all applicable local, state, and federal regulations pertaining to the removal of asbestos.
