**By the City of Homer, Alaska  
For the HERC 2 – Hazardous Materials Abatement**

**Hazardous Building Materials Survey**  
(Asbestos and Other Regulated Materials)  
**HERC Buildings 1 and 2**  
**Homer, Alaska**

**March 26, 2020**

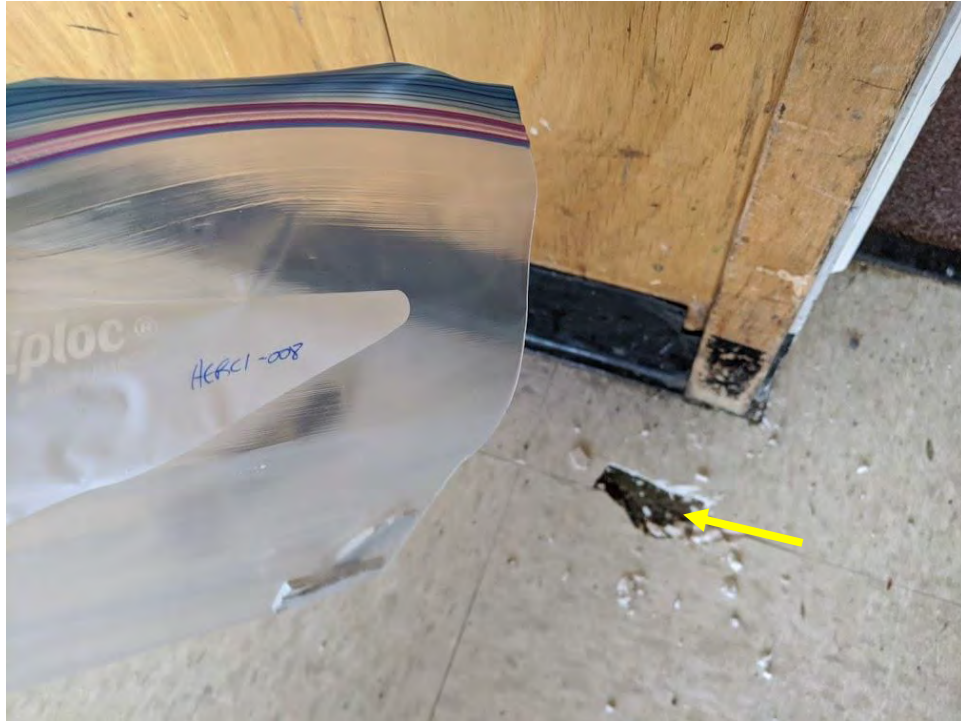
**Photo 1:** This photo shows sample location HERC 1-008 which is of ACM black mastic under the floor tile in room 107.

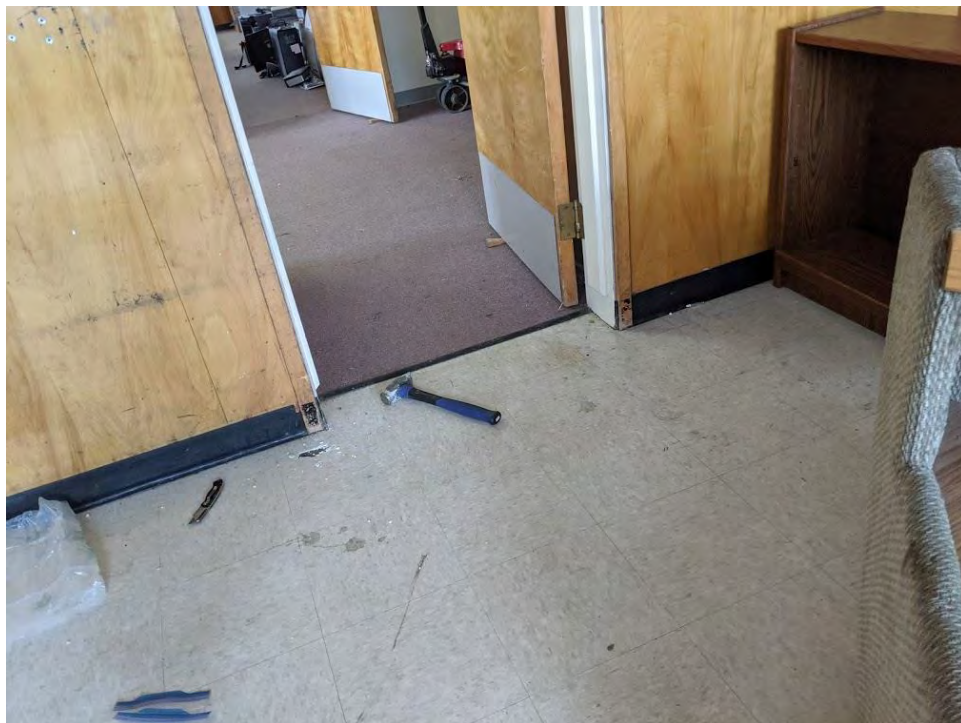
**Photo 2:** This photo shows ACM black mastic under the floor tile in room 107.

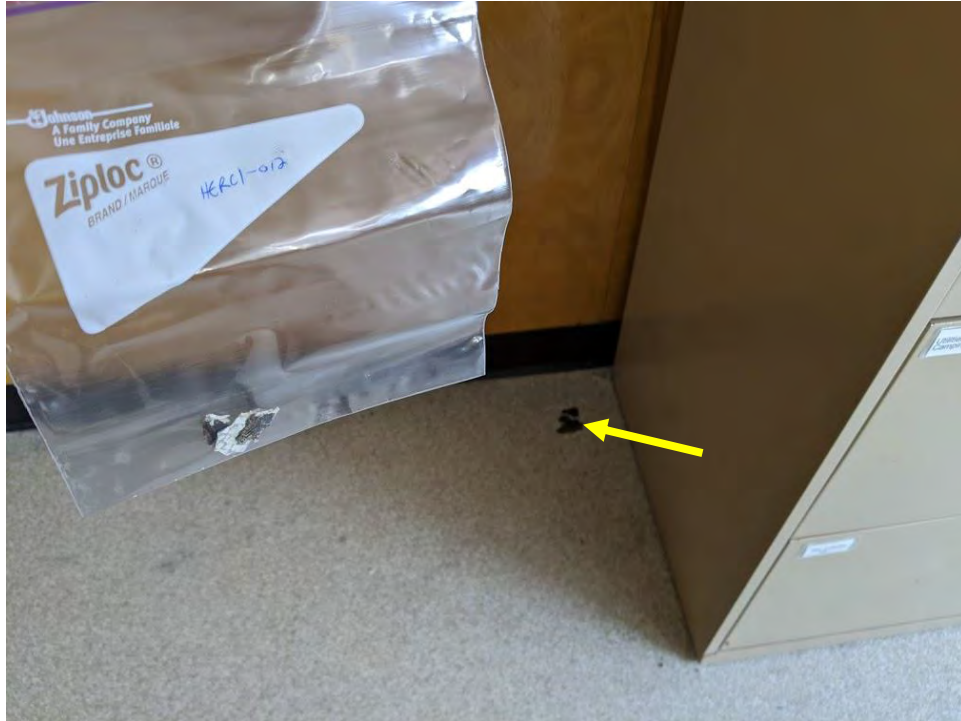
**Photo 3:** This photo shows sample location HERC 1-012 which is of ACM black mastic under the floor tile in room 108.

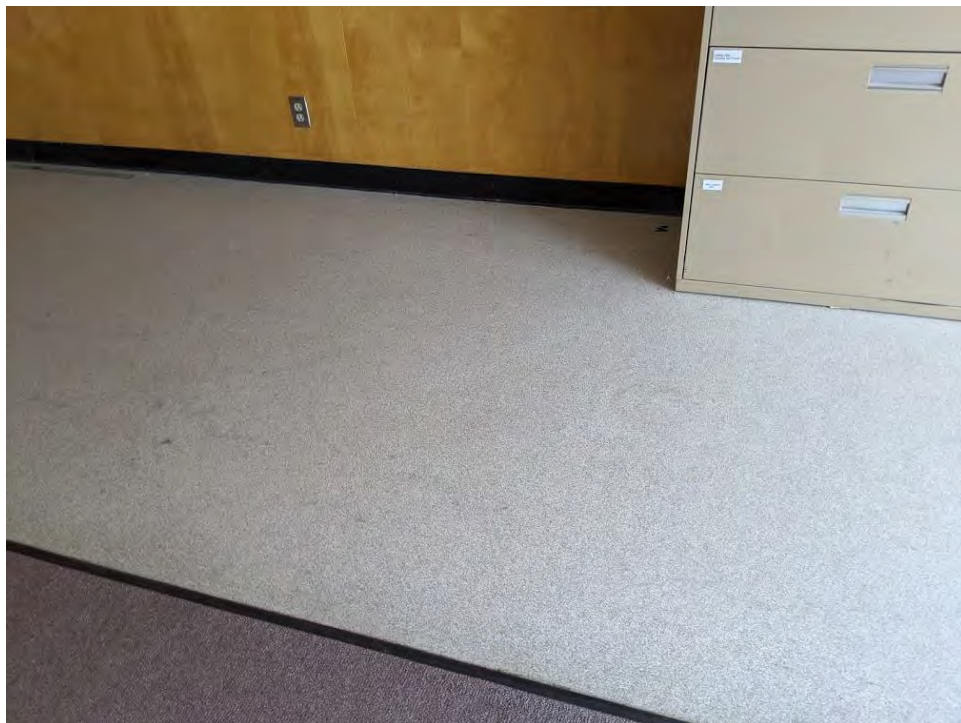
**Photo 4:** This photo shows ACM black mastic under the floor tile in room 108.

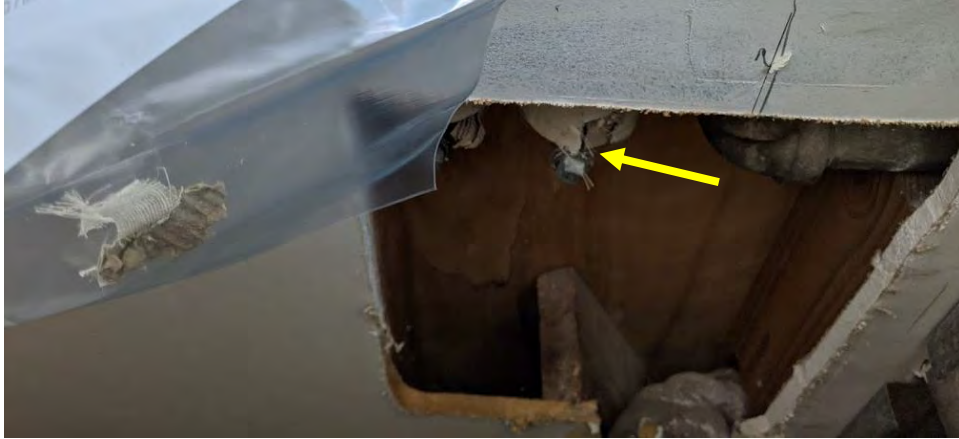
**Pipe insulation elbow (off-white wrap) (TSI):** Sample HERC 1-024, which was collected from a hard-pack elbow in HERC 1 room 111 (science room). The main pipe runs were insulated with fiberglass and the ACM is limited to the elbows. The laboratory noted three distinct layers/types of wrap within this sample these included and off-white woven, tan wrap, and off-white wrap. The off-white wrap was the layer determined to be ACM. The off-white wrap was observed above the drop down ceiling in room 111. Approximately 75% of the ceilings were looked above and only this room as well as others noted below were observed in the buildings. No TSI was observed in the bathroom chase, but some may be located in the wall cavities with hot water lines. This material is considered friable and meets the definition of RACM. Up to 100 ACM elbows are assumed present.

**Photo 5:** This photo shows sample location HERC 1-024 which is of ACM off-white wrap around a pipe elbow found in the walls of room 111 (science room).

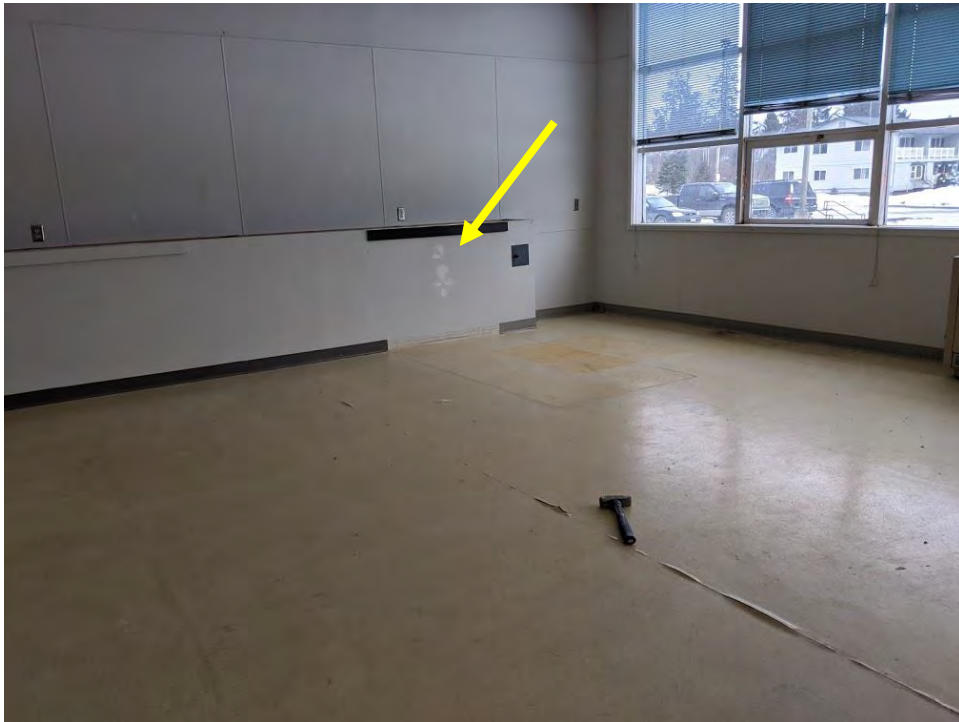
**Photo 6:** This photo shows the location of ACM off-white wrap around a pipe elbow found in the wall of room 111.

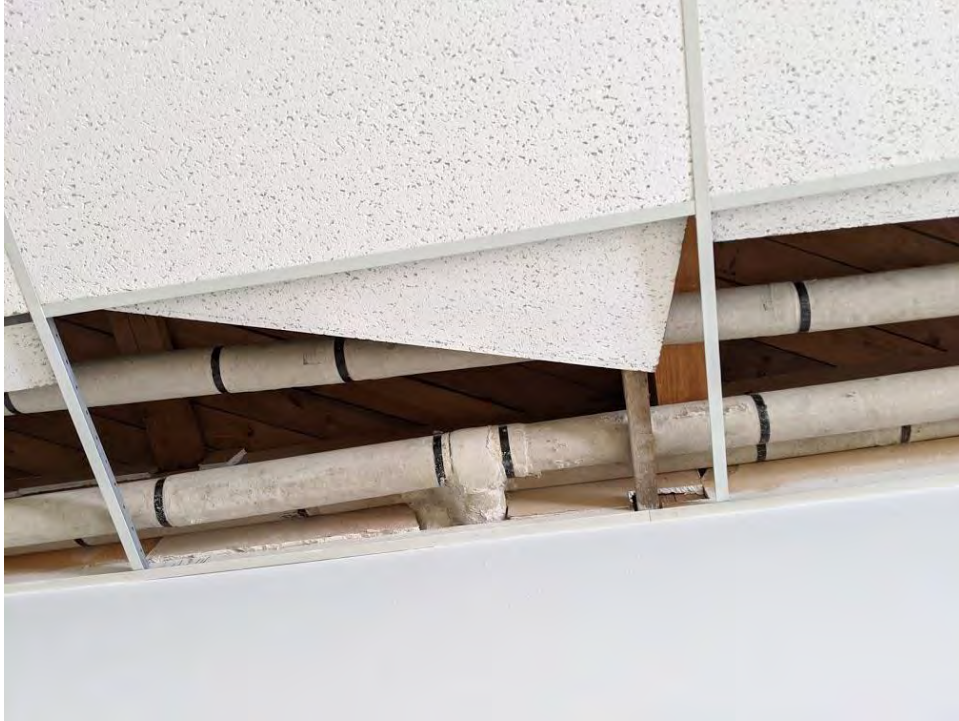
**Photo 7:** This photo shows the location of ACM off-white wrap around a pipe elbow found in the ceiling of room 111.

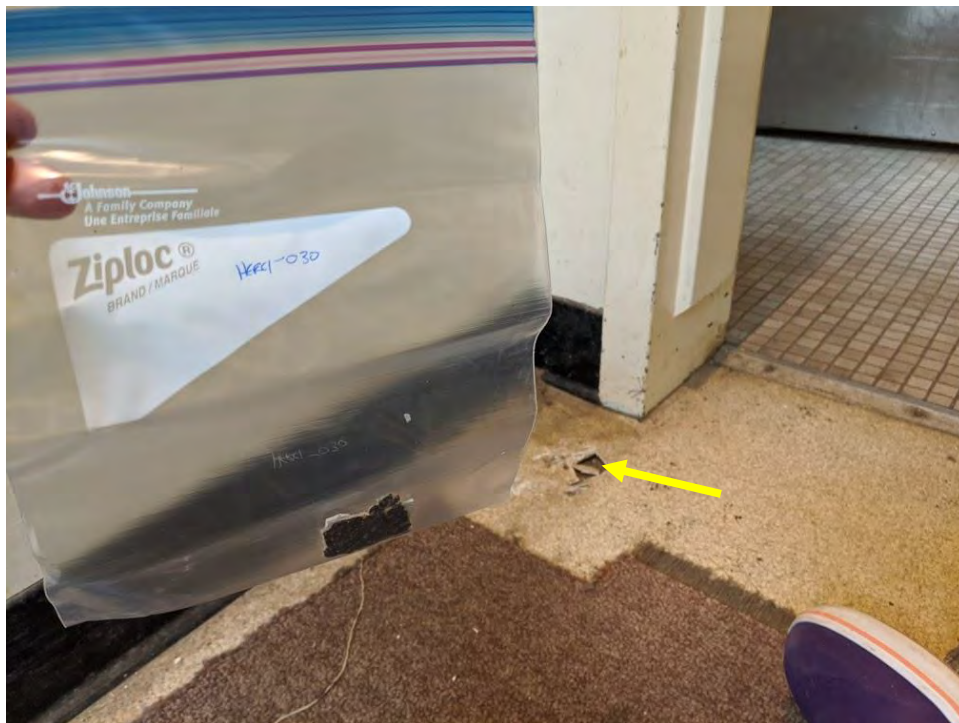
**Photo 8:** This photo shows sample location HERC 1-030 which is of ACM black mastic under the floor tile in room 118 (janitor's closet between boy's and girl's restroom).

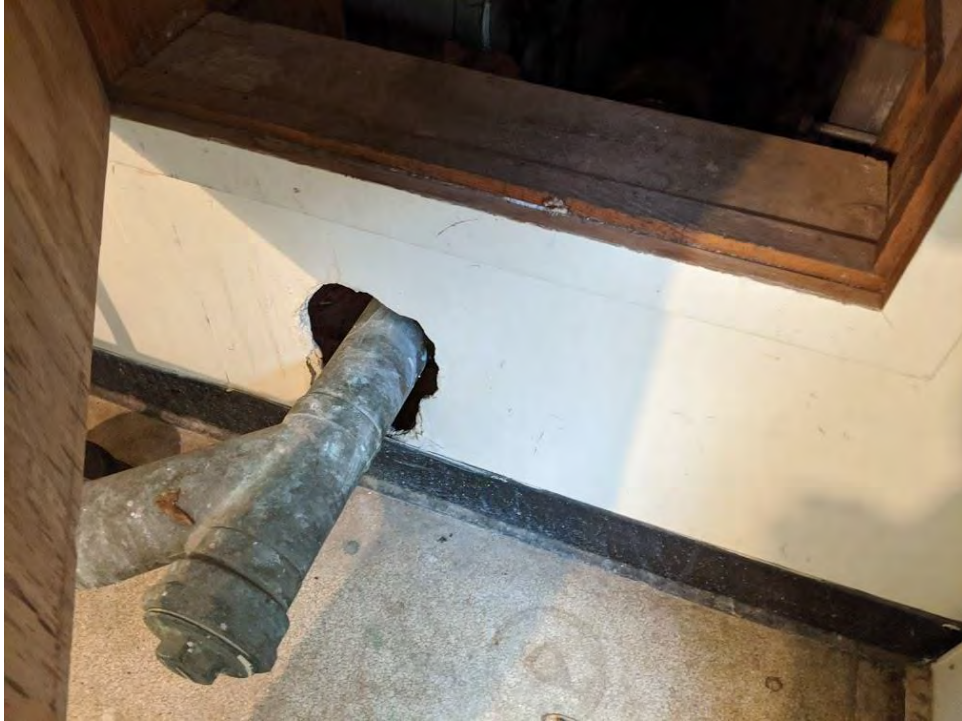
**Photo 9:** This photo shows protruding pipe into the wall in room 118 (janitor's closet between boy's and girl's restroom).

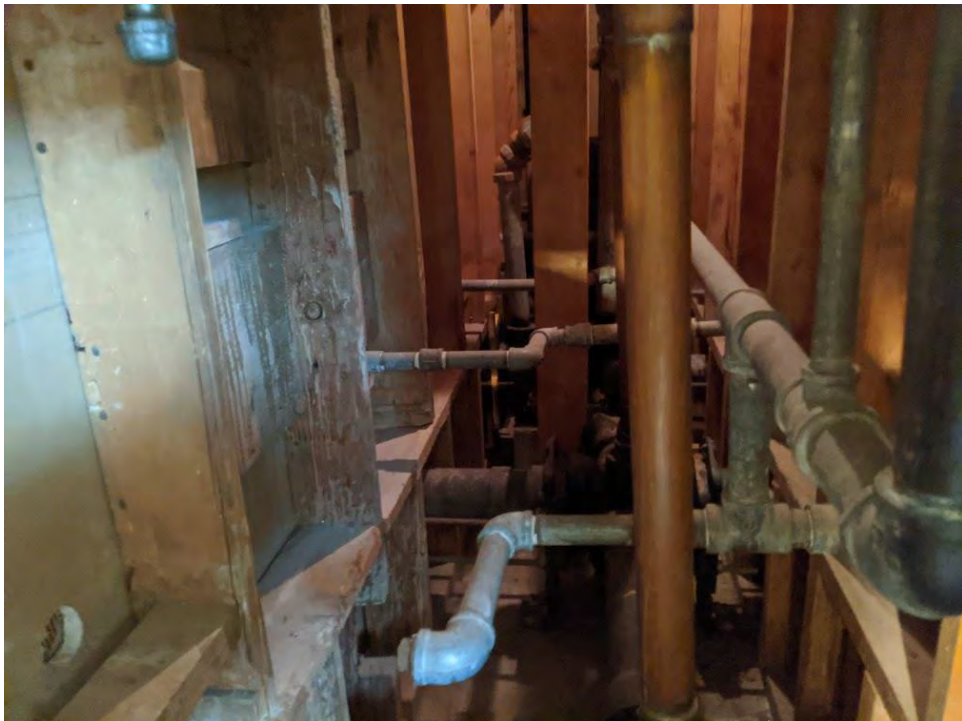
**Photo 10:** This photo shows piping associated with restrooms in room 118 (janitor's closet between boy's and girl's restroom).

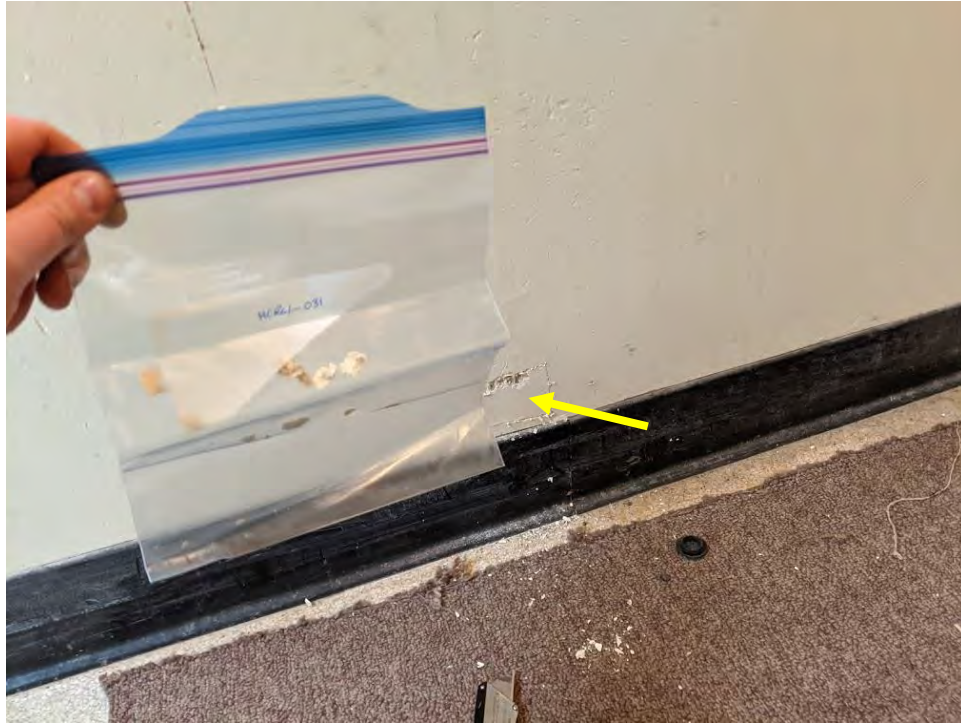
**Photo 11:** This photo shows sample location HERC 1-031 which is of ACM off-white joint compound found layering the plywood wall of room 118 (janitor's closet between boy's and girl's restroom).

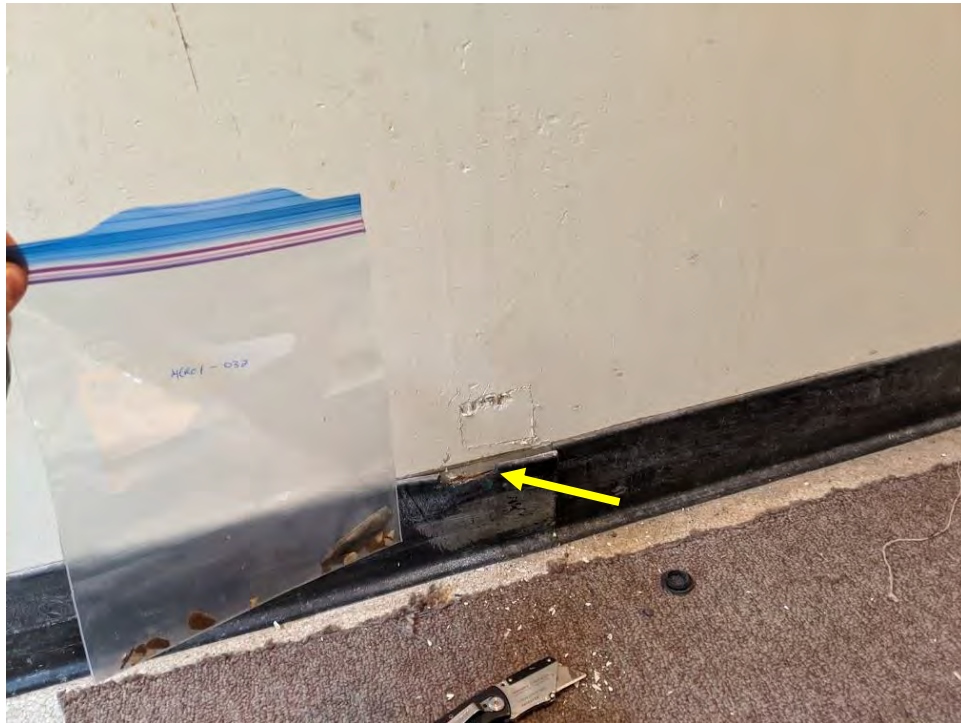
**Photo 12:** This photo shows sample location HERC 1-032 which is of ACM off-white joint compound found layering the plywood wall of room 118 (janitor's closet between boy's and girl's restroom).

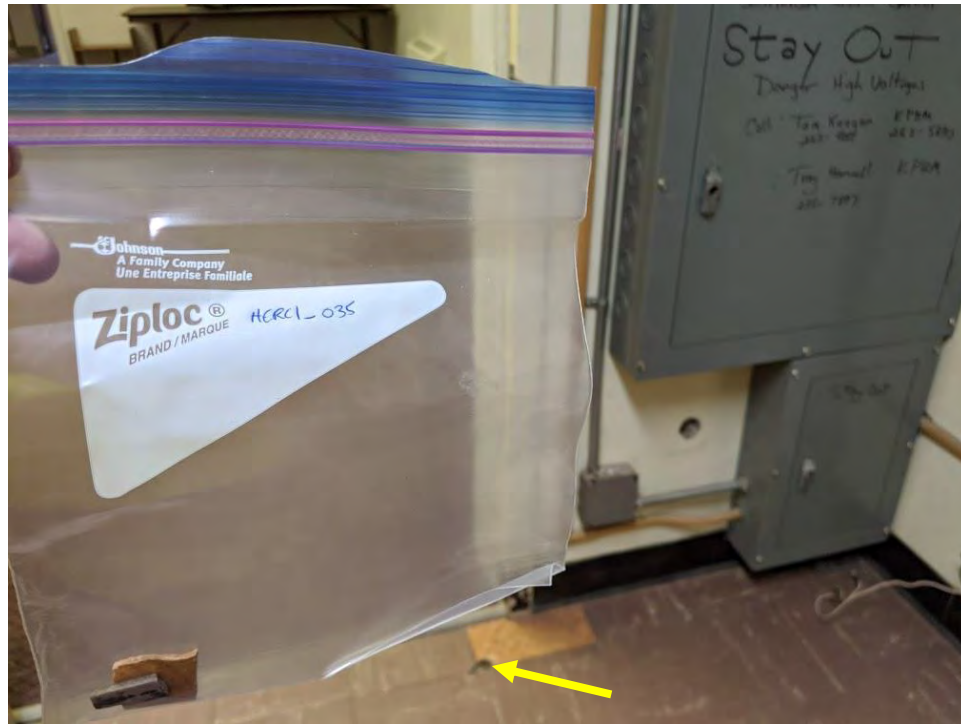
**Photo 13:** This photo shows sample location HERC 1-035 which is of ACM black mastic under the floor tile in the storage closet of the fan room.

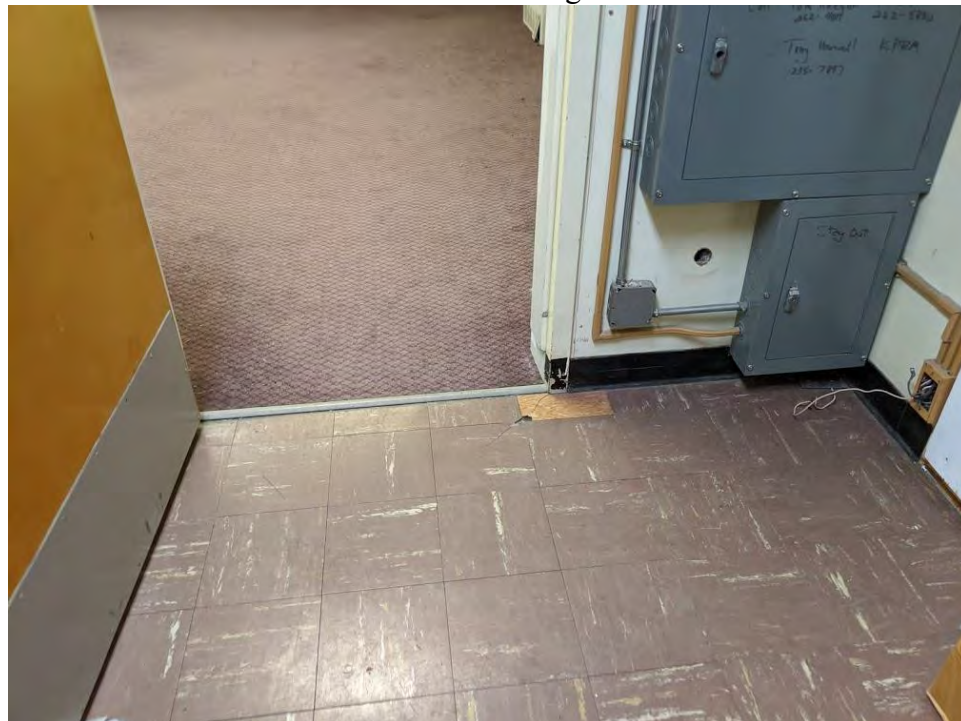
**Photo 14:** This photo shows ACM black mastic under the floor tile in the storage closet of the fan room.

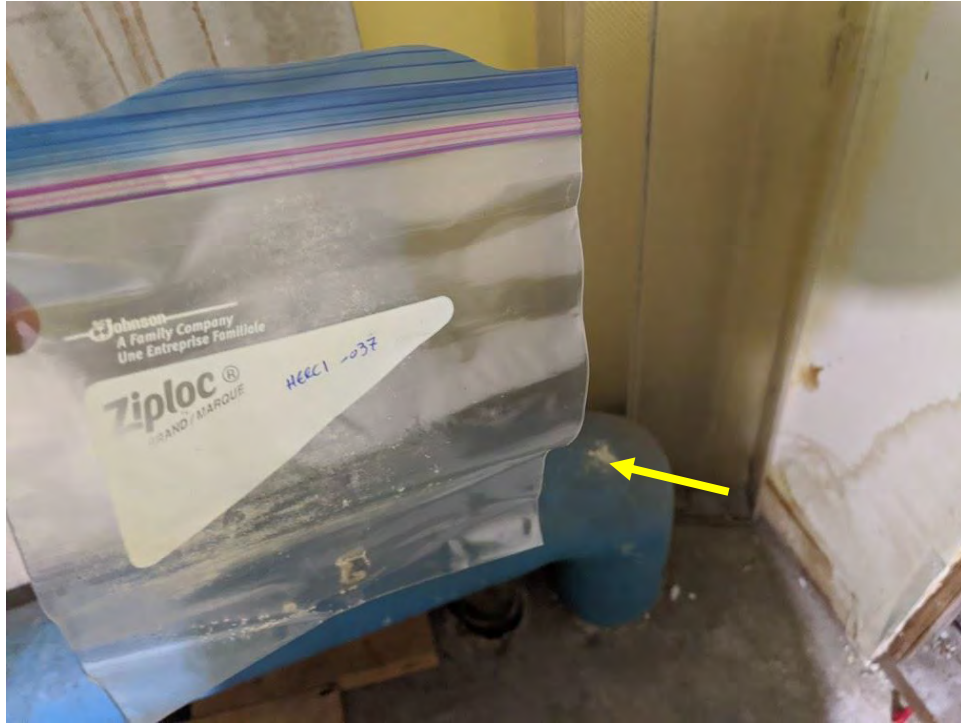
**Photo 15:** This photo shows sample location HERC 1-037 which is of ACM off-white insulation around a pipe elbow found in the fan room.

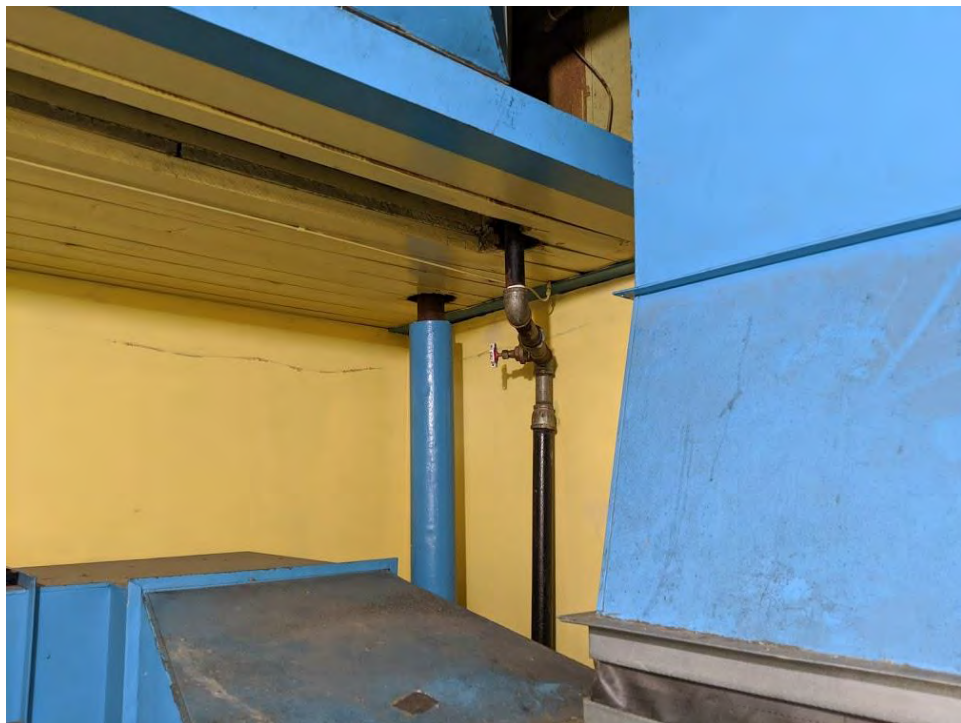
**Photo 16:** This photo shows piping that contained ACM off-white insulation around a pipe elbow found in the fan room.

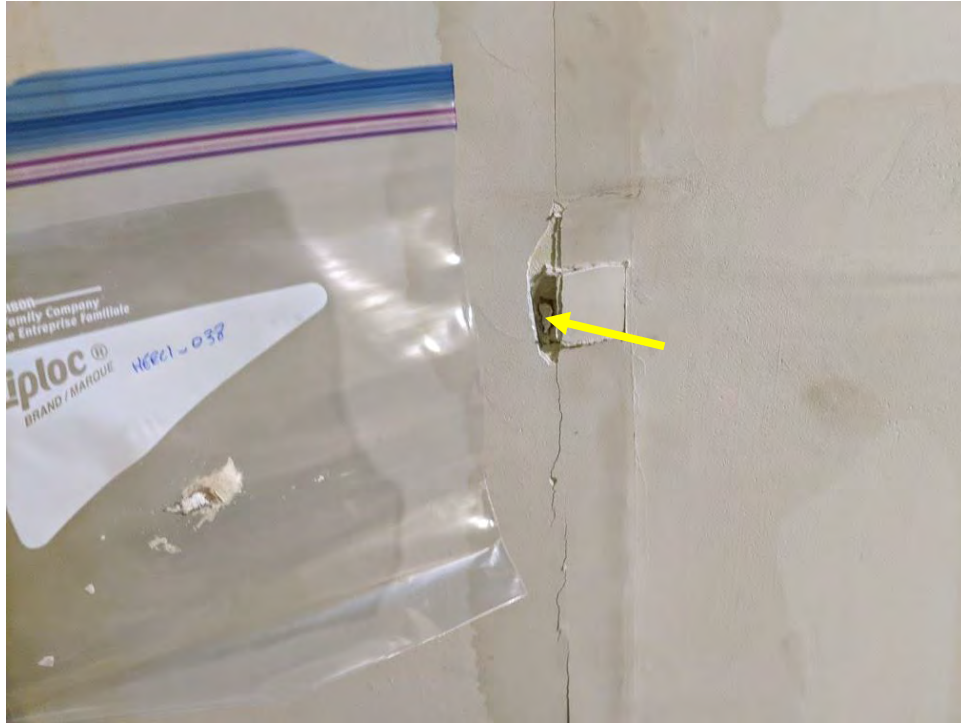
**Photo 17:** This photo shows sample location HERC 1-038 which is of ACM tan joint compound attached to plywood in one wall found in the fan room.

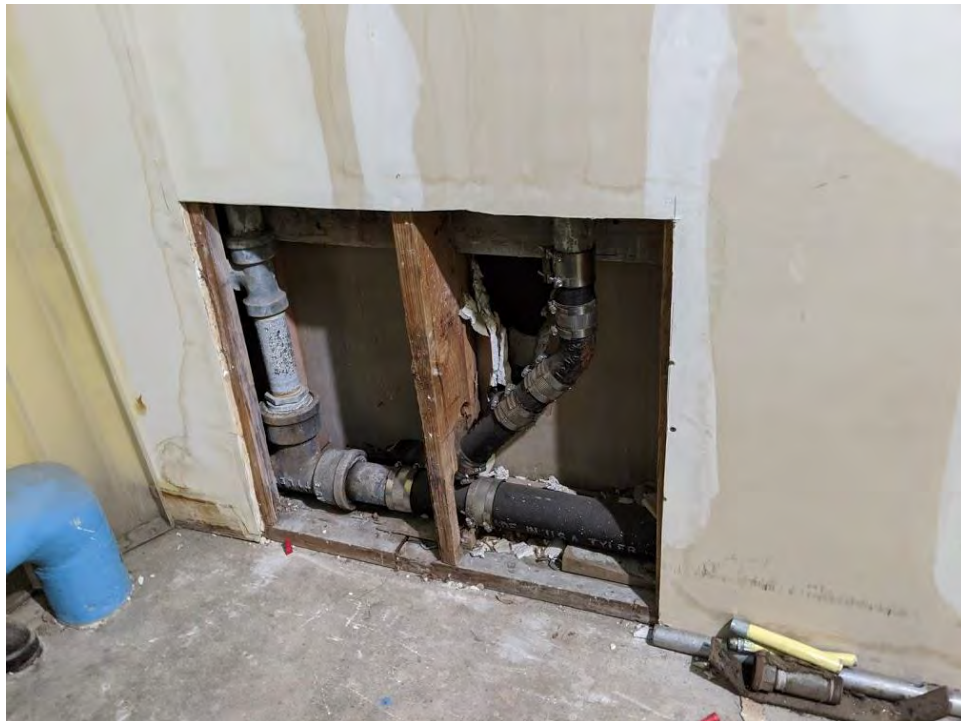
**Photo 18:** This photo shows ACM tan joint compound attached to plywood in one wall found in the fan room.

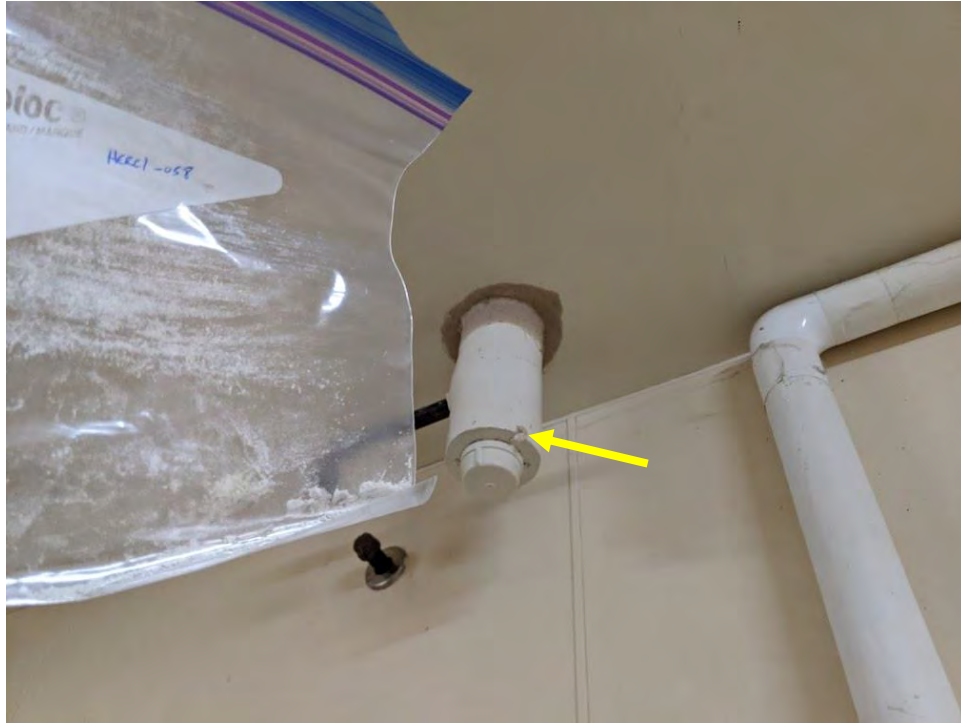
**Photo 19:** This photo shows sample location HERC 1-058 which is of ACM white insulation around a pipe found in the men's locker room.

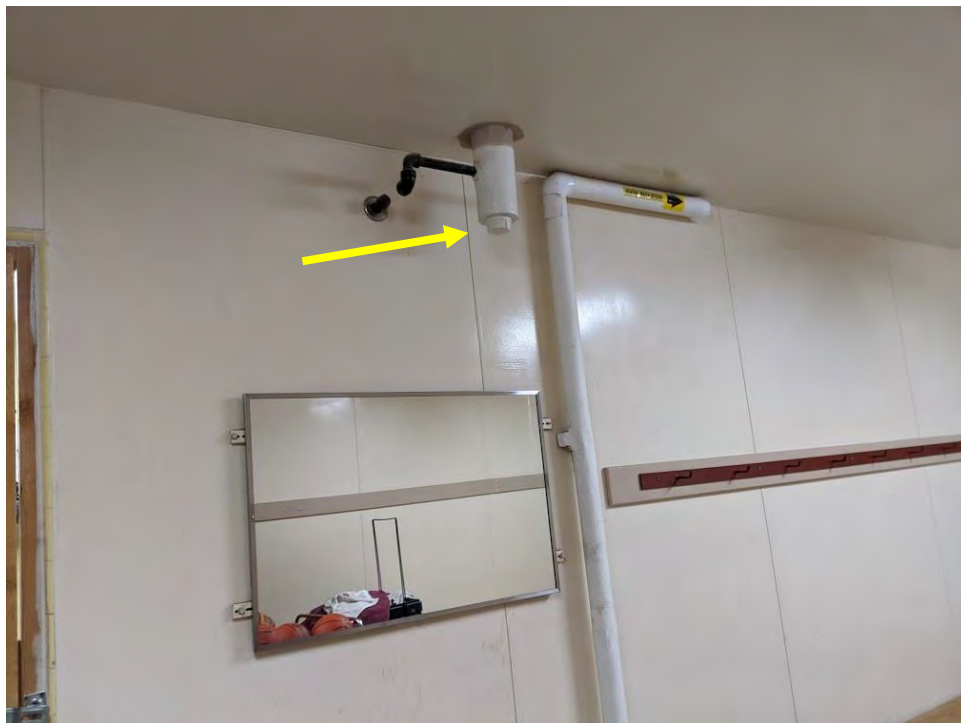
**Photo 20:** This photo shows ACM white insulation around a pipe found in the men's locker room.

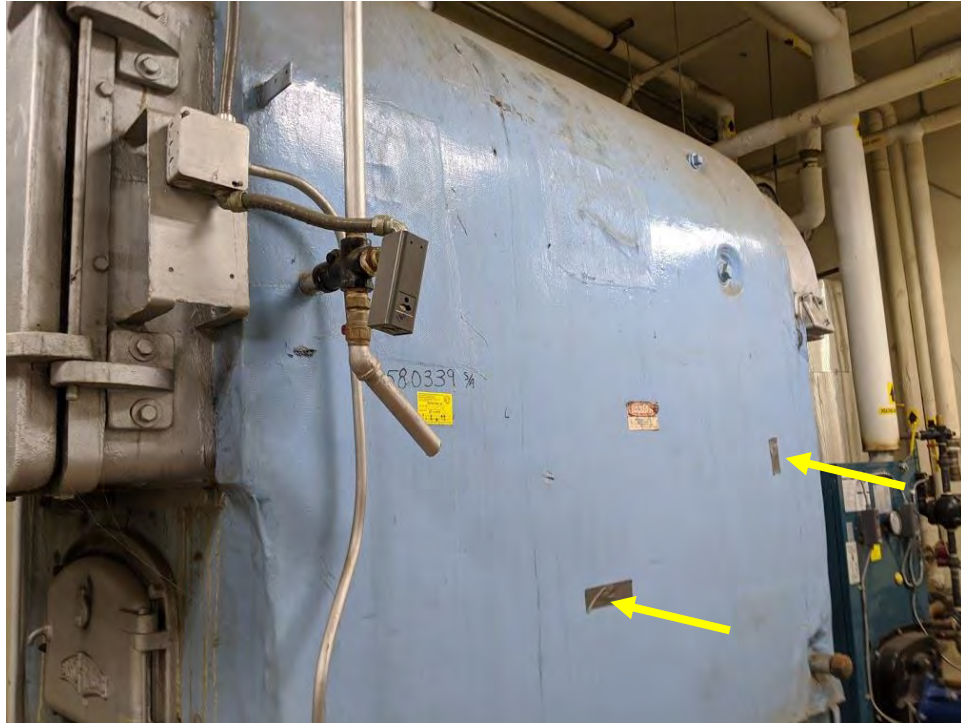
**Photo 21:** This photo shows sample locations HERC 1-064 and 065 which is of ACM white insulation coating a boiler found in the boiler room.

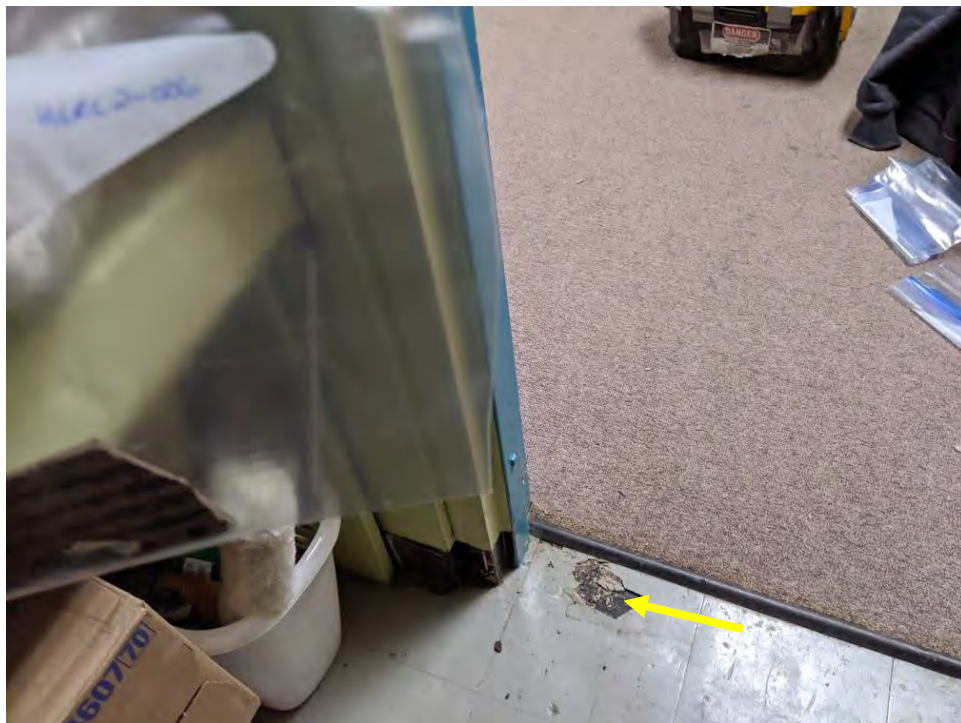
**Photo 22:** This photo shows sample location HERC 2-006 which is of ACM grey floor tile and black mastic under the floor tile in the storage closet.

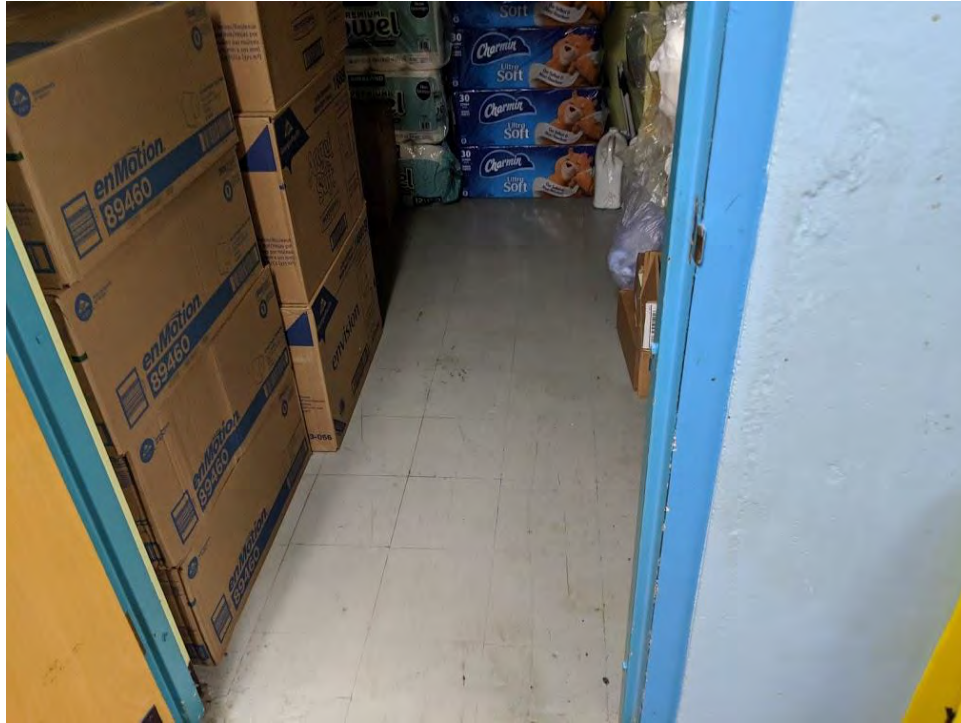
**Photo 23:** This photo shows ACM grey floor tile and black mastic under the floor tile in the storage closet.

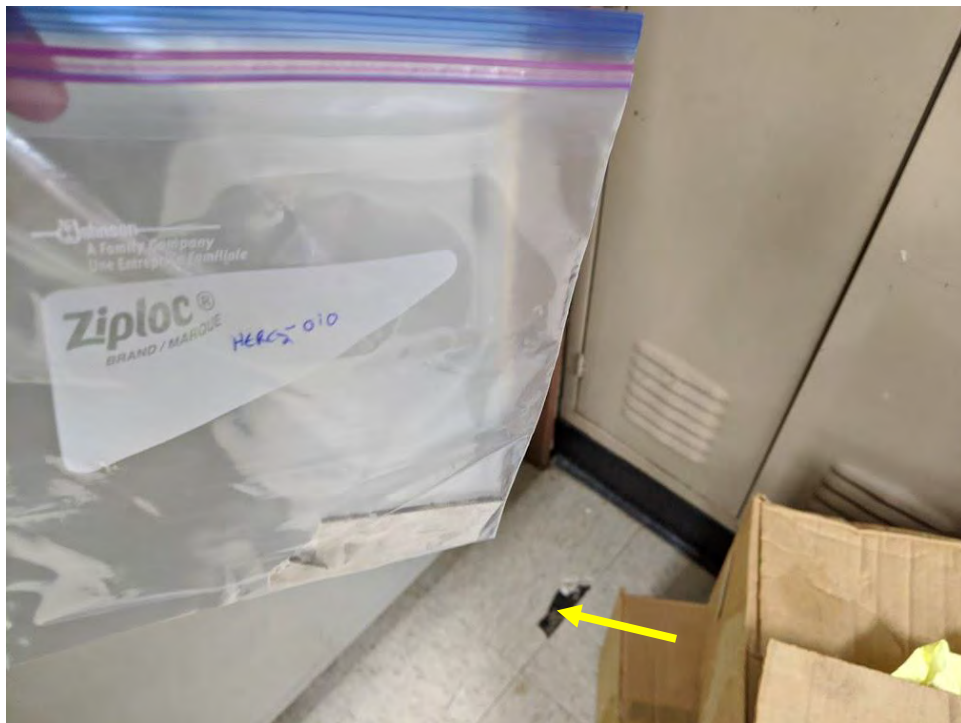
**Photo 24:** This photo shows sample location HERC 2-010 which is of ACM black mastic under the floor tile found in classroom 2.

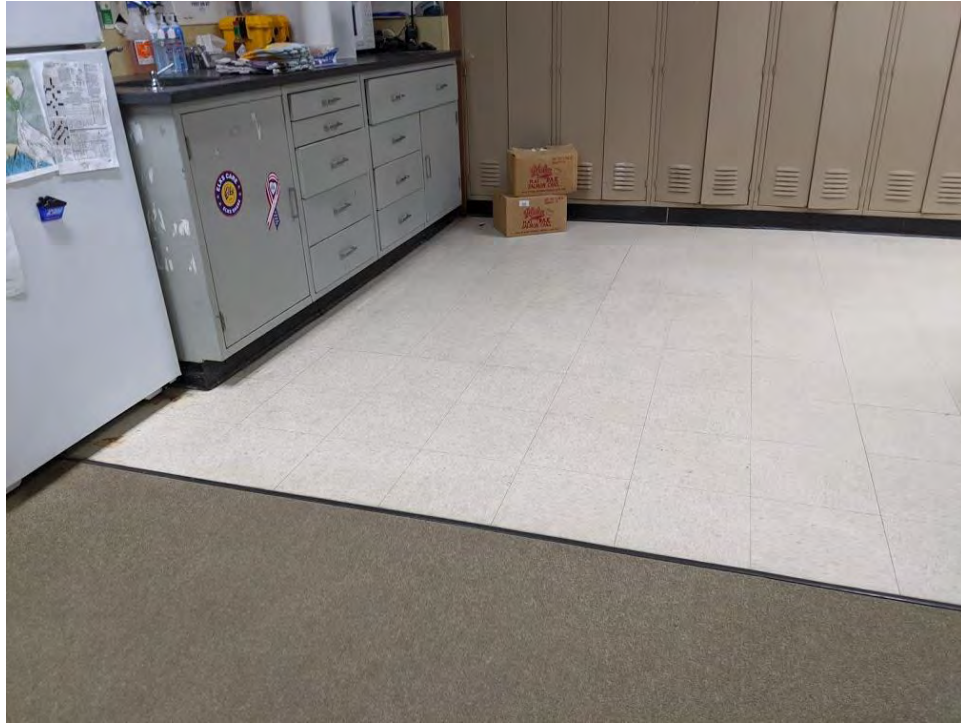
**Photo 25:** This photo shows ACM black mastic under the floor tile found in classroom 2.

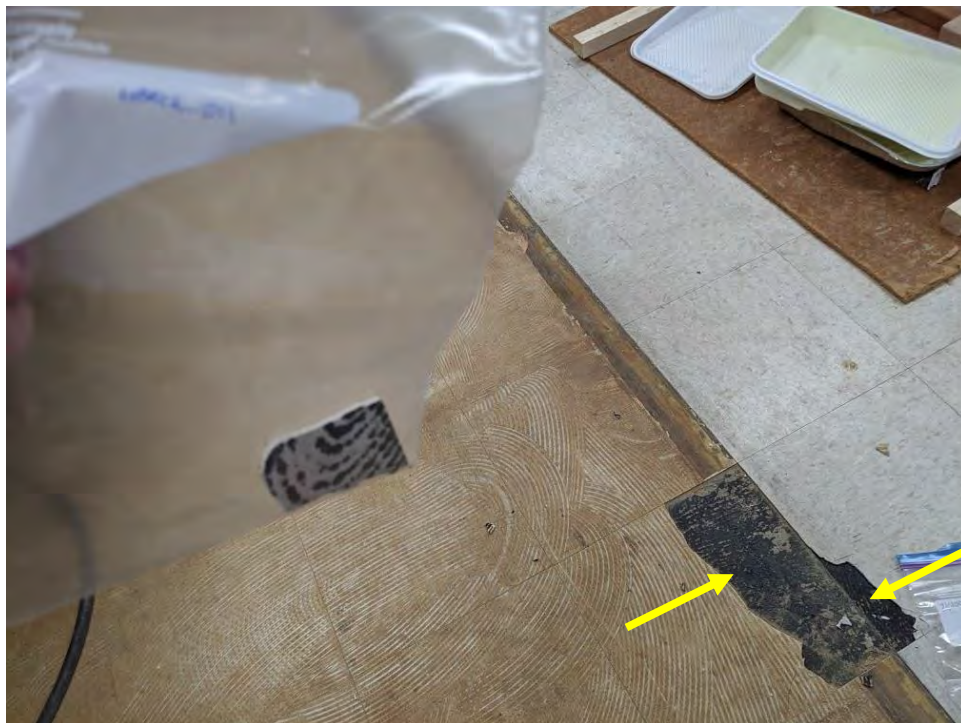
**Photo 26:** This photo shows sample locations HERC 2-011 and 012 which is of ACM black mastic under the floor tiles found in classroom 1.

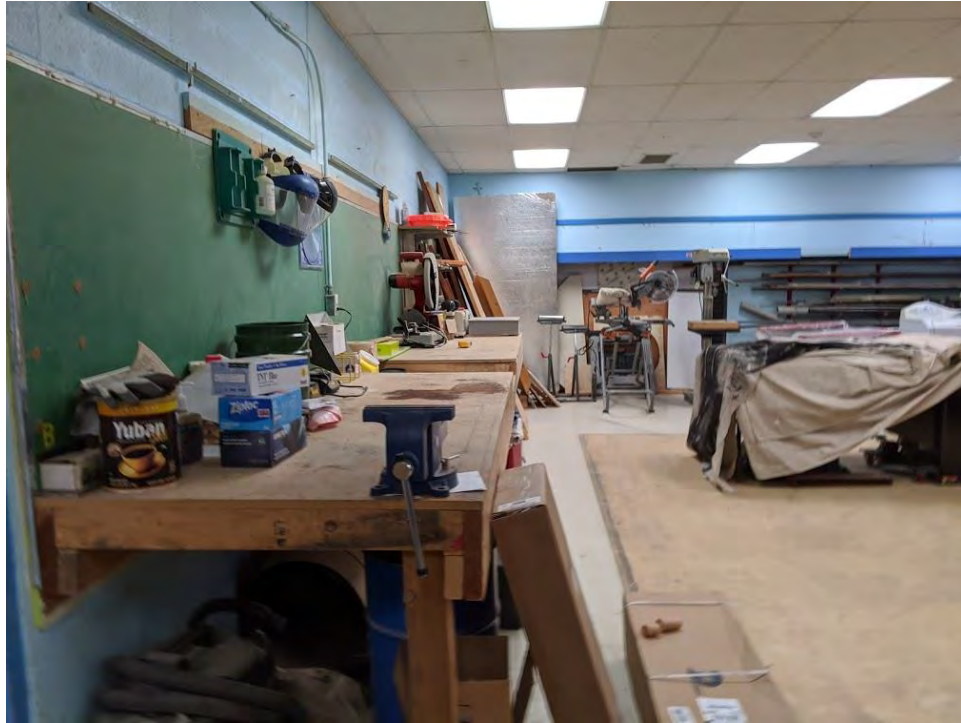
**Photo 27:** This photo shows ACM black mastic under the floor tiles found in classroom 1.

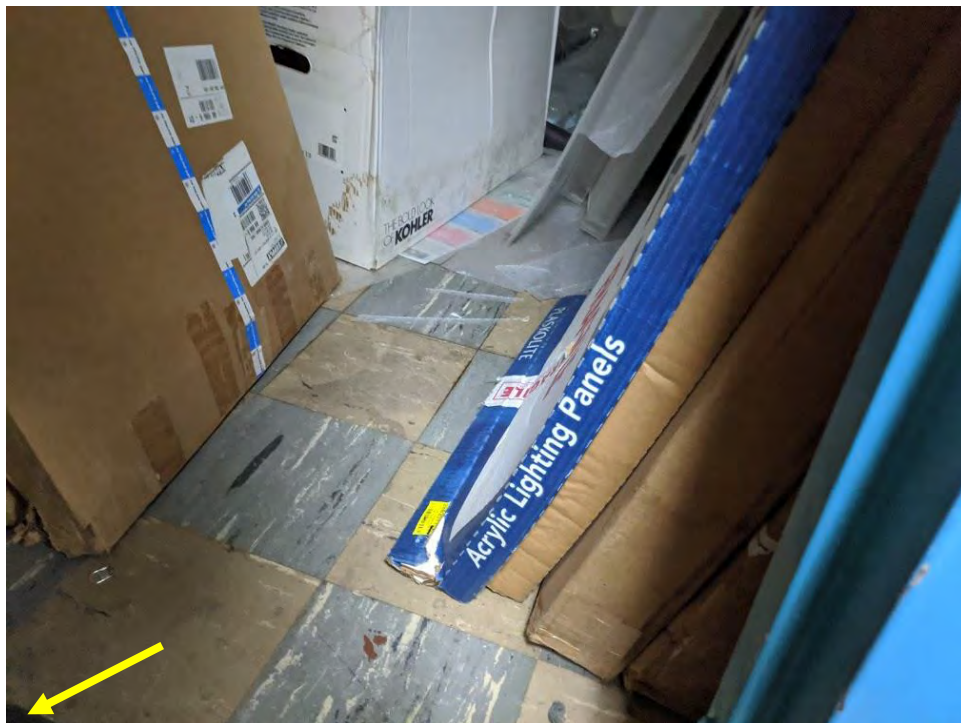
**Photo 28:** This photo shows sample location HERC 2-018 which is of ACM grey/yellow floor tile and black mastic under the floor tile found in the storage closet.

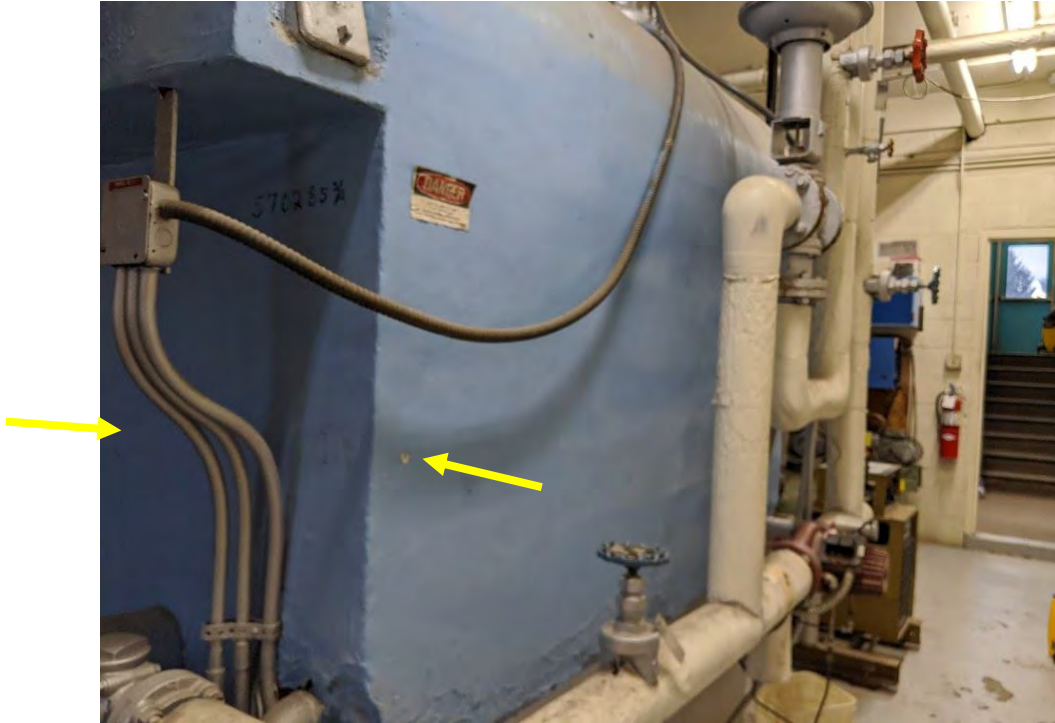
**Photo 29:** This photo shows sample locations HERC 2-021 and 022 which is of ACM white insulation coating a boiler found in the boiler room.
