# **Hazardous Materials Assessment**

City of Homer, Public Works Department,
Homer Education and Recreation Complex (HERC) 1 Screening,
Homer Education and Recreation Complex 1 (HERC1),
450 Sterling Highway,
Homer, Alaska 99603

Assessment Date: May 05-06, 2023

Report Date: July 25, 2023

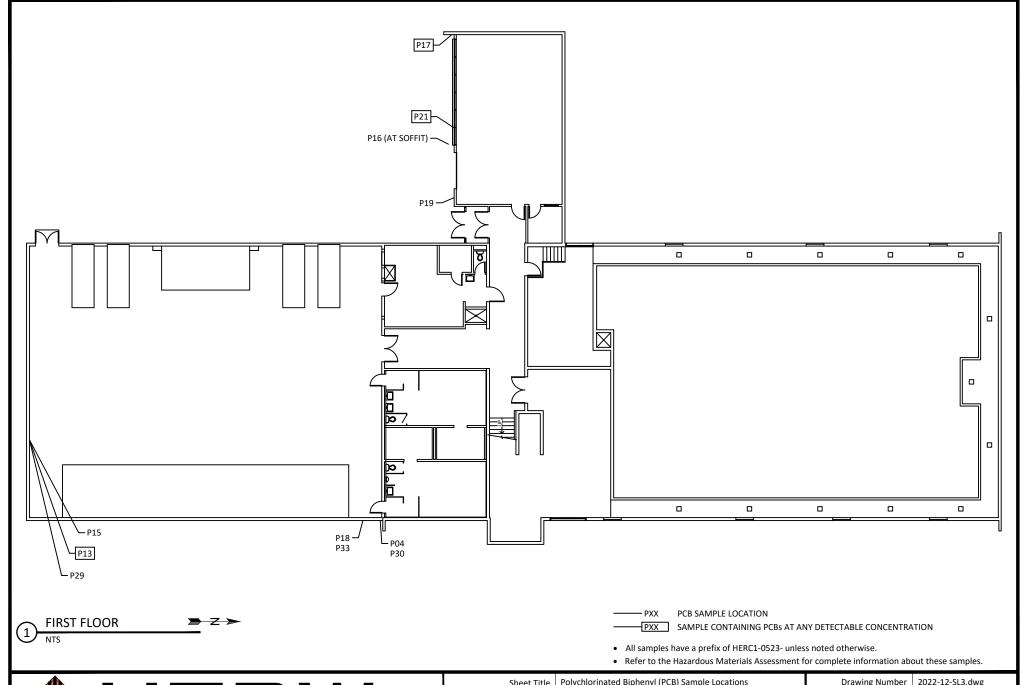
The beige paint on the exterior concrete walls was confirmed to contain 0.90 mg/Kg of total PCBs which is less than the 1 mg/Kg threshold set by the Alaska DEC. However, because this result is close to the threshold, this report recommends assuming that the paint and the surface of the concrete substrate will be classified as a PCB waste by Alaska DEC regulations. This recommendation is based on the fact that only a limited number of samples were collected, and because the sample collection process introduces contaminants into the sample which could potentially "dilute" the total PCB concentrations in the target material, which in this case was the paint and not the concrete substrate. This report assumes that the corrugated metal siding will have little to no contamination within its matrix due to leaching of PCBs from the applied beige paint.
