# City of Homer

## Memorandum 20-072

**TO:** Marvin Yoder, City Manager  
**FROM:** Carey Meyer, City Engineer  
**DATE:** May 11, 2020  
**SUBJECT:** Seawall Failure Concerns

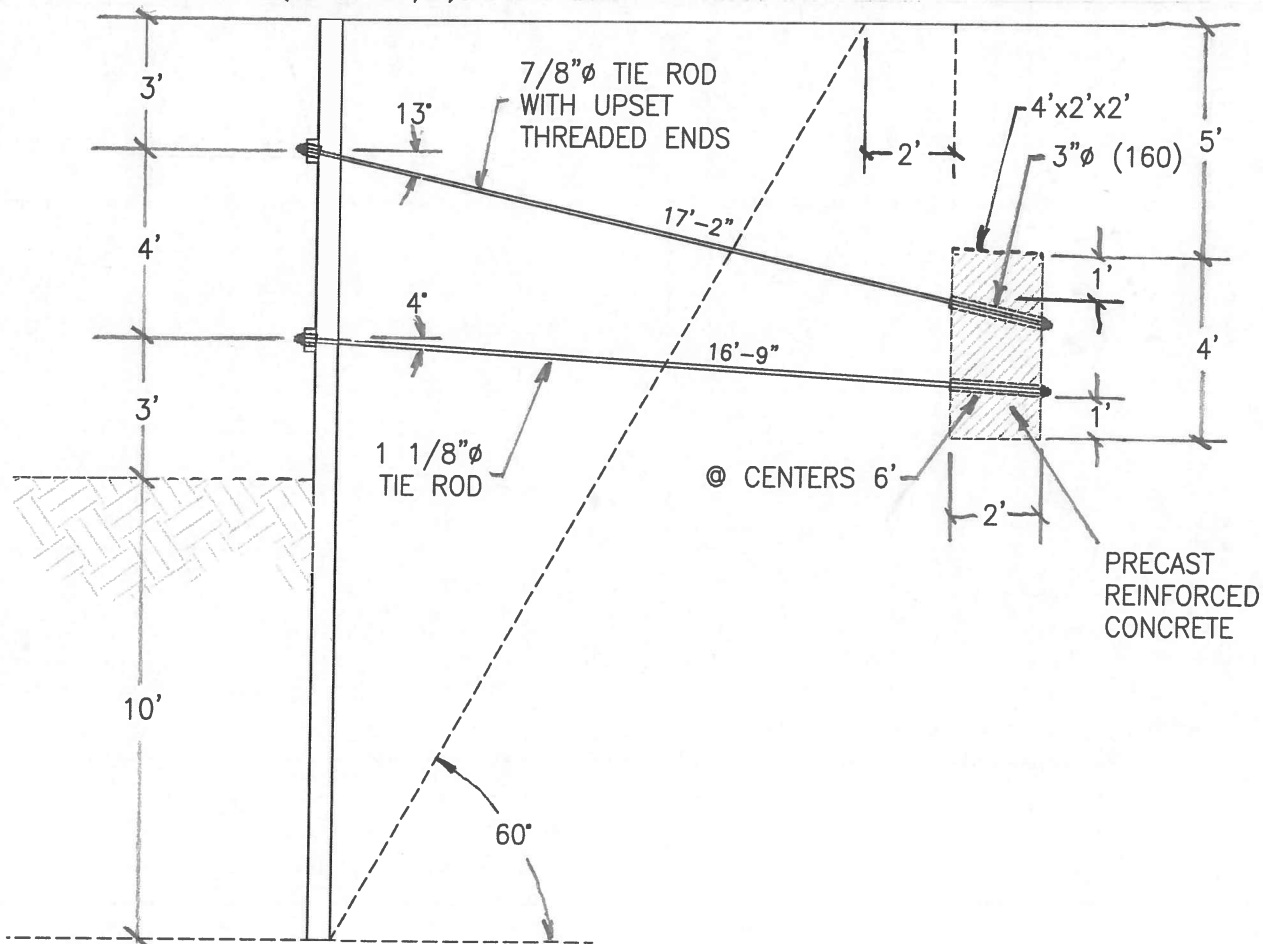
Our seawall was designed to utilize less rigid piling and tie-rods connected to concrete blocks (sometimes called dead men) buried behind the wall to provide the additional support necessary. See attached drawing. The blocks are tie-rodged to the wall. This tie-rod technique is used successfully in many civil engineering applications.

The vulnerability of this technique is that loss of the backfill in which the tie-rodged concrete “dead men” block is buried can result in the loss of structural support of the wall. As long as the wall protects the material behind the wall, the concrete blocks will continue to provide wall support.
