# AGENDA ITEM REPORT

**Ordinance 23-12, An Ordinance of the City Council of Homer, Alaska Amending the FY23 Capital Budget by Appropriating \$63,070 from the Port Reserves Fund for Professional and Technical Assistance to Support Submission of a Port Infrastructure Development Program Grant Application for the Purpose of Float Replacement in the Small Boat Harbor. City Manager/Port Director.**

## System 1 Condition Report

*City of Homer*  
**Homer Small Boat Harbor  
Float Condition Assessment**

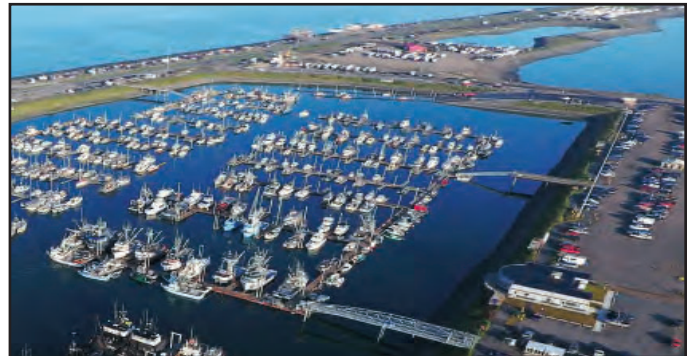
System 4 floats to be replaced.

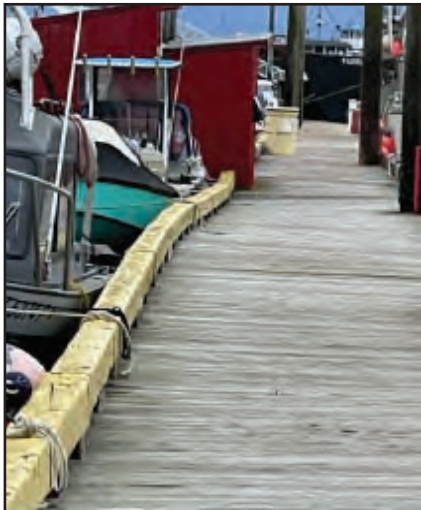
The Headwalk Float AAA is warped, suggesting a failure in the structural members below the deck and lack of flotation..

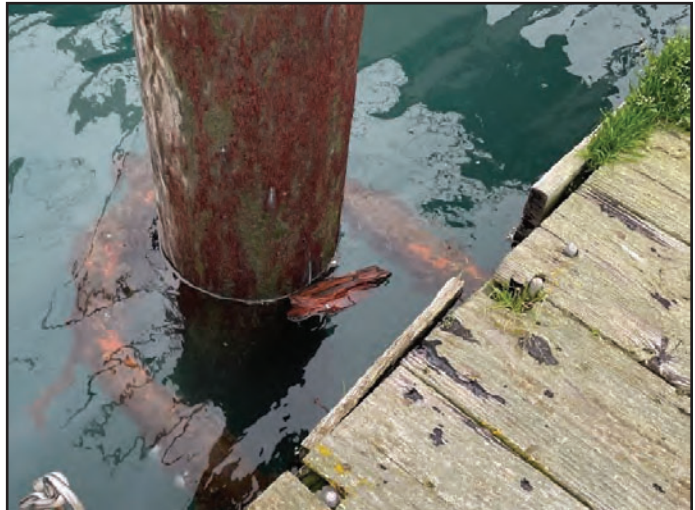
Low freeboard resulting in submerged pile collar. Decking has rot and hardware connections protrude through it.

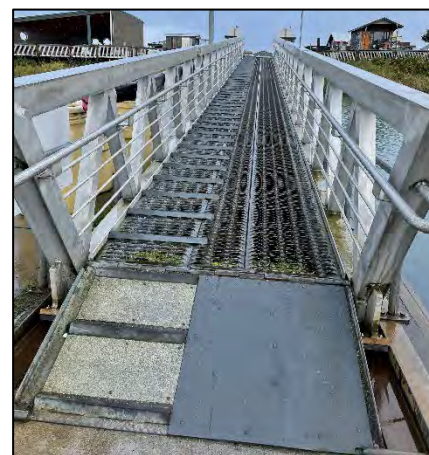
*Figure 2.1: aluminum gangway with steel floor grating and landing tracks*

ADA gangway is not required at some of the other locations. However, we recommend that any new project that replaces a trestle, should consider providing a new 80-ft or longer covered gangway with flooring that meets ADA.

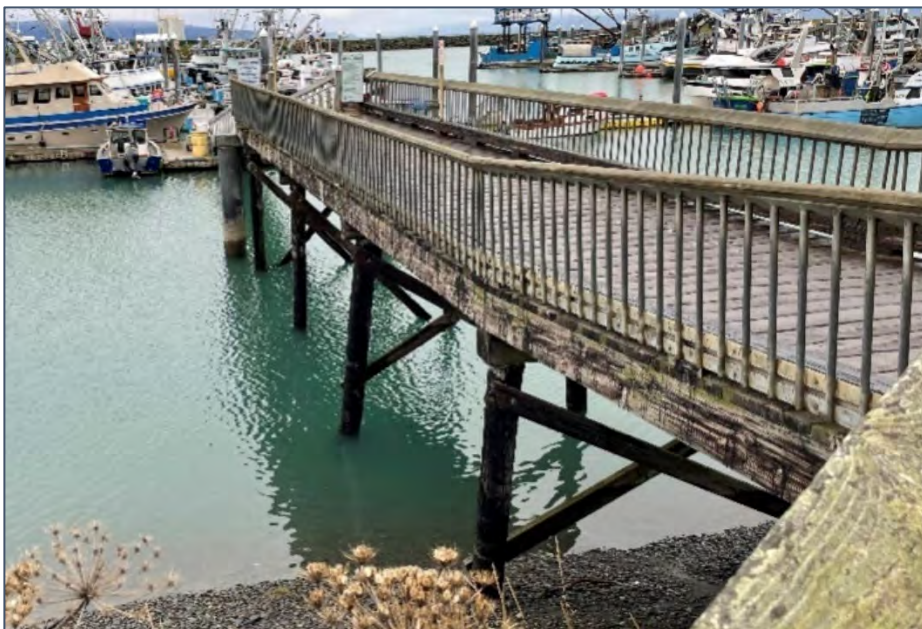
The decking and bullrails on the two trestles have evidence of deterioration due to wear. The timber support piles have moderate section loss and minor splits and gouges. Timber support piles have timber cross bracing (Figures 2.2 and 2.3. Some of the cross bracing has major deterioration, some boards are missing, and hardware located in the tidal zone is partially corroded (Figures 2.2 through 2.5). Note that the trestle decks on both Ramp 1 at Ramp 2 appear to have a dip—where it changes from a sloped deck to a level deck. Handrails appear to be a later addition to these trestles. Embedment depths on the timber piles is not evident, but timber harbor piles of this time period in Alaska were not typically driven to depths sufficient to withstand heavy axial or seismic/lateral loads, especially without relying on the cross bracing. If not already, vehicle access to these trestles should be restricted.

Figure 2.2: Ramp 1 timber pile supported trestle.

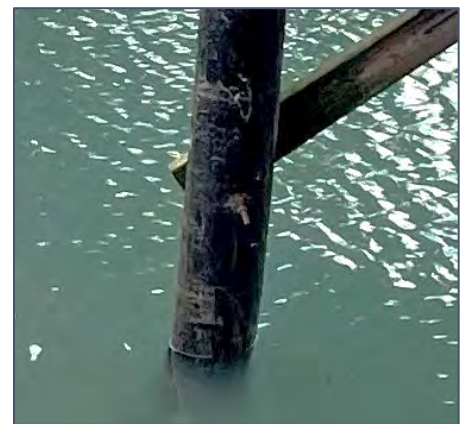
Figure 2.3: lower hardware connections appear corroded.

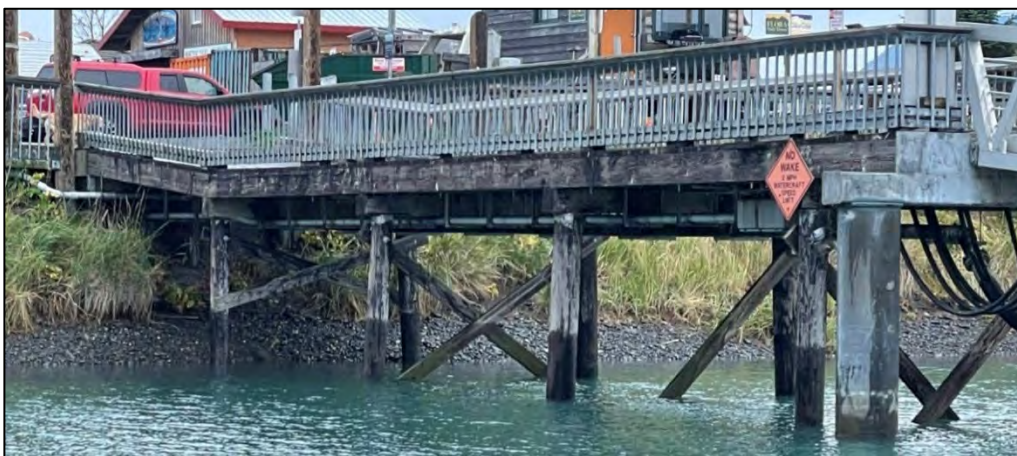
Figure 2.4: Ramp 2 timber pile supported trestle.

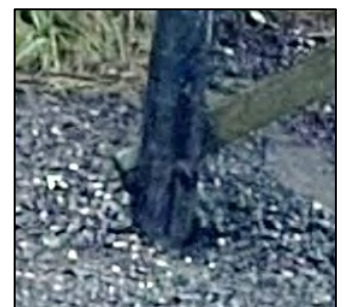
Figure 2.5: cross bracing connections corroded and in split timber

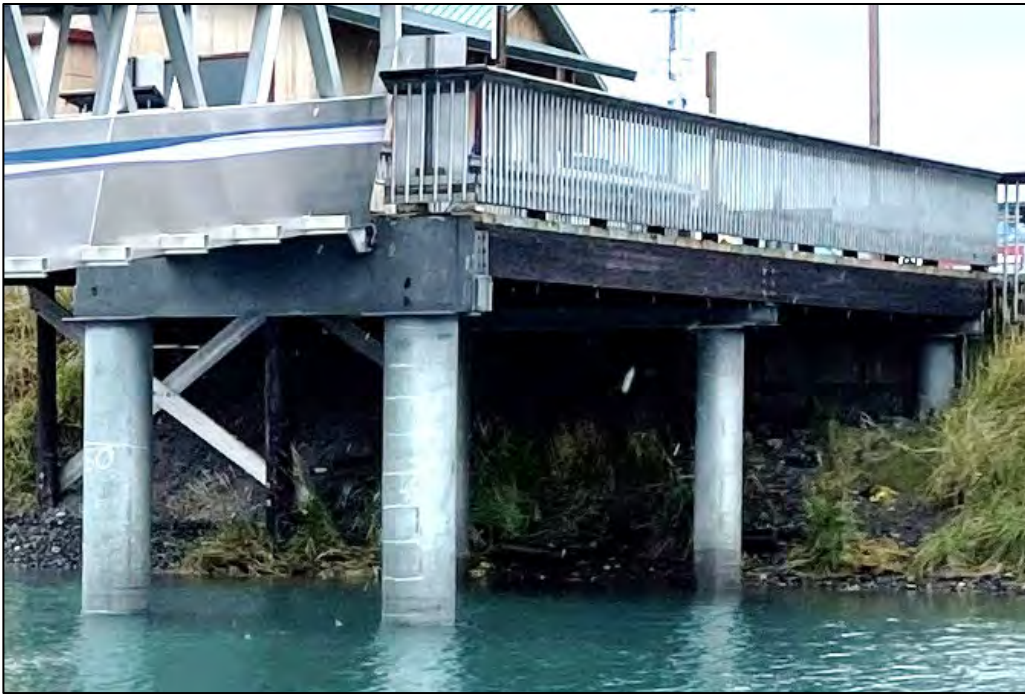
Figure 2.6: Ramp 3 trestle.

Ramp 3 has a timber trestle with steel piles and a 100-ft long roofed/sided gangway that was installed in 2015 (Figure 1.3). As noted, Ramp 3 is in good condition and provides ADA-access to Homer Harbor. The Ramp 3 timber trestle structure appears to be securely attached to the pile caps with steel plates (Figure 2.6). The seaward-most four piles have evidence of corrosion below tide line.

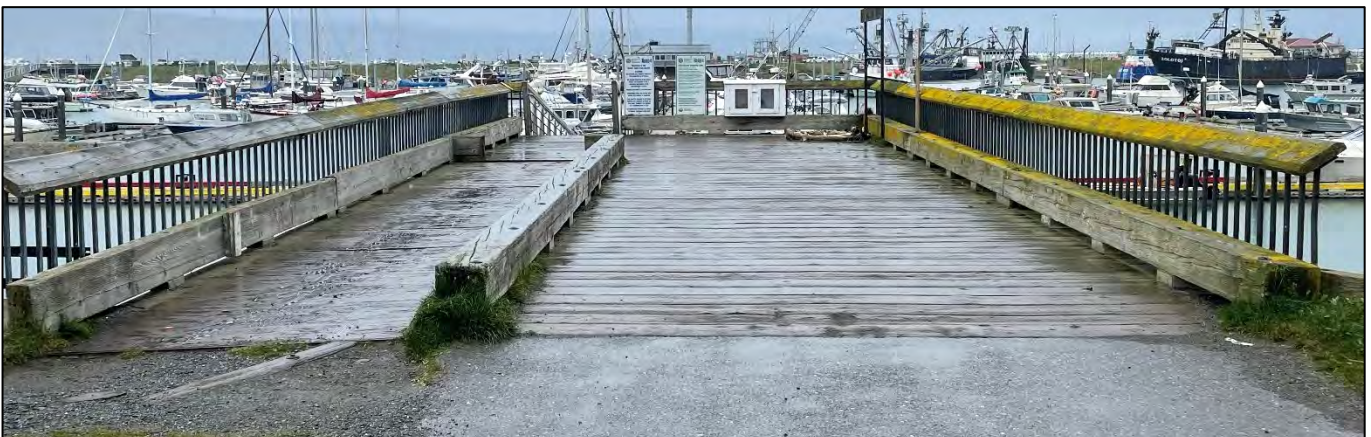
The Ramp 4 trestle has evidence of minor to moderate wear in decking as well as evidence of fungal decay and minor checks/splits in bullrails and handrails (Figure 2.7). The trestle appears to have had some modifications, with the shoreward end appearing older, more deteriorated than the seaward end. The steel piles at the seaward end are secured into the timber beams with steel plates and bolts, while the shoreward end of the timber structure appears to rest on the steel piles (Figure 2.8). Also noted, although not part of the harbor facilities being inspected, the adjacent timber retaining wall and steel piles that support the adjacent boardwalk appeared to be displaced and broken.

Figure 2.7: Ramp 4 trestle

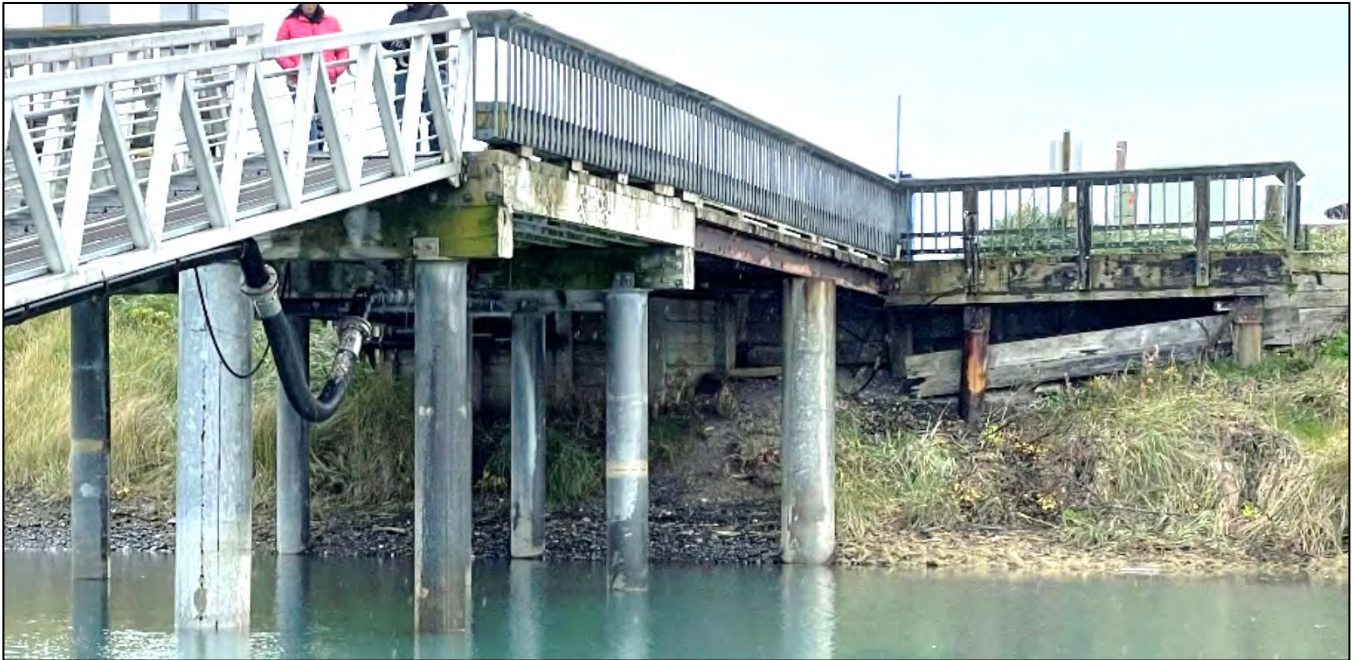
Figure 2.8: Ramp 4 trestle, noting newer/older portions of timber trestle and pile-to-beam attachments.

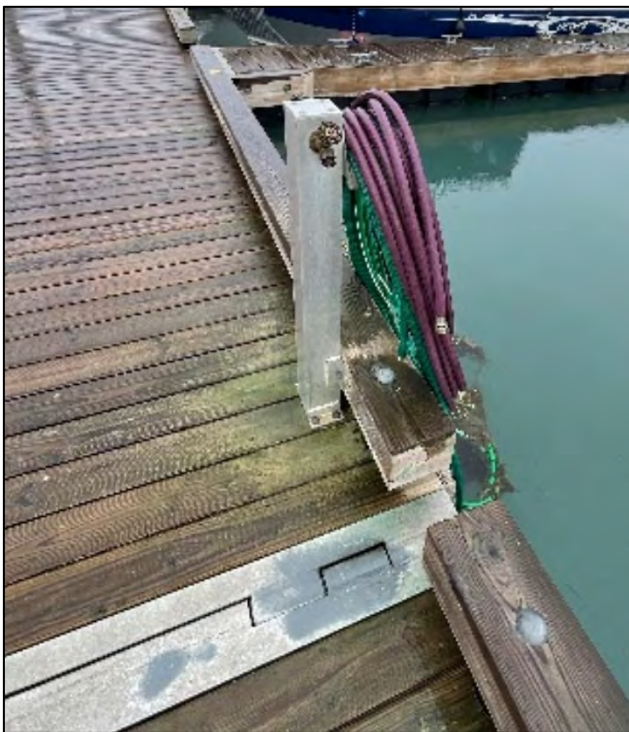
Figure 2.10: Hose bib riser, typical on R & S Floats. Note fungal growth on timber and partially worn anti-skid on steel hinge connections.

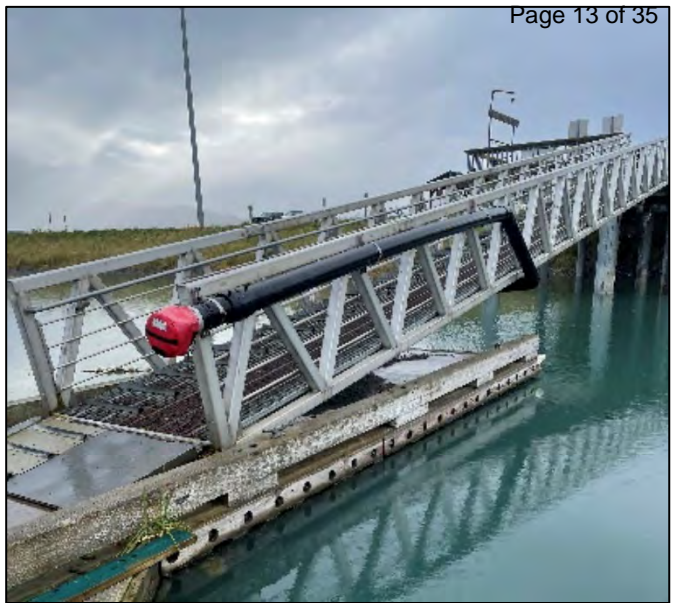
Fire suppression systems include fire extinguishers placed on the floats as well as a dry standpipe fire suppression system with an upland charging station for Fire Department use. According to the National Fire Protection Association (NFPA) 303 “*Fire Protection for Marinas and Boatyards*”, the fire suppression system appears to be inadequate because the above-water piping is HDPE which is not fire-resistant (Figures 2.12 and 2.13). A failure in part of the piping system due to melting during a fire could render the system useless or worse cause delay in fighting a fire. The above-water HDPE pipe should be replaced with metal pipe or it may be possible to install a suitable fireproof cover sleeve.

Figure 2.13: Fire system HDPE piping on Ramp 4.

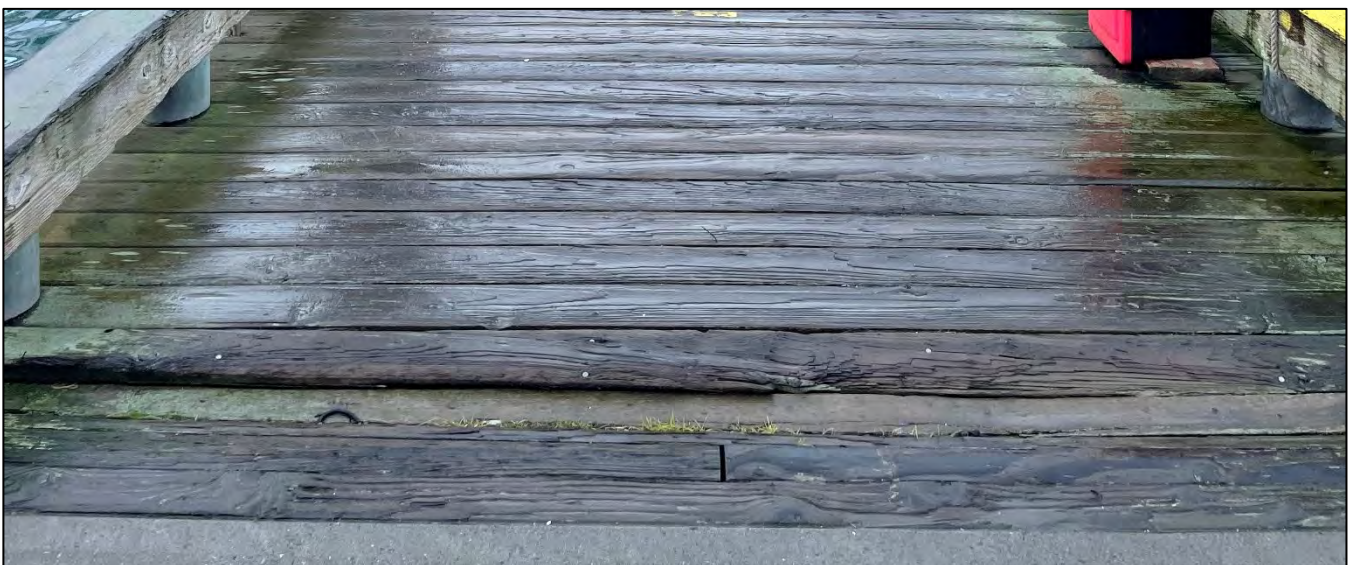
Figure 2.14: Typical decking wear at high traffic areas (float intersections)

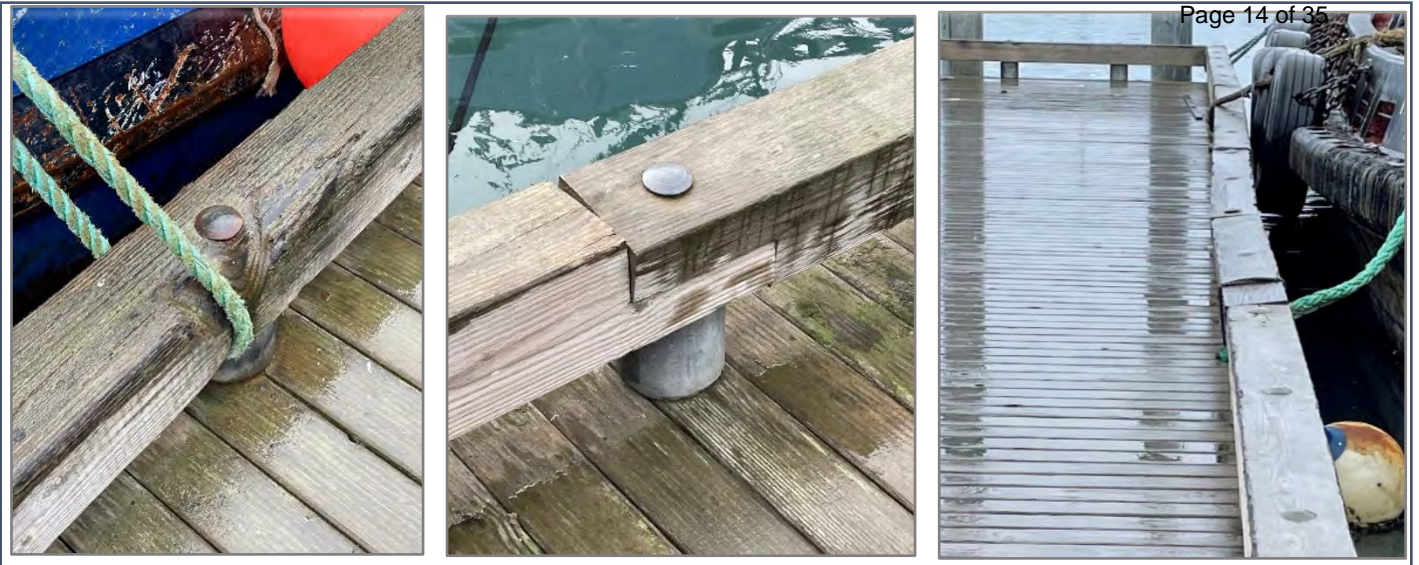
Figure 2.15: Bullrails worn, twisted out of position, and broken from supports.

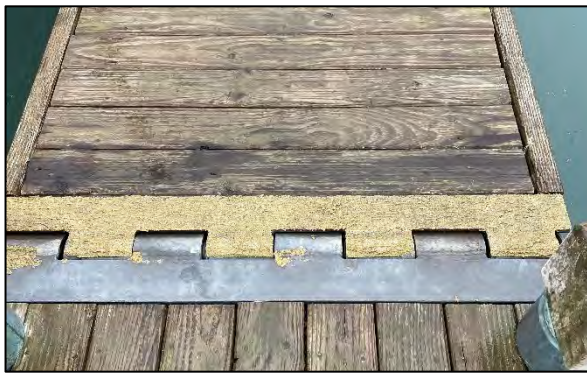
Figure 2.16: Worn non-skid coating at hinges.

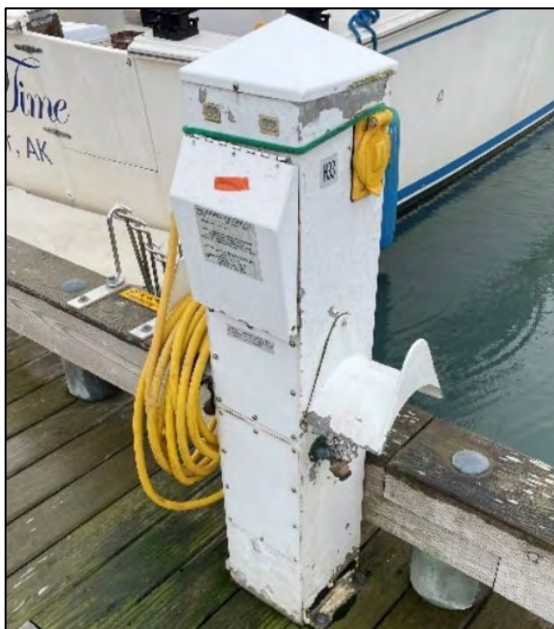
Potable water is piped within or under the floats and hose bibs are provided at each stall, along with power service in a combined pedestal, similar to that on J Float (Figure 2.3). However, the pedestals on these floats appeared to have a coating issue. The paint appeared bubbled and peeled in places, exposing the metal housing to corrosion (Figure 2.18).

Figure 2.18: Power/water pedestal coating damage

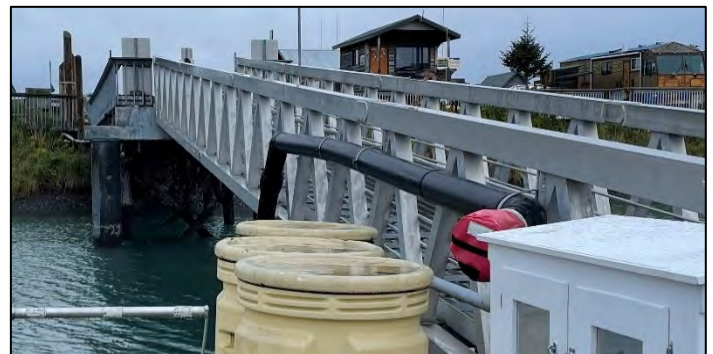
Fire suppression systems include fire extinguishers placed on the floats as well as a dry standpipe fire suppression system. The fire suppression system for these floats is supplied from Ramp 2 (Figure 2.17). The above-water piping for the fire suppression system is HDPE which is not a fire resistant material. The above-water HDPE pipe should be replaced with metal pipe or it may be possible to install a suitable fire resistant sleeve.

Figure 2.17: HDPE fire suppression piping at Ramp 2

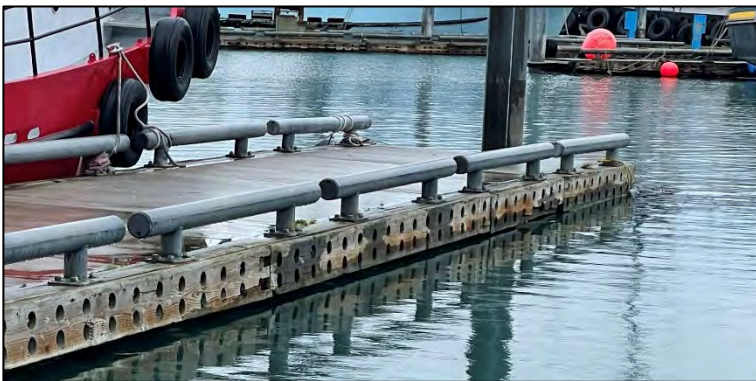
The floats were found to be in serious condition. The headwalk float A between B and D Floats appeared as well as the end of main Float C appeared to have a twist in the float suggesting possible broken concrete and/or through rods. In general, the freeboard was low throughout the facility indicating inadequate reserve flotation (Figure 2.19); moderate to major checks, splits, breaks and other damage to timber walers and rubboards (Figures 2.20 and 2.21), and corroded and missing through rods (Figure 2.22). Steel bullrails have been installed by mounting through damaged timber walers, which may result in loss of mooring.

Figure 2.19: Concrete stall float with low freeboard, and in the water at the end.

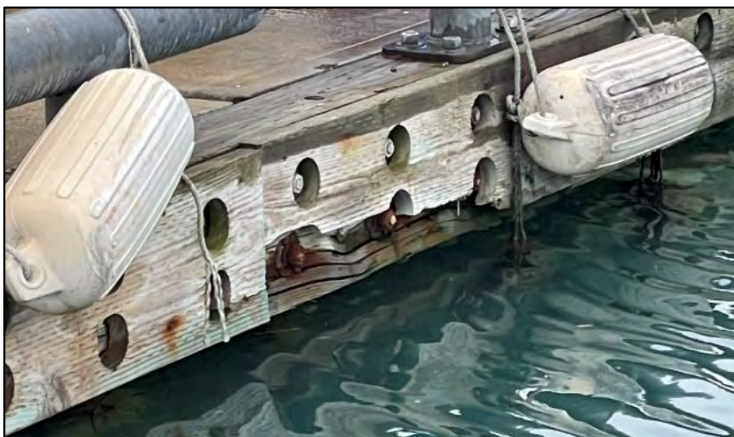
Figure 2.20: Broken rubboard and corroded through rods

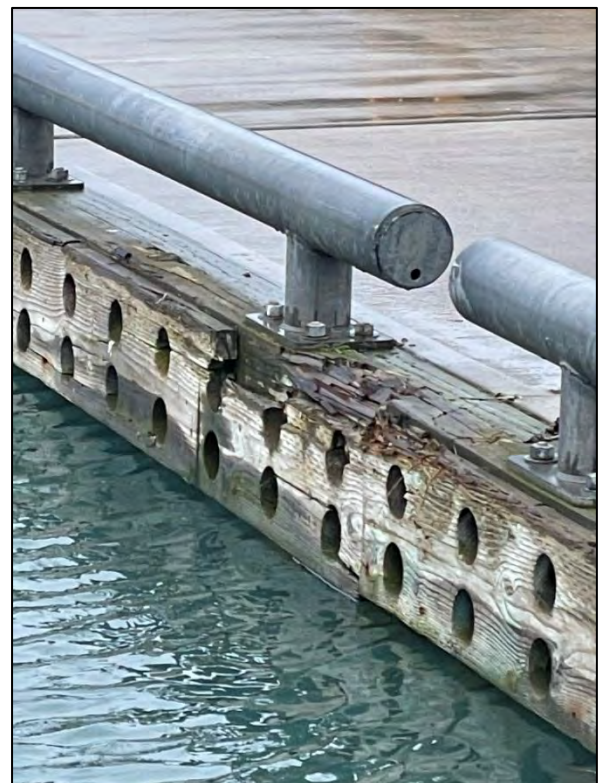
Figure 2.21: Deteriorated timber rubboard and waler. Steel bullrail mounted in waler.

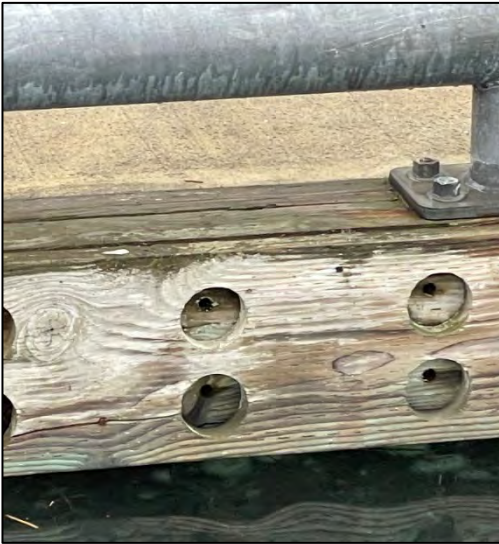
Figure 2.22: Missing through rods.

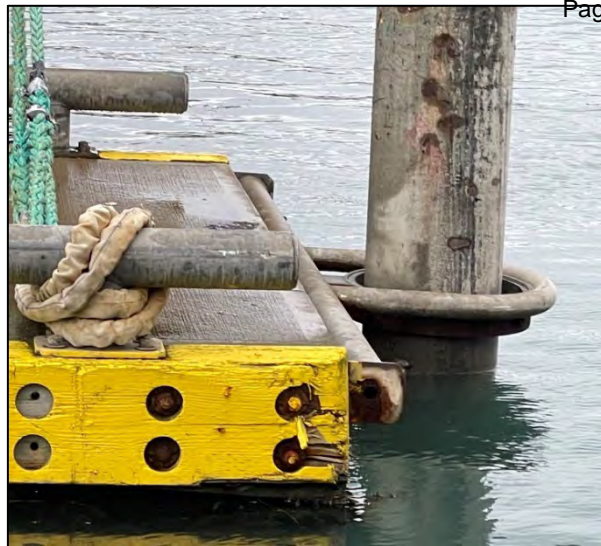
Piles generally had areas of consumed galvanizing within the tidal zone, and active corrosion was observed on some of the piles (Figure 2.23). The piles had new anodes installed in 2018.

Figure 2.23: Pit corrosion and other areas of active corrosion is evident on some piles

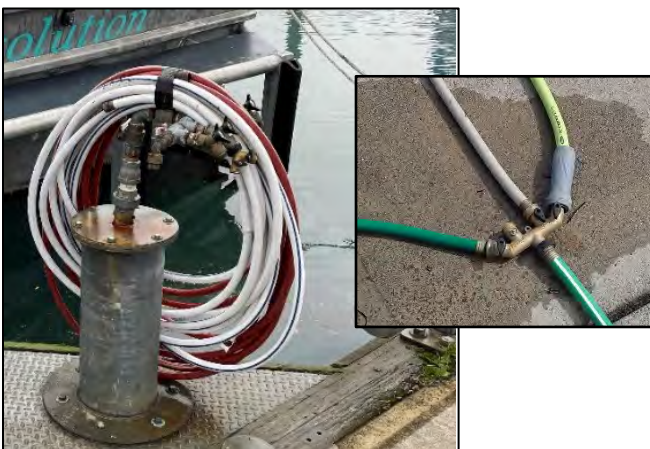
The water distribution system appears to be a piped system from the gangway ramp to the headwalk float, where a single riser with multiple hose bibs is provided near the intersection with each of the three main floats (Figure 2.24). In some locations hoses were attached to the outside of the main float to individual vessel slips. Garden hoses are typically not NSF-approved for potable water distribution and hence should not be used as part of a public water distribution system. Multiple hose connections indicate inadequate backflow protection (Figure 2.24).

Figure 2.25: Water service riser at the head of each main float (left) and multiple hose connections.

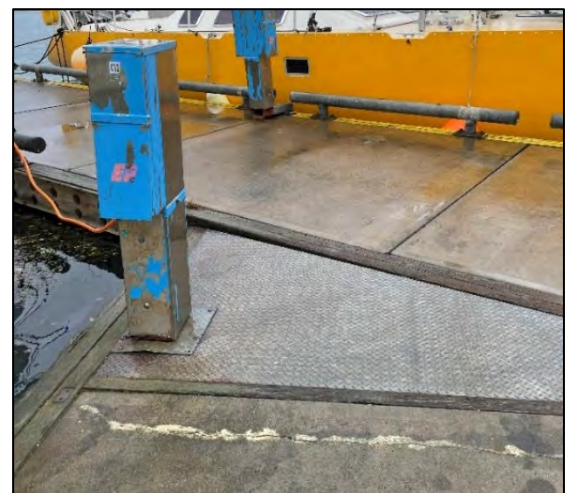
Power service is provided to B, C and D Floats. Many power pedestals have broken or loose mounts (Figure 2.25).

Figure 2.24: Typical power pedestal, many with damaged mounts. Note also typical minor crack in concrete.

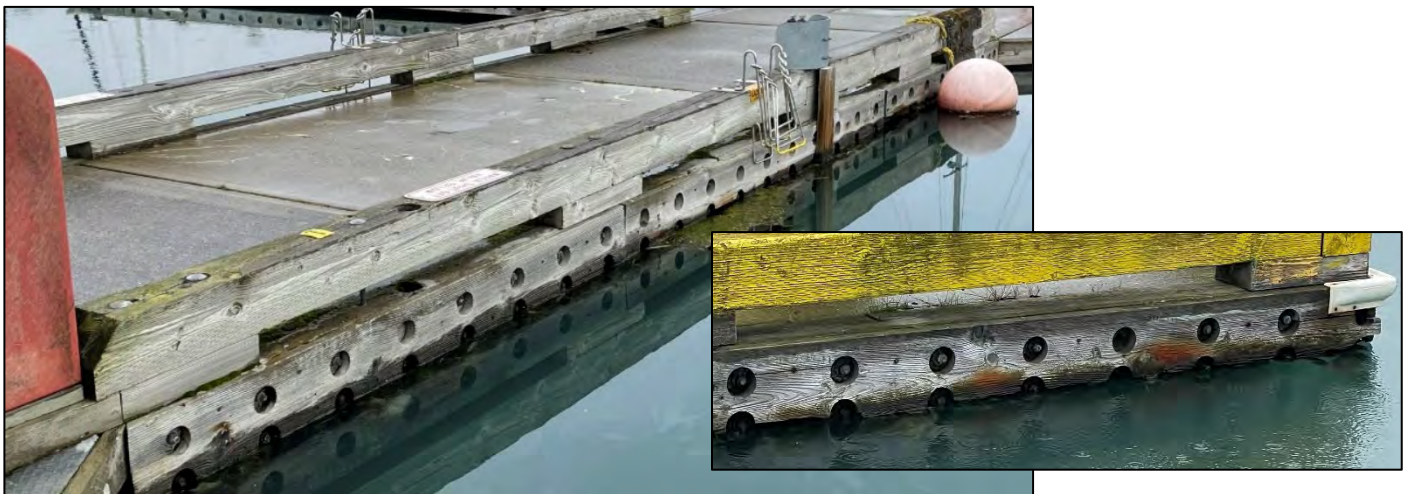
The 1986 Concrete Floats in System 1 include Main Floats K, L, M, N, P, Q and connecting headwalk Float A from S Float (Drawing G2). The concrete floats in this portion of System 1 are generally in serious condition, with some specific areas in critical condition. There is very low freeboard throughout the float system (Figure 2.26). Concrete surfacing has widespread areas of patched concrete over patched concrete—showing many years of repairs (Figure 2.27). Some stall floats are listing to one side or have been refurbished by adding timber decking added over the top and lumber attached to the sides (Figure 2.27). The City has added floatation to some of the headwalk/utility floats to keep them from sinking. Many areas of fungal decay and vegetation were observed. Timber bullrails and walers have moderate to major checks and splits, some running through the full depth of the member as well as some that are partially broken from their mountings (Figure 2.28). Cleats mounted in decayed or broken walers also have reduced capacity.

Figure 2.26: Concrete floats showing low freeboard and corroding and missing through rods.

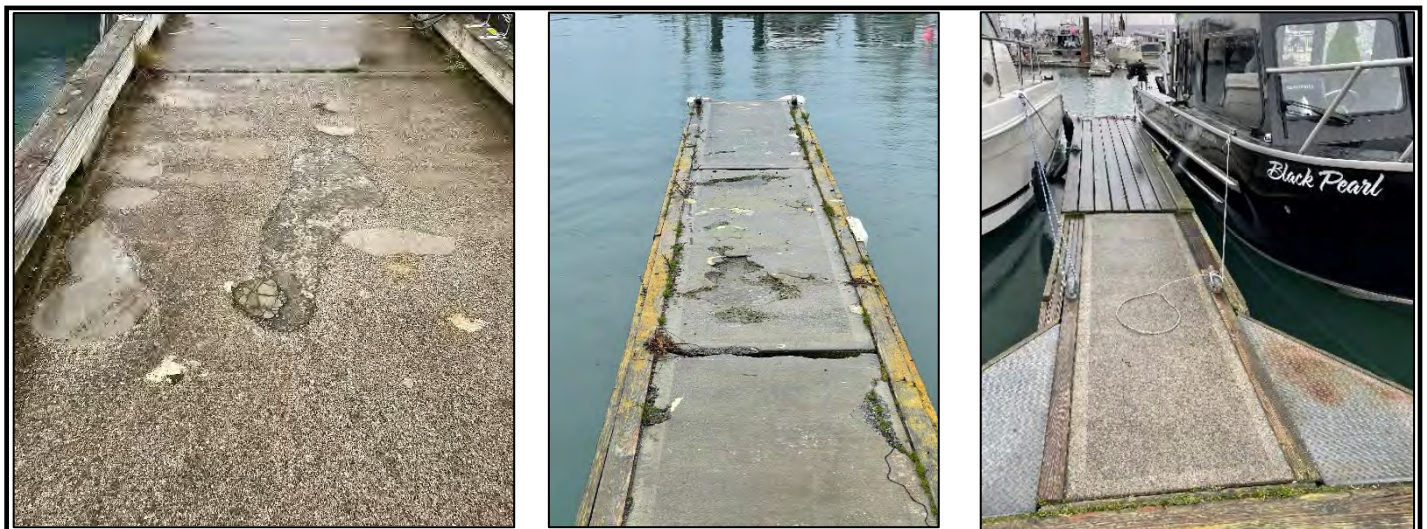
Figure 2.27: Deteriorated concrete surface and concrete repairs, including covering with timber decking.

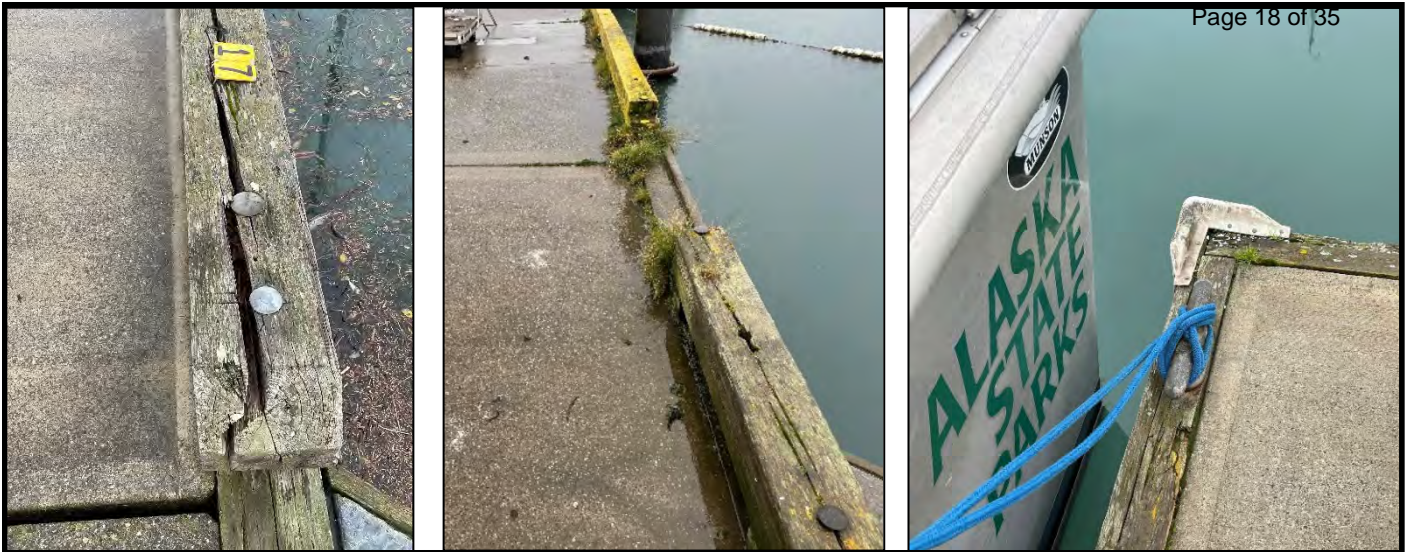
Figure 2.28: Bullrails will major splits and missing section, and cleat mounted in damaged timber waler.

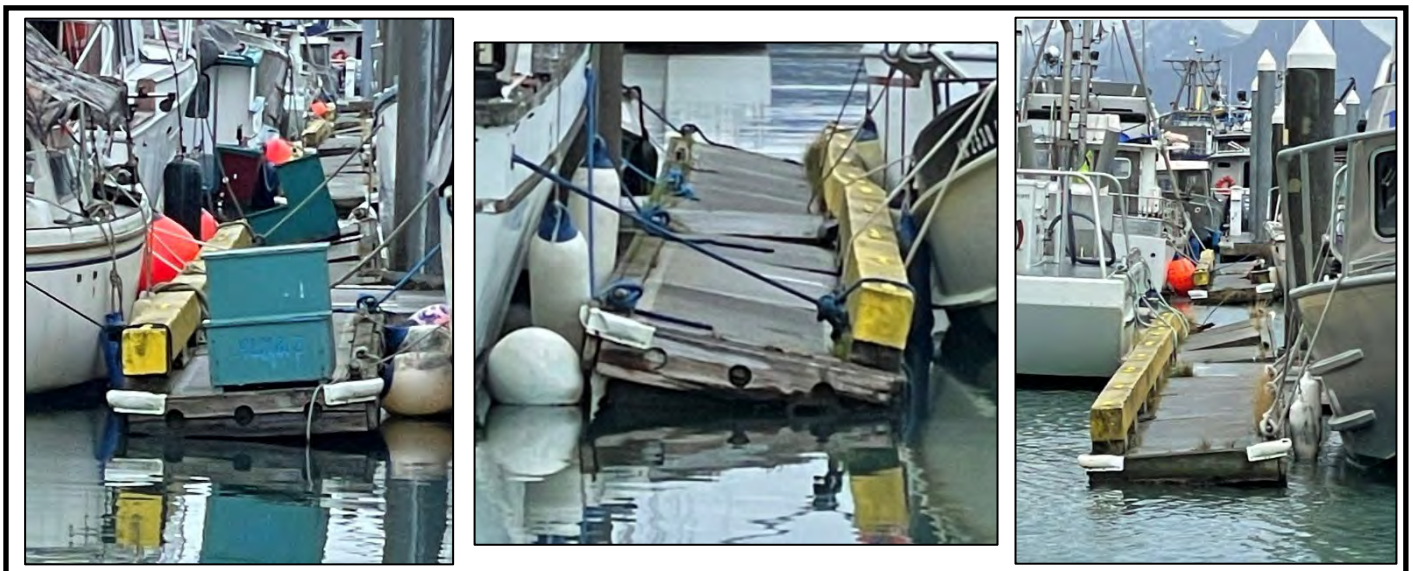
Stall flats on both sides of the Tee floats, at the end of each of the main float rows (Q, P, N, M, L, and K) nearest the main harbor navigation channel, are severely listing and broken loose from their connections to the main float (Figure 2.29). Walers on these floats have major deterioration. Modifications have been made to keep the floats from coming apart (Figure 2.30). It is thought that wave action in the channel acting on the moored vessels in the end slips has overstressed the end floats and caused breakage of the deteriorated structural members in these float connections. This is considered an area of critical condition and immediate repair or removal of the end floats and/or restrictions on use of these slips should be implemented as soon as practicable. Except for these end floats, the rest of these concrete floats in this area are considered to be in serious condition. When these floats are eventually replaced, the fairway distance between J and K Floats as well as between Q and R Floats should be increased to meet current standards (Drawing G2).

Figure 2.29: Tee floats, located along the harbor channel, are broken and severely listing.

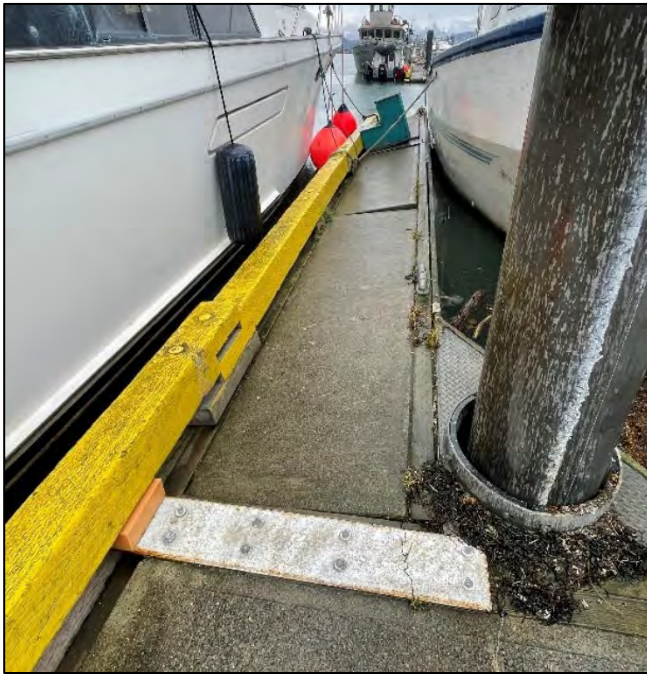
Figure 2.30: A metal plate has been installed to a broken Tee Float. Note the bullrail has come apart at the splice.

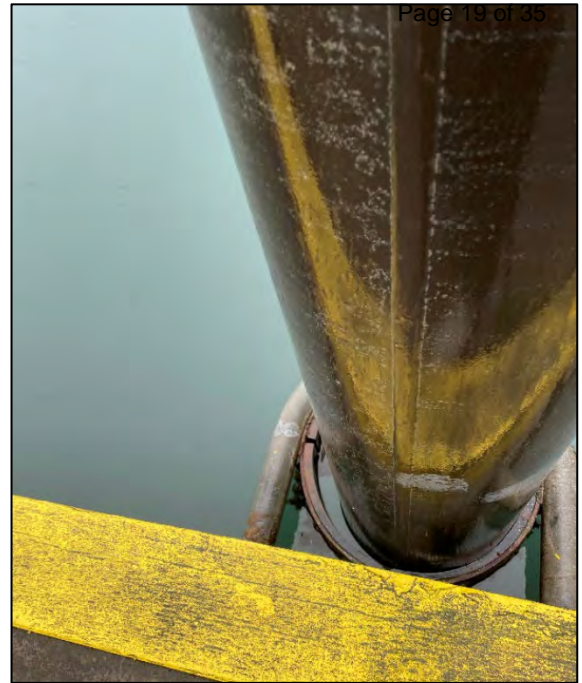
Steel piles are used to secure the floats, and in this area of System 1 the original galvanized coating on many of the piles has been consumed and there is evidence of corrosion (Figure 2.31). A project is underway to install anodes on the piles in this area.

Figure 2.31: Typical steel pile and exterior pile hoop. Note galvanized pile coating is consumed

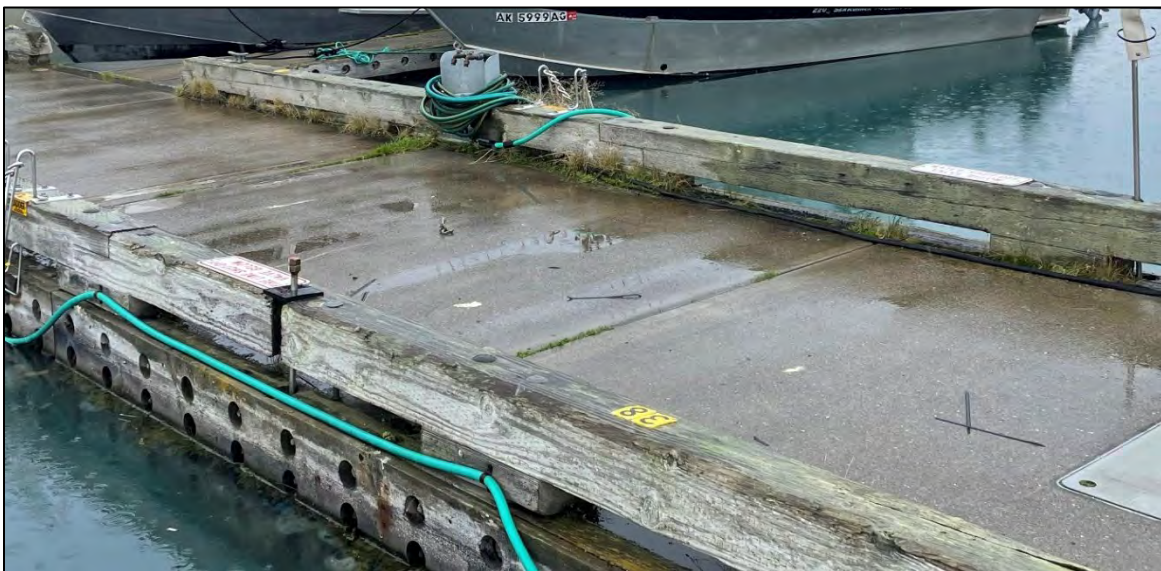
Figure 2.32: Water service on main float. Note T-handle used to operate the water valve, which is located underneath the float. Garden hoses run from under the float and are attached to the side of the float in places.

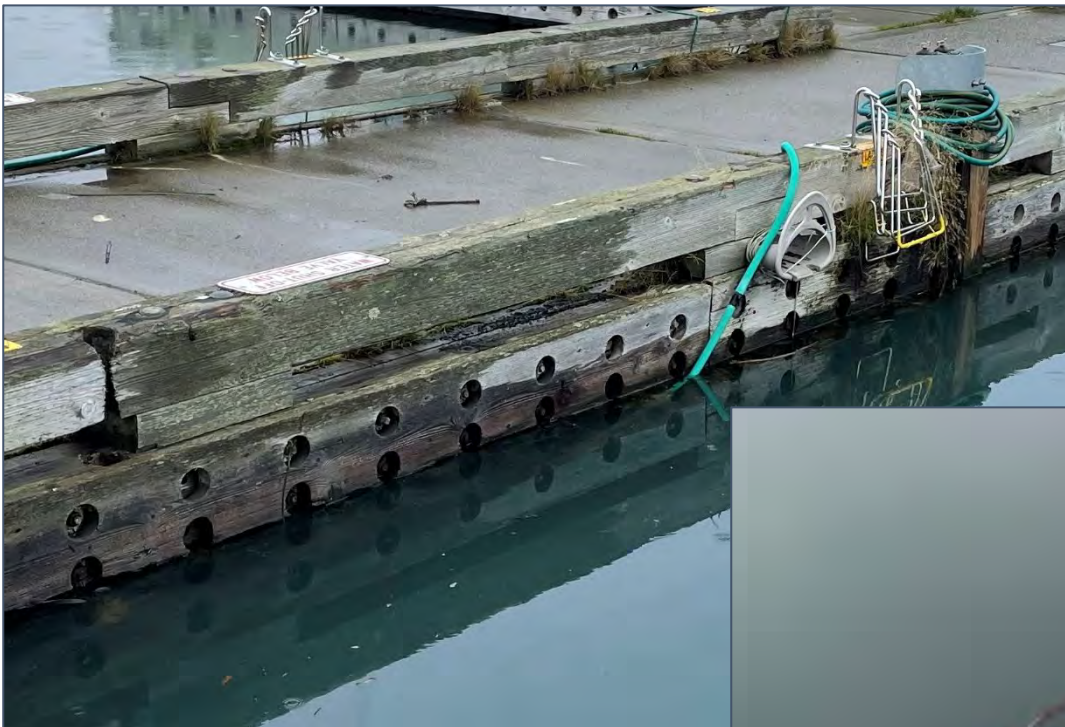
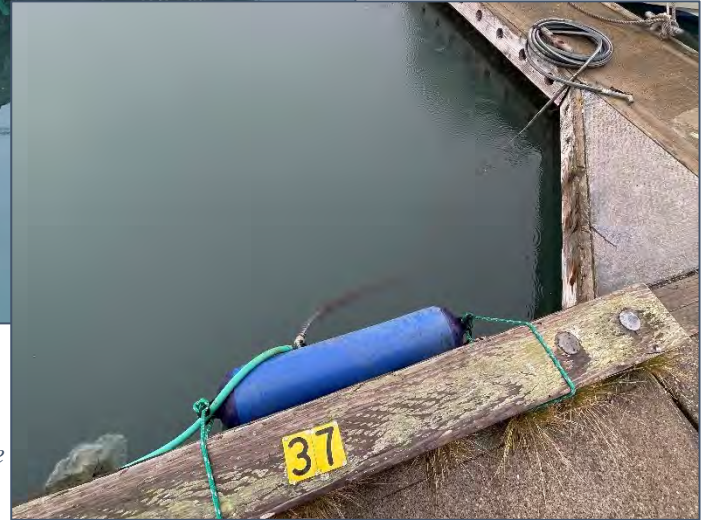
*Figure 2.33: Water distribution, with location of valve at the far left (photo above) and hose coming up from under the float. Photo to right shows a hose from under the float to a 3-way connection, with one end going under the float and the other to a nearby slip, with a sprayer attachment.*

Note that the garden hoses are not NSF-approved materials and so would not satisfy the requirements of a public water system for potable water use. It is unlikely, given all the various hose connections, that sufficient backflow prevention is provided. Signs should be posted to clarify the water is non-potable. When new floats are installed, the new water system should be constructed of materials suitable for drinking water and include proper backflow prevention, as regulated/permitted by Alaska Department of Environmental Conservation (ADEC).

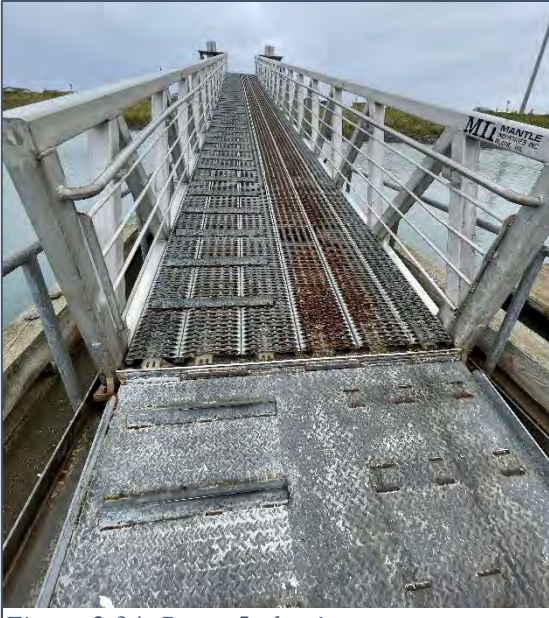
Figure 2.34: Ramp 5 aluminum gangway w steel floor grating.

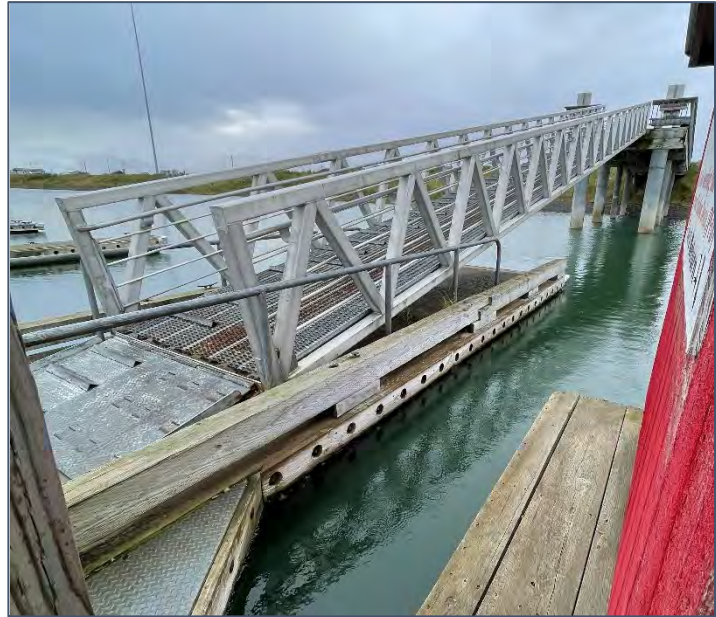
The Ramp 5 approach trestle and gangway have evidence of wear, typical of their age. Steel piles have evidence of corrosion in the tidal zone. Trestle timber treatment is reduced, some minor cracking in pile caps, and decking has evidence of wear. The gangway ramp, at 70-ft long does not meet ADA-guidelines; however, as long as there are sufficient ADA slips (5 total) in the 20-24-ft length available in the harbor (i.e., System 1), this is not required; although it is recommended to replace the ramp with an 80-ft minimum length ADA ramp when the trestle and/or floating docks are replaced. The gangway ramp bottom slide guides have evidence of wear and these as well as the steel floor grating have evidence of corrosion (Figure 2.34). However, there is no visible major damage or defects that immediately affect the capacity of these structures; other than the float on which the gangway ramp lands has low freeboard, as is noted by the timber walers in/near the water especially at the shoreward end (Figure 2.35).

Figure 2.35: Ramp 5 trestle and gangway. Note landing on concrete float with reduced freeboard.

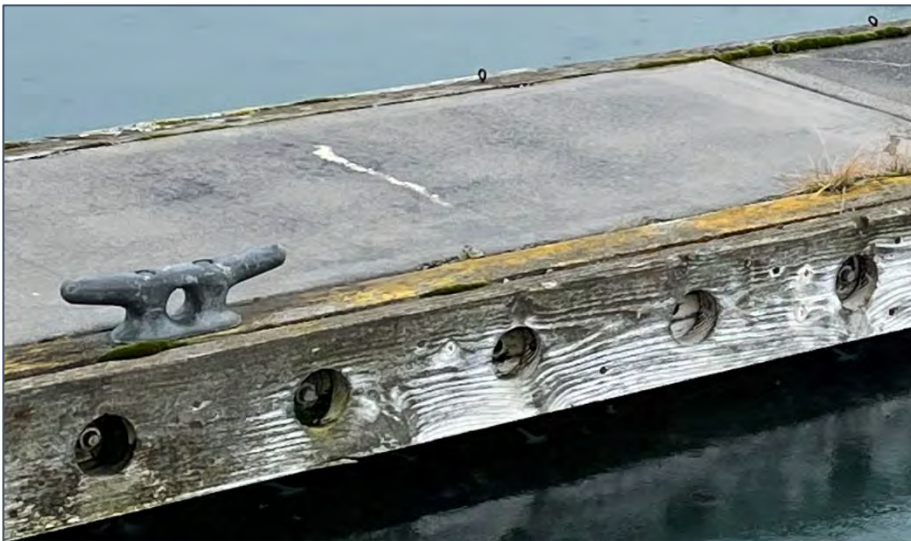
*Figure 2.37: Through rods corroded or missing.*

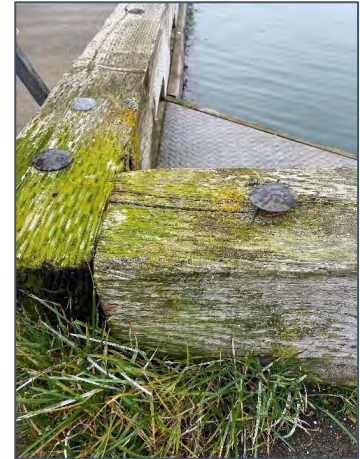
*Figure 2.38: Deteriorated bullrails*

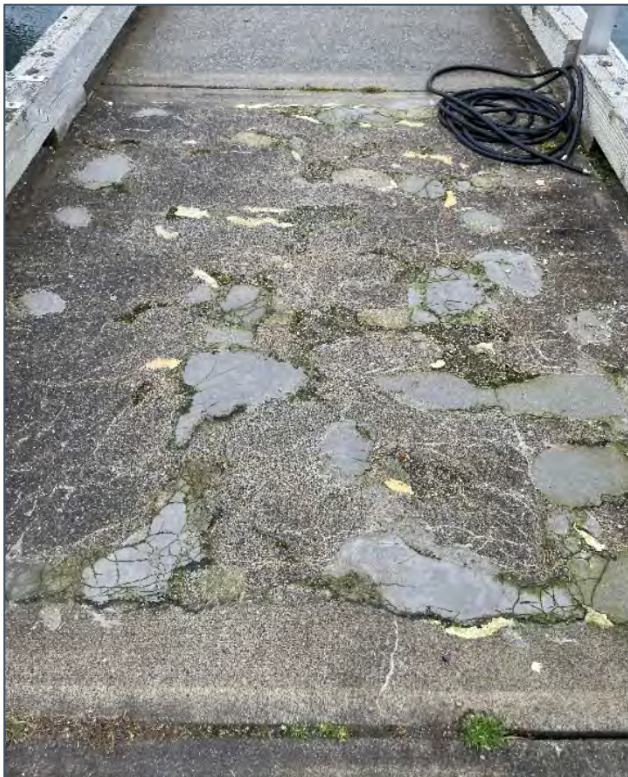
Years of maintenance is evident: patches over already patched concrete (Figure 2.39) decking over deteriorated concrete stall floats (Figure 2.41), replacing sections of timber bullrails and rubboards, and adding safety equipment including fire extinguishers and ladders is evident and have allowed continued use of these floats.

*Figure 2.39: Deteriorated/patched concrete on main floats.*

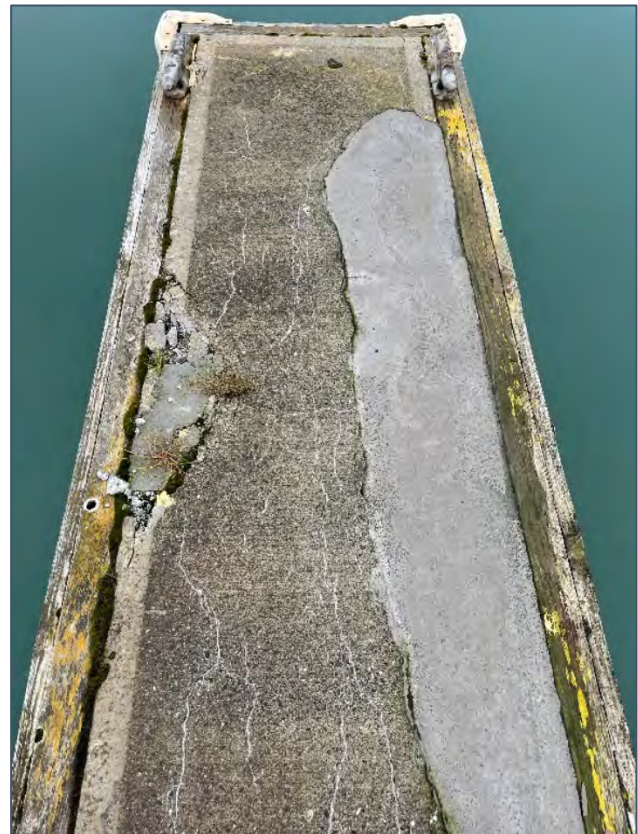
*Figure 2.40: Patched concrete and deteriorated waler and rubboards on stall floats.*

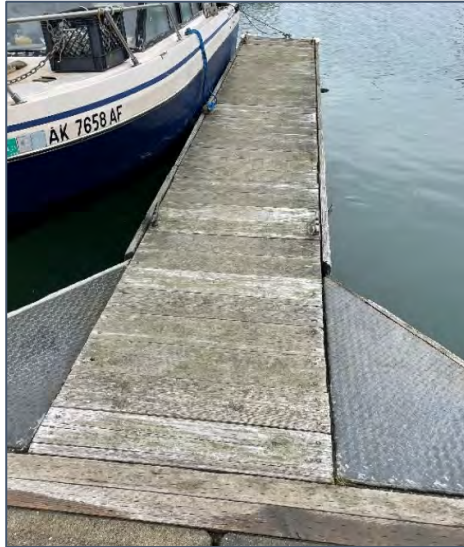
Figure 2.41: concrete stall float with decking attached over the top.

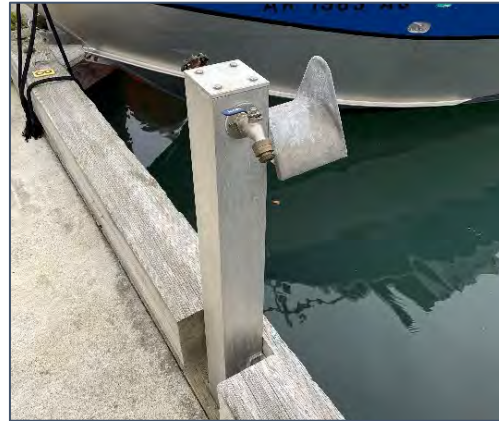
The water distribution system at System 2 appears to have been added and modified over the years. It is fed from System 1 (S Float) via an underwater flex hose. Hose bib stanchions are located periodically on the floats (Figure 2.42). Users run hoses across the floats to the nearest hose bib. A reduced pressure backflow prevention assembly was not evident/observed for this system. The hose bibs are equipped with vacuum breakers; however, these are not reliable or normally accepted as the only backflow prevention device in a public water system. In addition, some hoses had splitters to individual slips, and these did not have vacuum breakers.

Figure 2.42: water hose bib and hose stand.
