# AGENDA ITEM REPORT

**Ordinance 23-12, An Ordinance of the City Council of Homer, Alaska Amending the FY23 Capital Budget by Appropriating \$63,070 from the Port Reserves Fund for Professional and Technical Assistance to Support Submission of a Port Infrastructure Development Program Grant Application for the Purpose of Float Replacement in the Small Boat Harbor. City Manager/Port Director.**

## System 1 Condition Report

*City of Homer*  
**Homer Small Boat Harbor  
Float Condition Assessment**

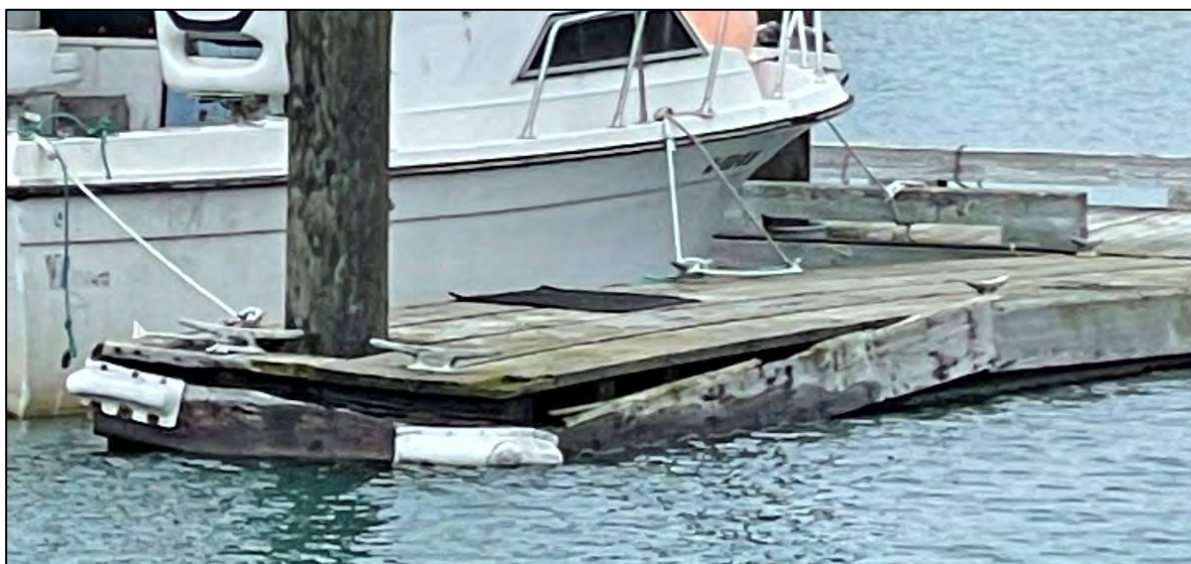
*Figure 2.43: Stall Float on CC Float with damaged timber waler, rubboard, and decking.*

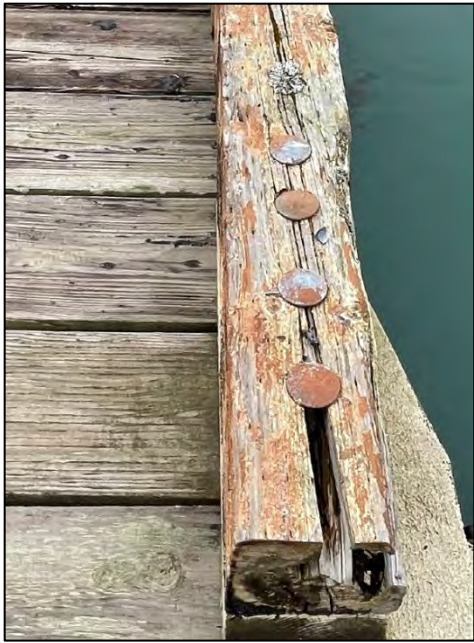
Figure 2.44: Cracked and deteriorated bullrail

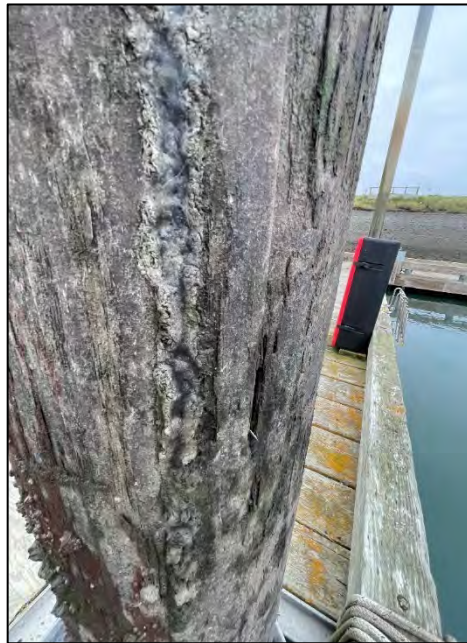
Figure 2.45: Timber pile with advanced deterioration/rot

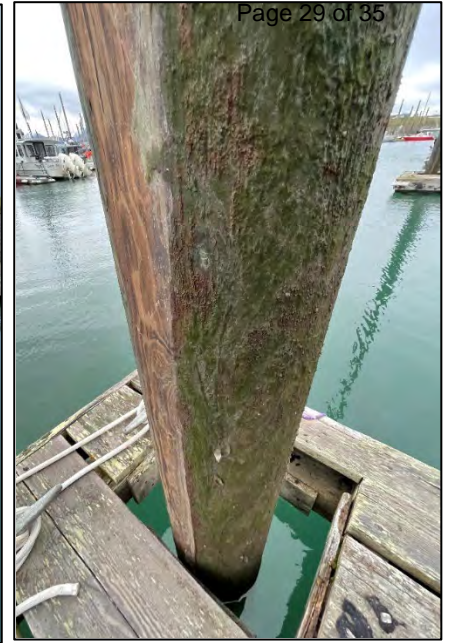
Figure 2.46: Moderate wear on timber piles.

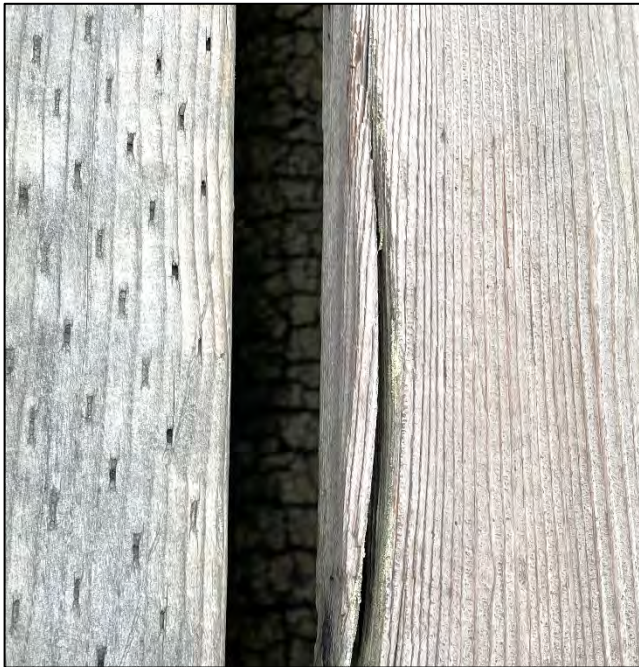
Figure 2.48: View between deck boards of deteriorated flotation foam.

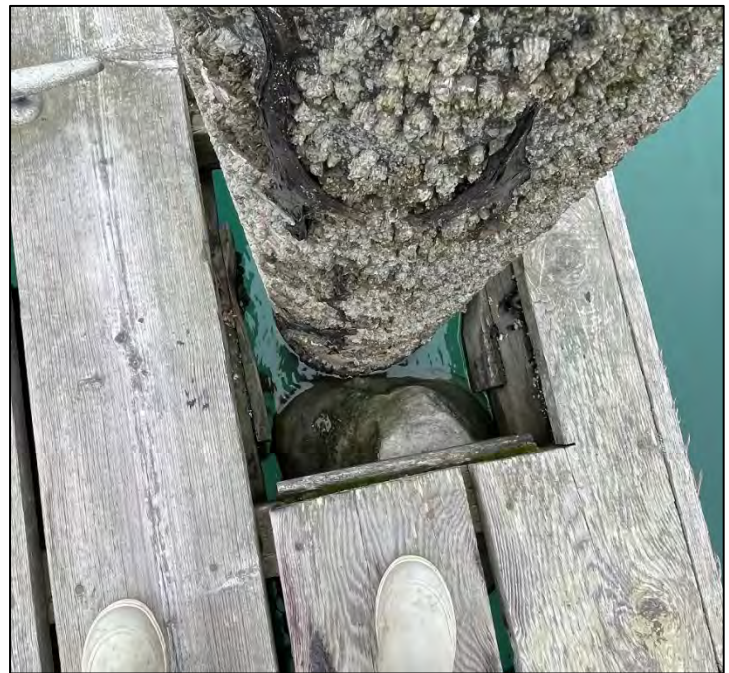
Figure 2.47: View under deck at a pile location. The odd shaped grey item floating between the pile and persons foot is very deteriorated flotation foam that is loose.

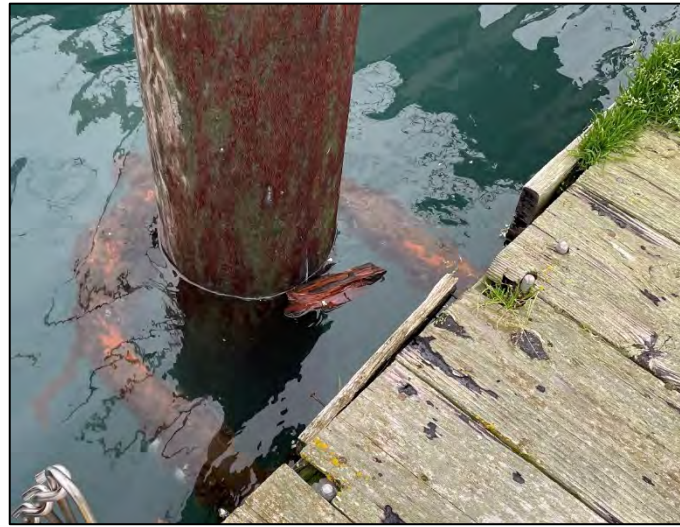
Figure 2.49: Low freeboard resulting in submerged pile collar. Also note hardware connections protruding through decking.

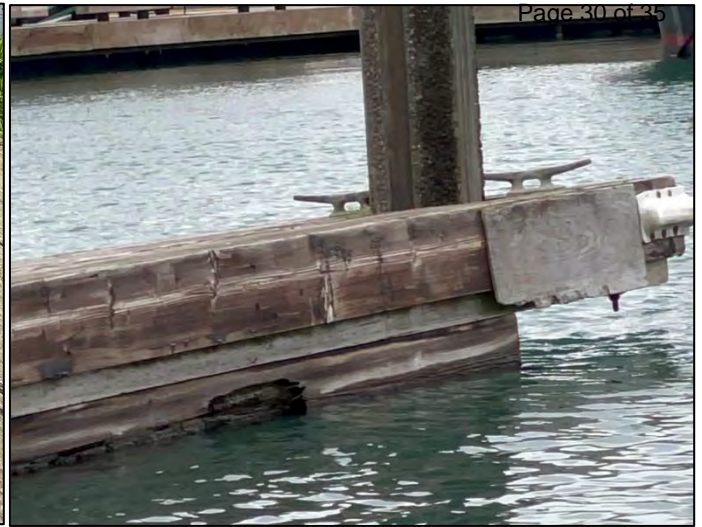
Figure 2.50: Example of a listing stall float (GG Float). Also note advanced rot/deterioration of below-deck timber.

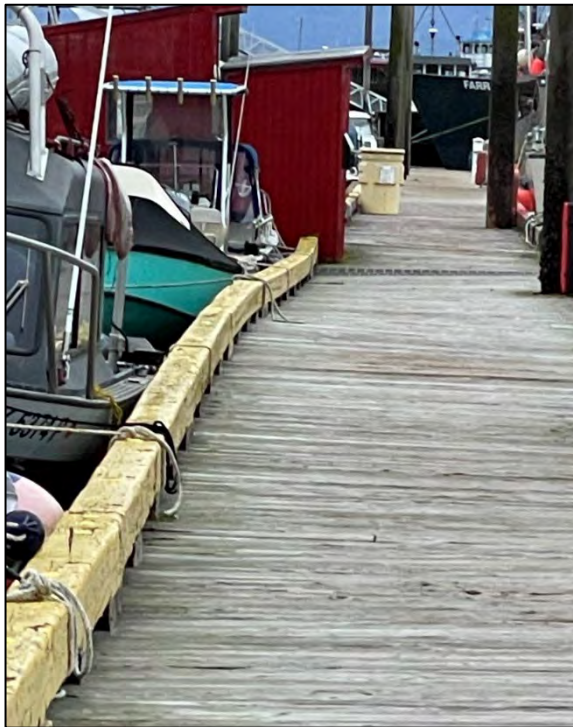
The headwalk Float AAA between Float EE and Float GG appears to be warped, suggesting a possible failure in structural members below the deck or lack of flotation or both (Figure 2.51). There are notably fewer piles on this section of Float AAA, which has contributed to this section of the float being overloaded.

Figure 2.51: Headwalk Float AAA between EE and GG Floats.

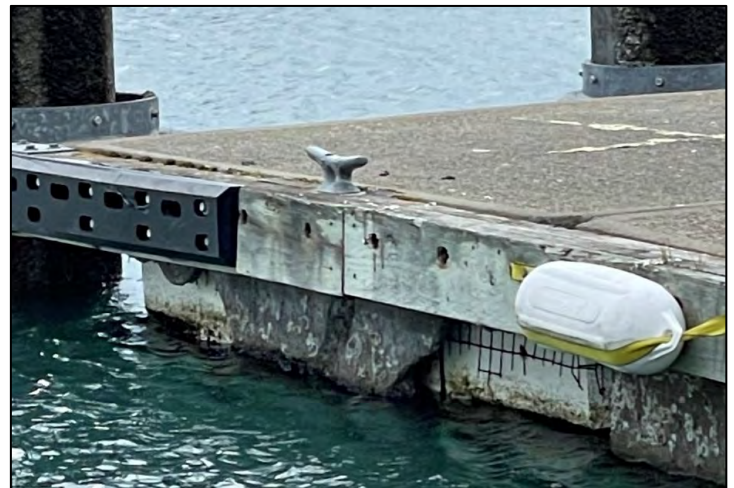
Concrete float modules located at the end of EE Float have spalled concrete, exposing the foam flotation and what may be a steel reinforcing mesh (Figure 2.52).

Figure 2.52: Spalled/missing concrete below deck with exposed foam and reinforcing.

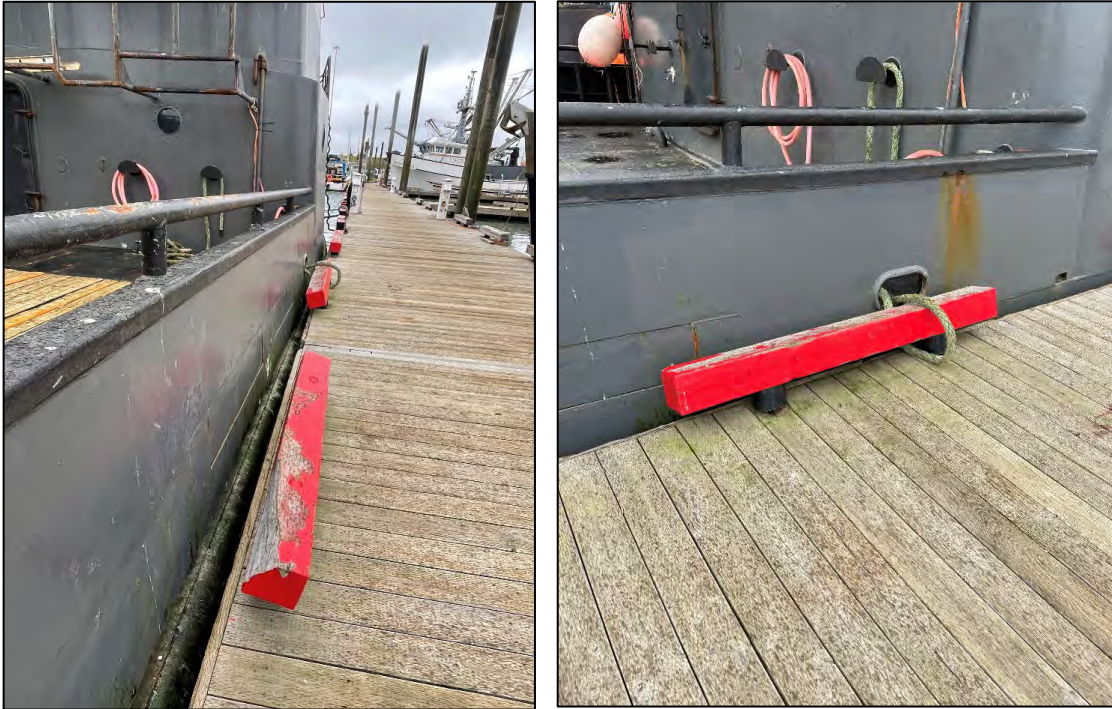
The FF Float system timber elements and steel piles and hardware show evidence of wear that is normal for a 20-year old facility with good maintenance. HH Floats and JJ Floats, along with the connecting AAA headwalk float were constructed in 2015 and appear to be good condition, with the exception of several bullrails, which appear to be overstressed. Several bullrails are damaged and bent at their mountings (Figure 2.53). Repairs might include more robust bullrail connections

Figure 2.53: Example of several bullrails that have been damaged on JJ Float.

that are more suitable for the vessels utilizing this float, possibly mounted to interior structural members offset from the edge of the float.

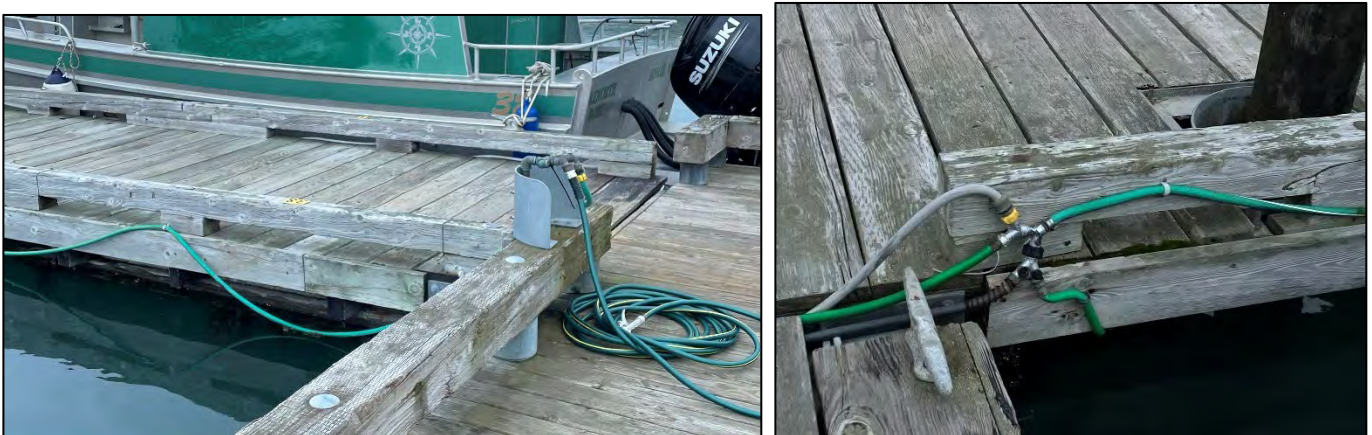
Note that the garden hoses are typically not NSF-approved materials and so would not satisfy the requirements of a public water system for potable water use. Given the various hose connections, backflow contamination is possible. Signs should be posted immediately to indicate the water is non-potable. When new floats are installed, the new water system should be constructed of materials suitable for drinking water and include proper backflow prevention, as regulated/permitted by ADEC.

Figure 2.54: Typical water service to main floats provided from headwalk float by various hoses/connections.
