# AGENDA ITEM REPORT

**Ordinance 23-12, An Ordinance of the City Council of Homer, Alaska Amending the FY23 Capital Budget by Appropriating \$63,070 from the Port Reserves Fund for Professional and Technical Assistance to Support Submission of a Port Infrastructure Development Program Grant Application for the Purpose of Float Replacement in the Small Boat Harbor. City Manager/Port Director.**

# Homer Small Boat Harbor Floating Dock Replacement Project Estimate (2022 US\$)

## System 1 Condition Report

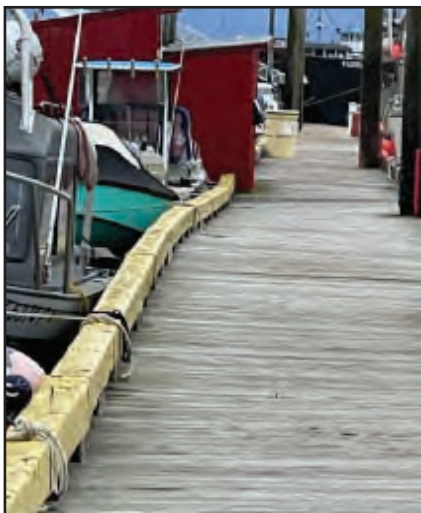
The Headwalk Float AAA is warped, suggesting a failure in the structural members below the deck and lack of flotation..

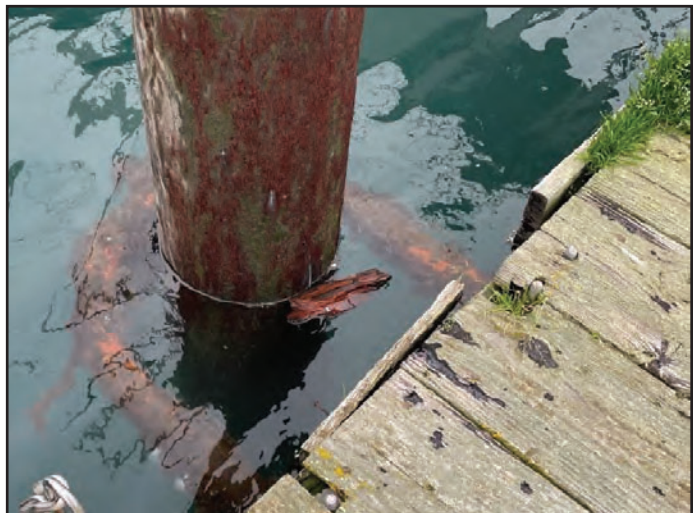
Low freeboard resulting in submerged pile collar. Decking has rot and hardware connections protrude through it.

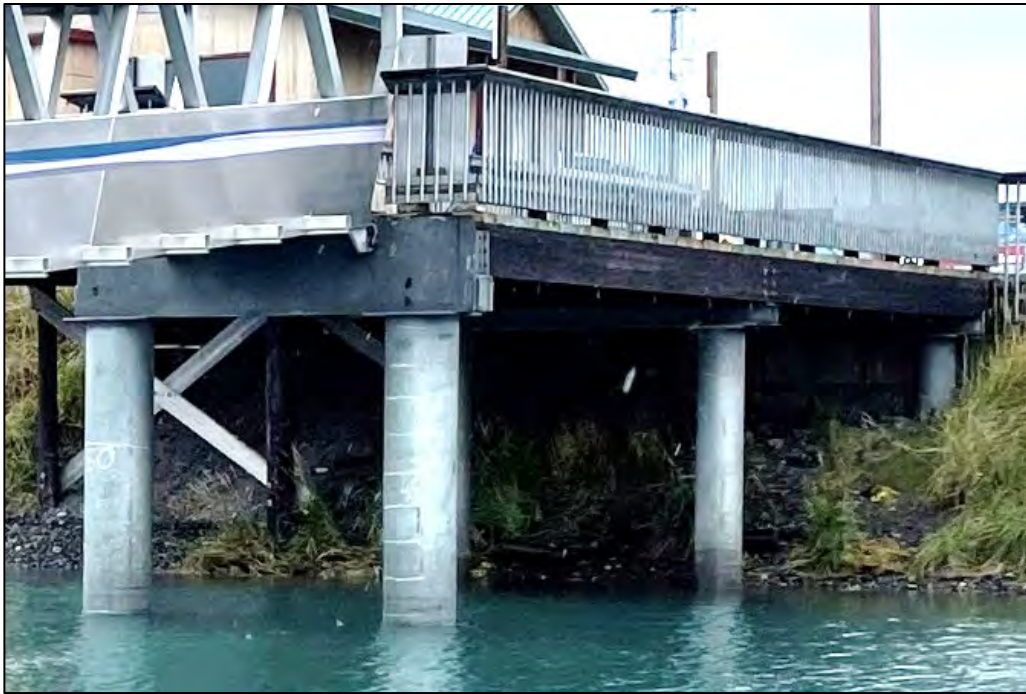
Figure 2.6: Ramp 3 trestle.

Ramp 3 has a timber trestle with steel piles and a 100-ft long roofed/sided gangway that was installed in 2015 (Figure 1.3). As noted, Ramp 3 is in good condition and provides ADA-access to Homer Harbor. The Ramp 3 timber trestle structure appears to be securely attached to the pile caps with steel plates (Figure 2.6). The seaward-most four piles have evidence of corrosion below tide line.

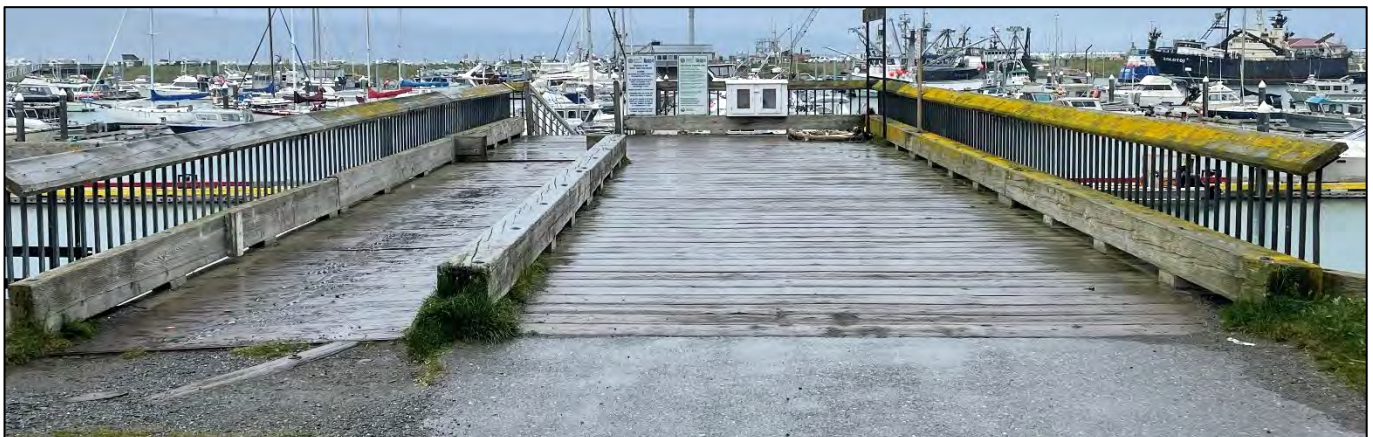
The Ramp 4 trestle has evidence of minor to moderate wear in decking as well as evidence of fungal decay and minor checks/splits in bullrails and handrails (Figure 2.7). The trestle appears to have had some modifications, with the shoreward end appearing older, more deteriorated than the seaward end. The steel piles at the seaward end are secured into the timber beams with steel plates and bolts, while the shoreward end of the timber structure appears to rest on the steel piles (Figure 2.8). Also noted, although not part of the harbor facilities being inspected, the adjacent timber retaining wall and steel piles that support the adjacent boardwalk appeared to be displaced and broken.

Figure 2.7: Ramp 4 trestle

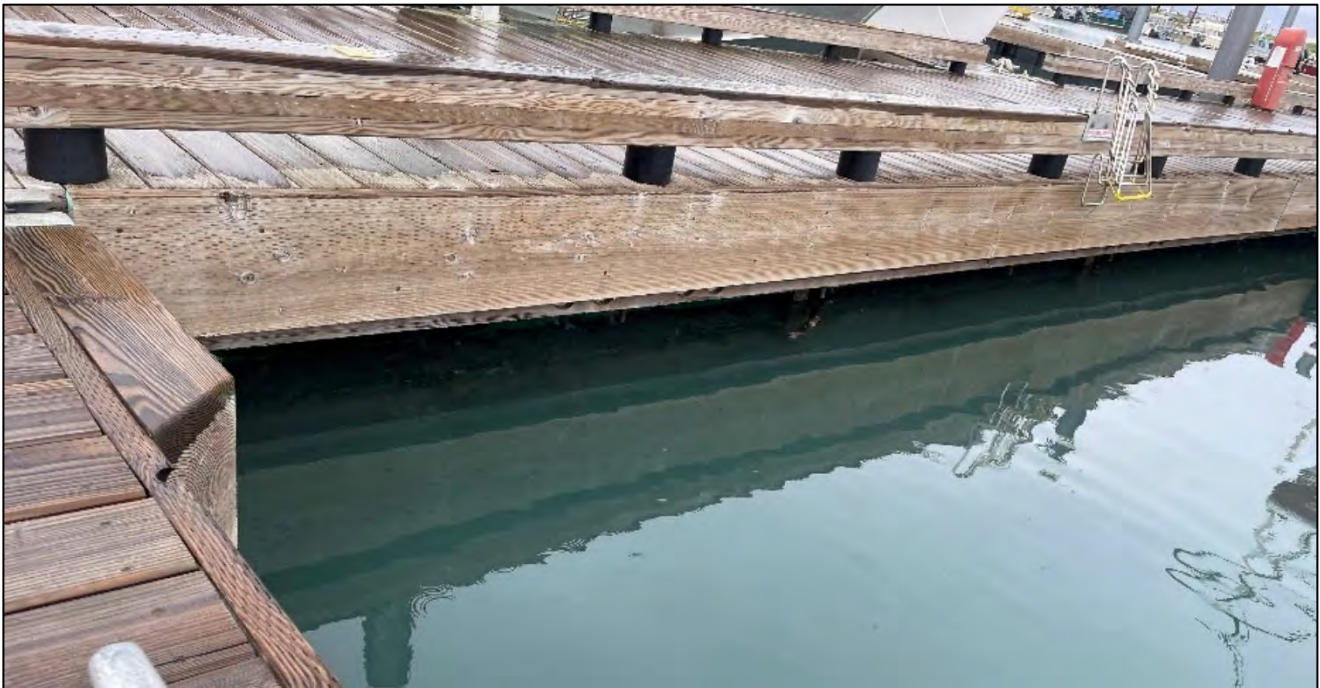
Figure 2.9: Timber floats have sufficient freeboard and reserve flotation.

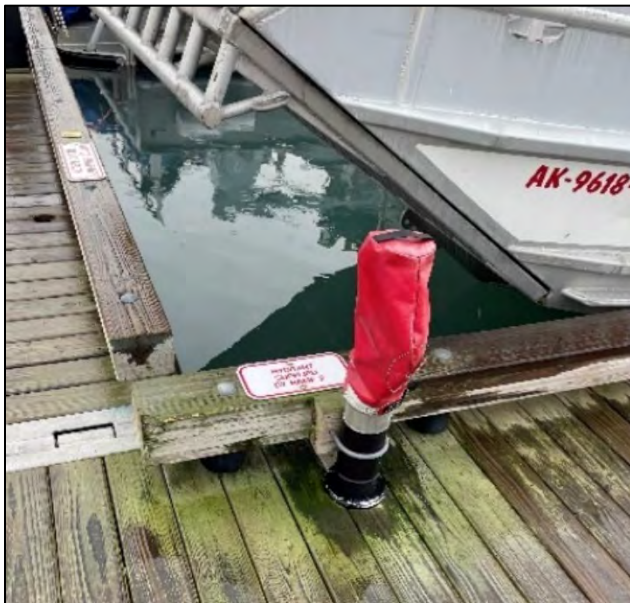
Figure 2.12: Fire suppression system standpipe/hydrant near J Float

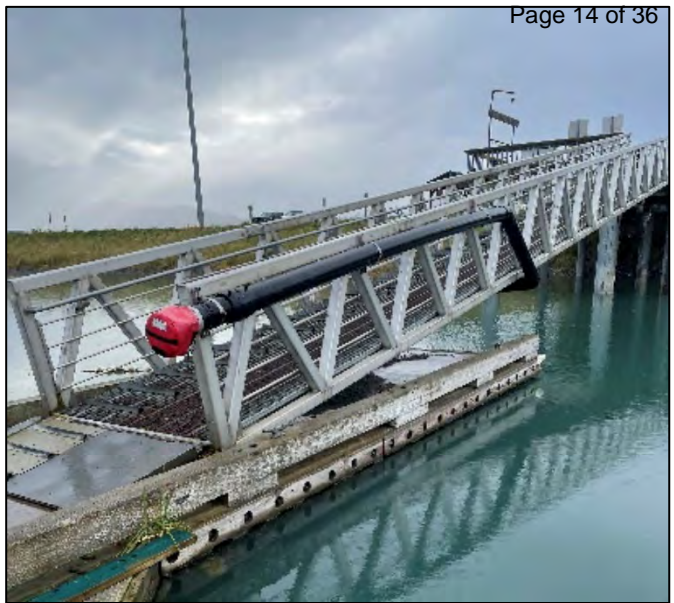
Figure 2.13: Fire system HDPE piping on Ramp 4.

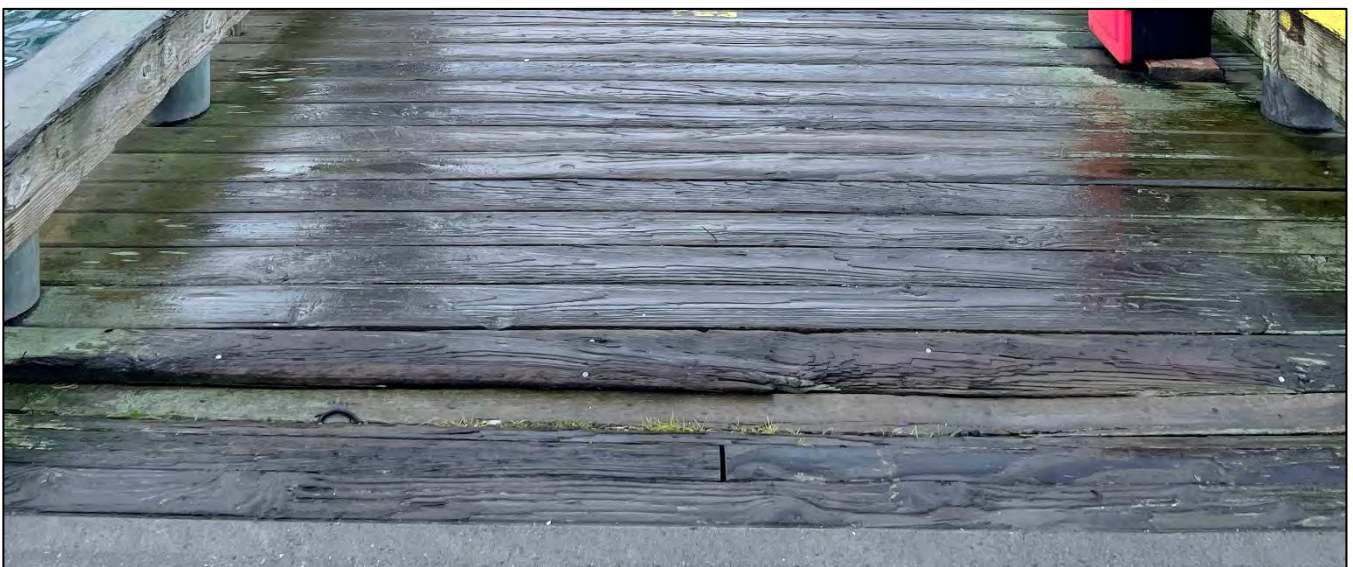
Figure 2.14: Typical decking wear at high traffic areas (float intersections)

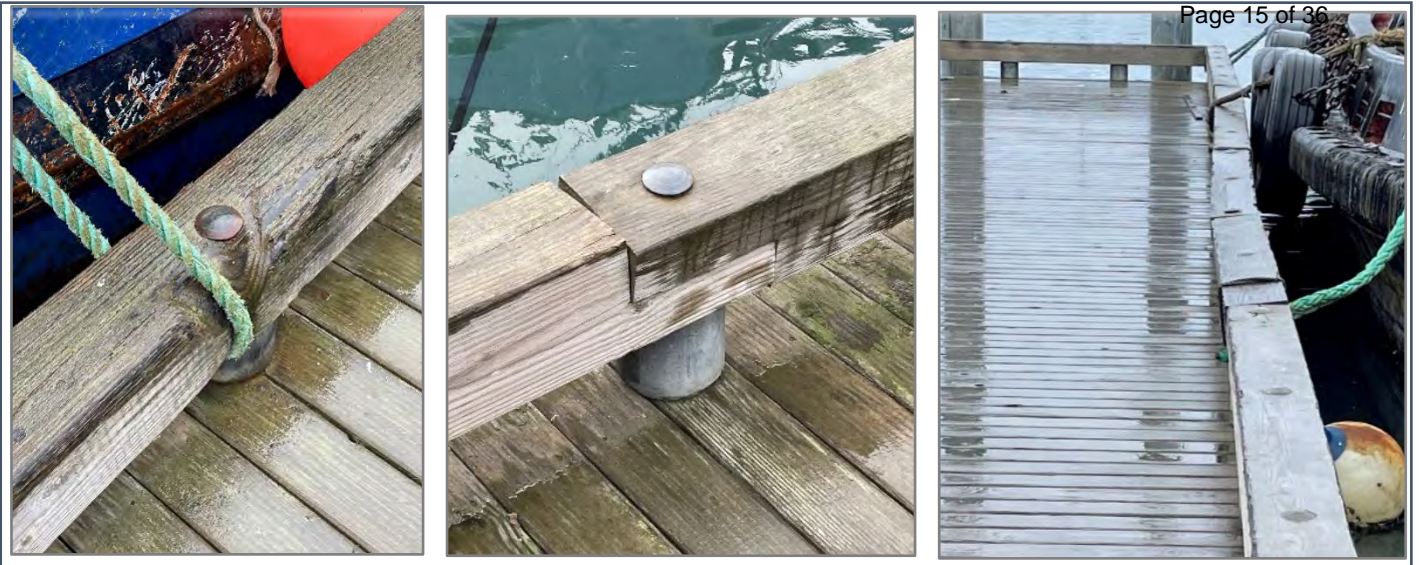
Figure 2.15: Bullrails worn, twisted out of position, and broken from supports.

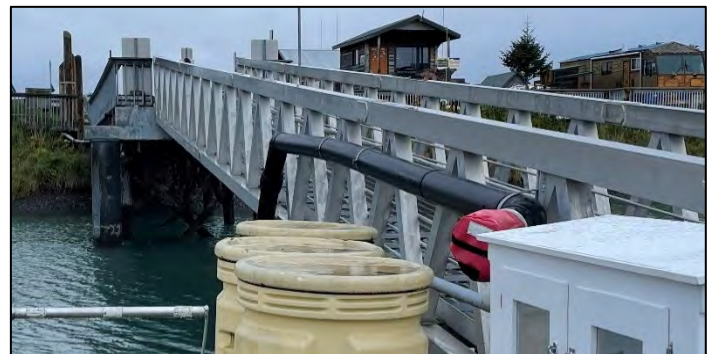
Fire suppression systems include fire extinguishers placed on the floats as well as a dry standpipe fire suppression system. The fire suppression system for these floats is supplied from Ramp 2 (Figure 2.17). The above-water piping for the fire suppression system is HDPE which is not a fire resistant material. The above-water HDPE pipe should be replaced with metal pipe or it may be possible to install a suitable fire resistant sleeve.

Figure 2.17: HDPE fire suppression piping at Ramp 2

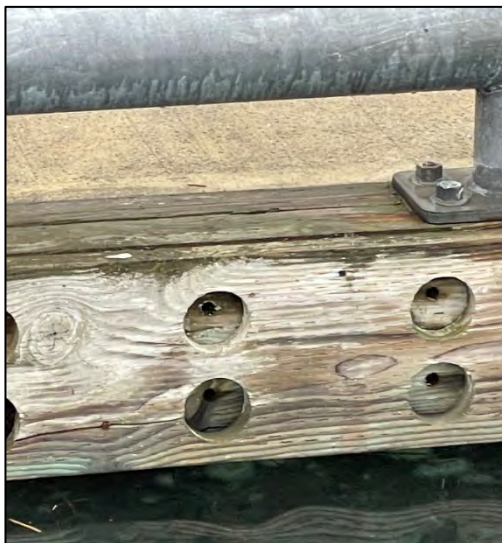
Figure 2.22: Missing through rods.

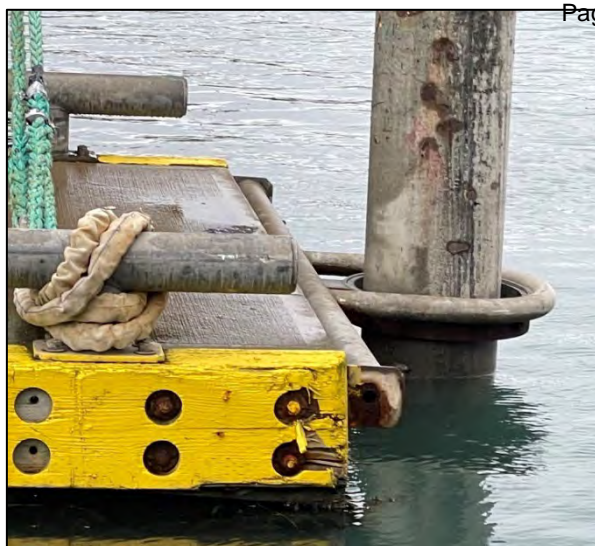
Piles generally had areas of consumed galvanizing within the tidal zone, and active corrosion was observed on some of the piles (Figure 2.23). The piles had new anodes installed in 2018.

Figure 2.23: Pit corrosion and other areas of active corrosion is evident on some piles

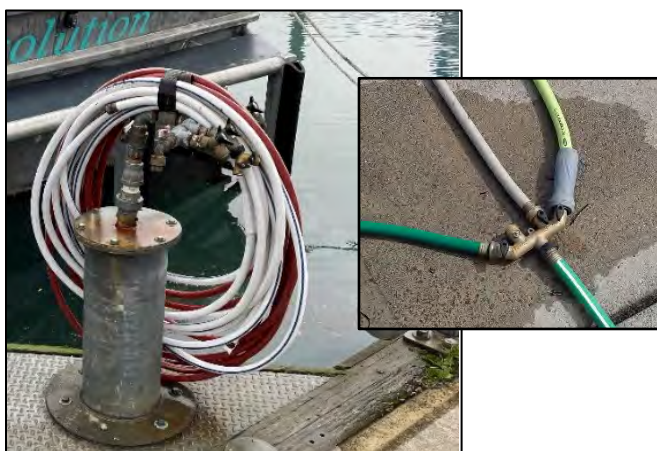
Figure 2.25: Water service riser at the head of each main float (left) and multiple hose connections.

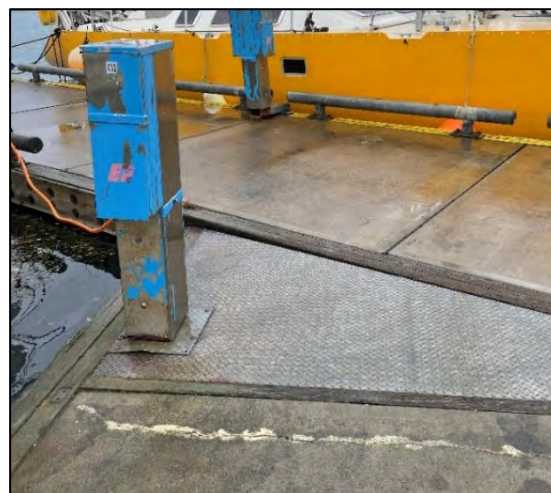
Power service is provided to B, C and D Floats. Many power pedestals have broken or loose mounts (Figure 2.25).

Figure 2.24: Typical power pedestal, many with damaged mounts. Note also typical minor crack in concrete.

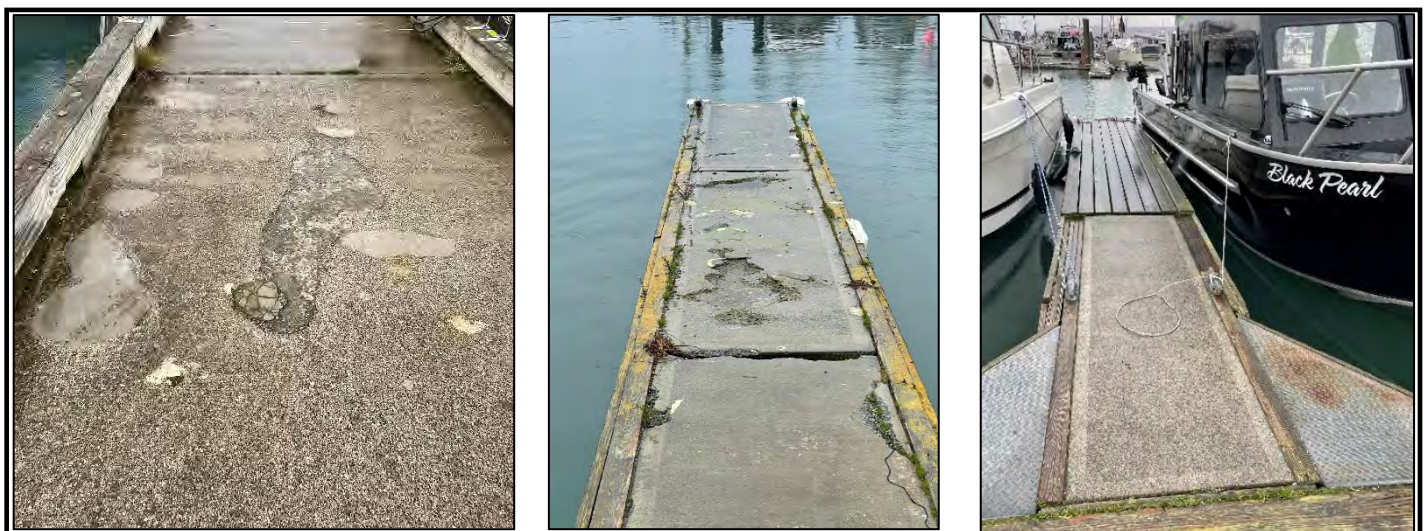
Figure 2.27: Deteriorated concrete surface and concrete repairs, including covering with timber decking.

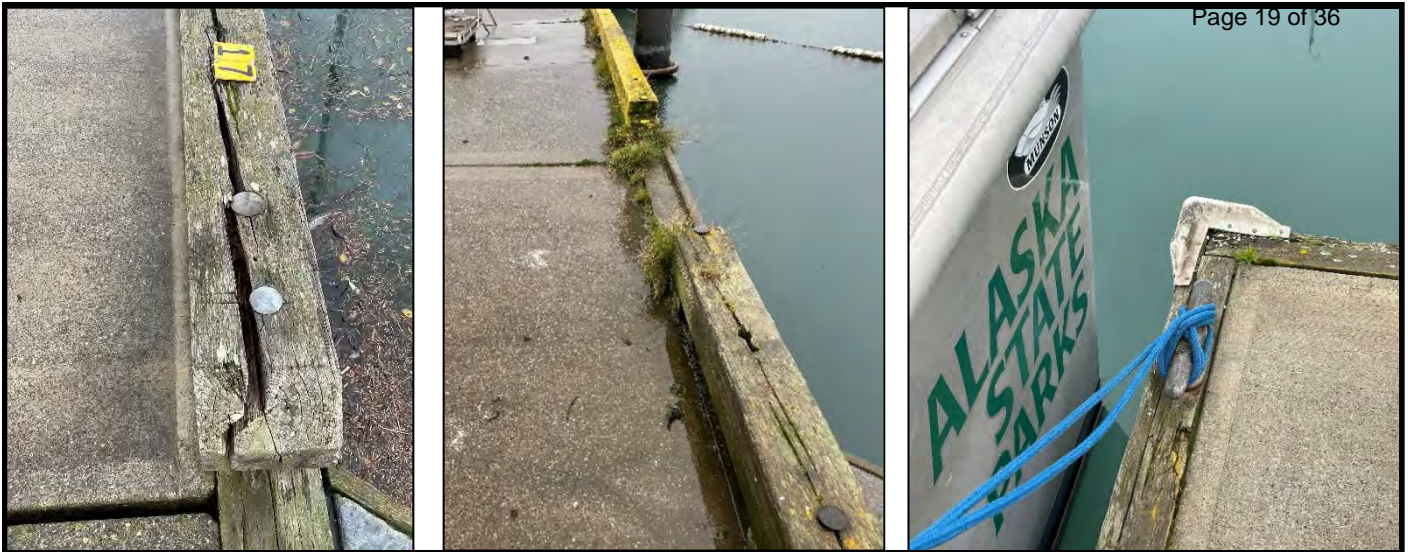
Figure 2.28: Bullrails will major splits and missing section, and cleat mounted in damaged timber waler.

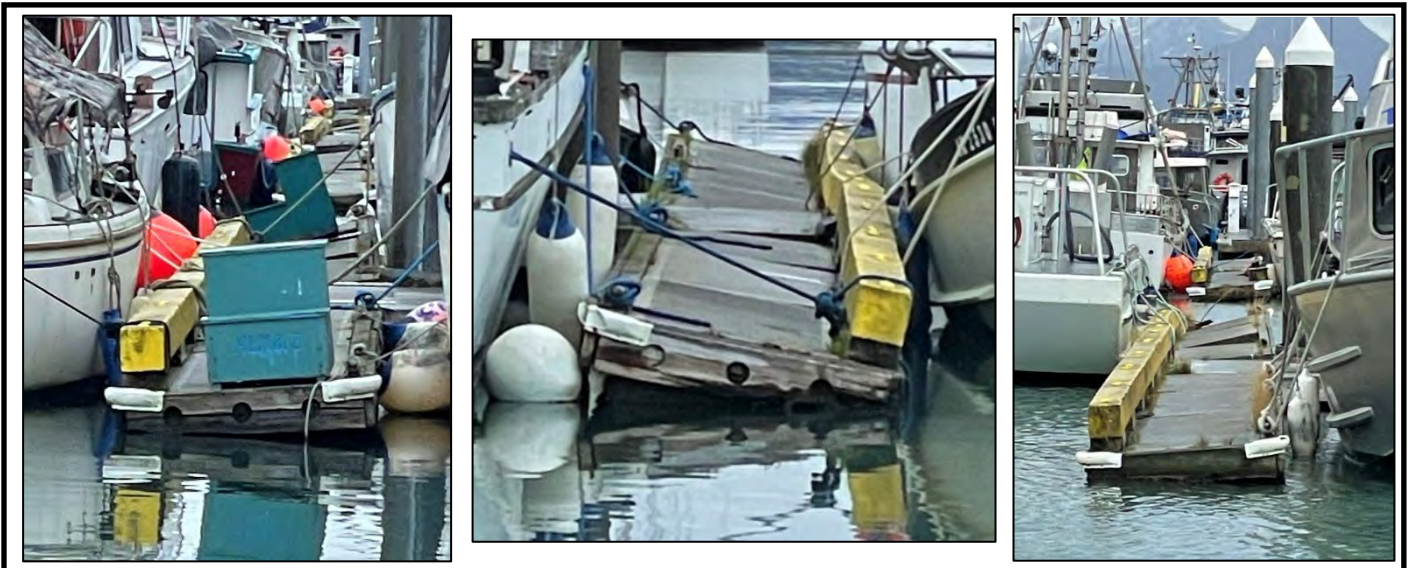
Stall flats on both sides of the Tee floats, at the end of each of the main float rows (Q, P, N, M, L, and K) nearest the main harbor navigation channel, are severely listing and broken loose from their connections to the main float (Figure 2.29). Walers on these floats have major deterioration. Modifications have been made to keep the floats from coming apart (Figure 2.30). It is thought that wave action in the channel acting on the moored vessels in the end slips has overstressed the end floats and caused breakage of the deteriorated structural members in these float connections. This is considered an area of critical condition and immediate repair or removal of the end floats and/or restrictions on use of these slips should be implemented as soon as practicable. Except for these end floats, the rest of these concrete floats in this area are considered to be in serious condition. When these floats are eventually replaced, the fairway distance between J and K Floats as well as between Q and R Floats should be increased to meet current standards (Drawing G2).

Figure 2.29: Tee floats, located along the harbor channel, are broken and severely listing.

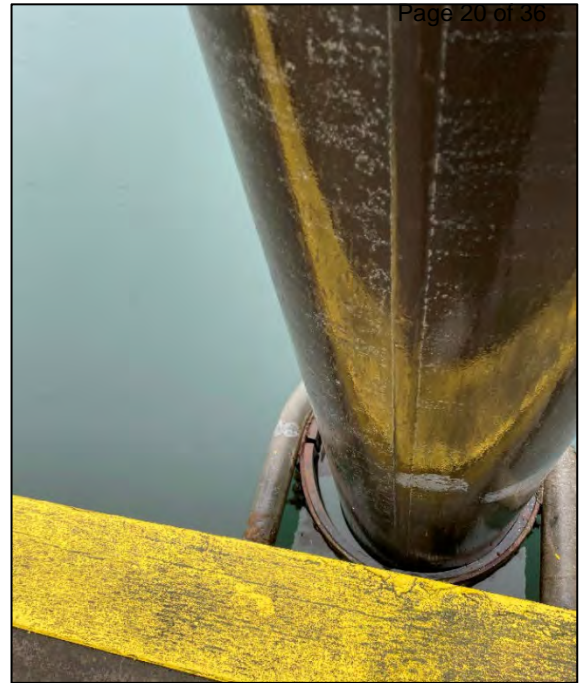
Steel piles are used to secure the floats, and in this area of System 1 the original galvanized coating on many of the piles has been consumed and there is evidence of corrosion (Figure 2.31). A project is underway to install anodes on the piles in this area.

Figure 2.31: Typical steel pile and exterior pile hoop. Note galvanized pile coating is consumed

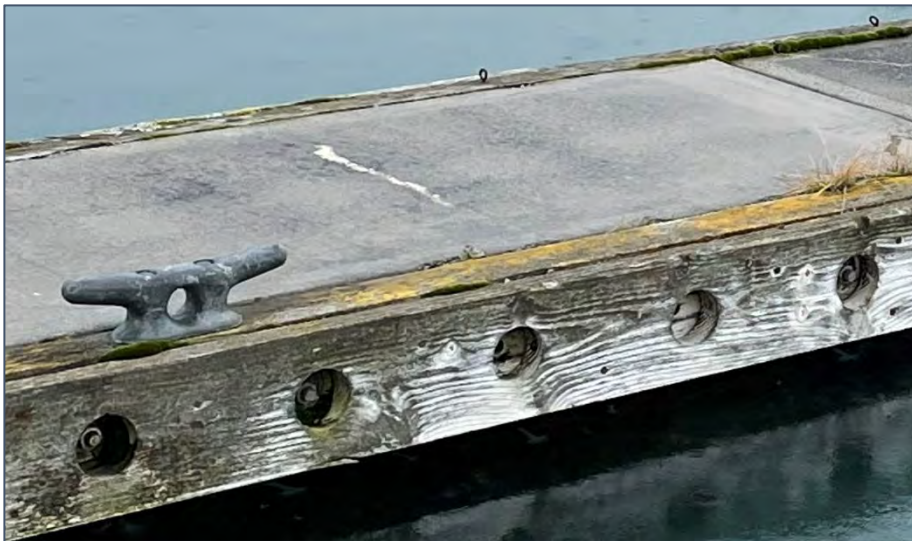
Figure 2.37: Through rods corroded or missing.

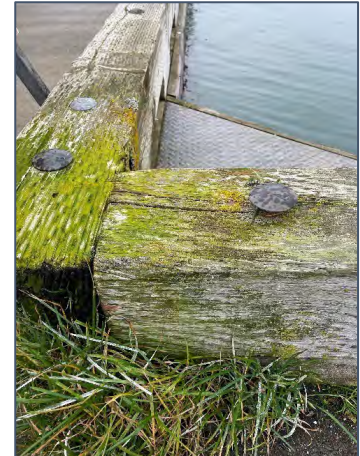
Figure 2.38: Deteriorated bullrails

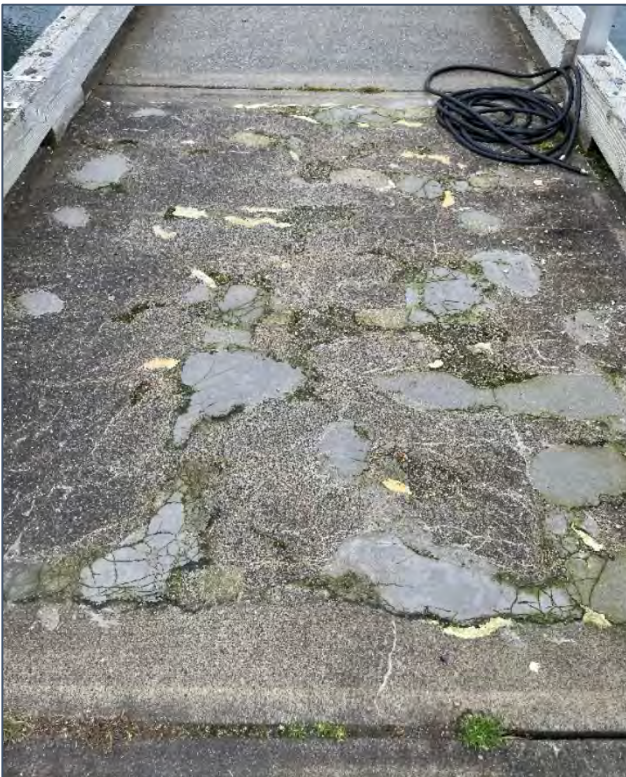
Years of maintenance is evident: patches over already patched concrete (Figure 2.39) decking over deteriorated concrete stall floats (Figure 2.41), replacing sections of timber bullrails and rubboards, and adding safety equipment including fire extinguishers and ladders is evident and have allowed continued use of these floats.

Figure 2.39: Deteriorated/patched concrete on main floats.

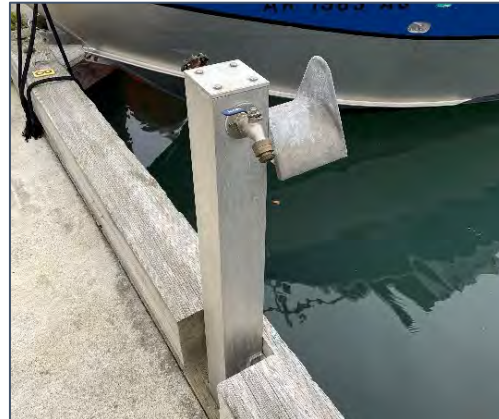
Figure 2.42: water hose bib and hose stand.

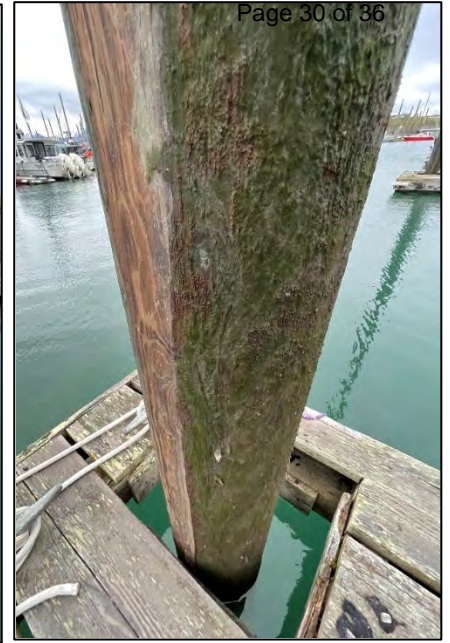
Figure 2.46: Moderate wear on timber piles.

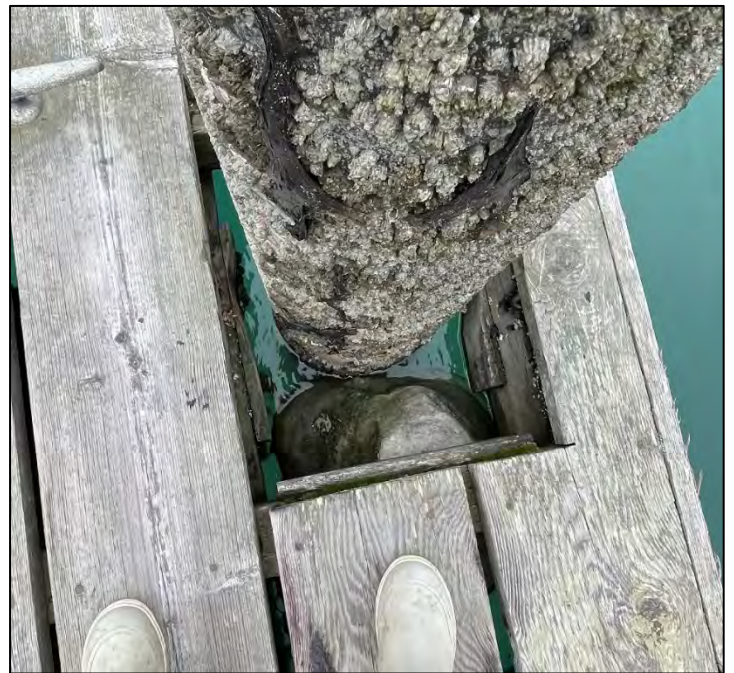
Figure 2.47: View under deck at a pile location. The odd shaped grey item floating between the pile and persons foot is very deteriorated flotation foam that is loose.

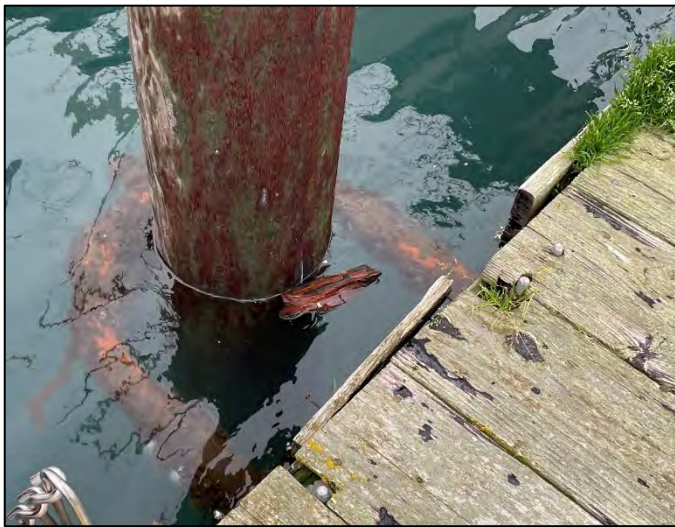
Figure 2.49: Low freeboard resulting in submerged pile collar. Also note hardware connections protruding through decking.

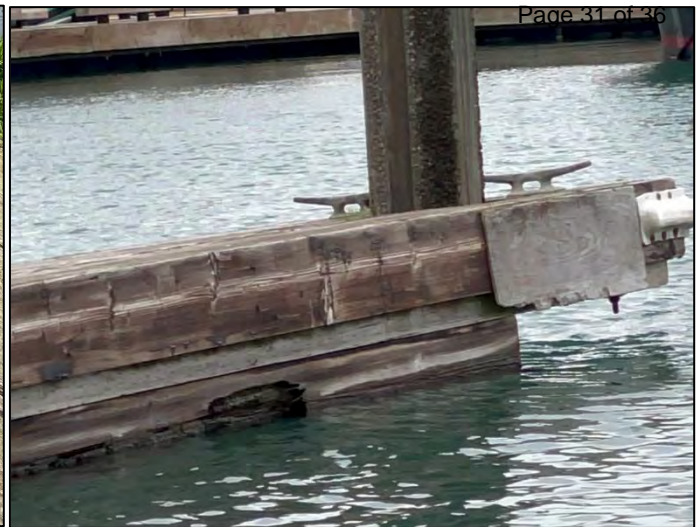
Figure 2.50: Example of a listing stall float (GG Float). Also note advanced rot/deterioration of below-deck timber.

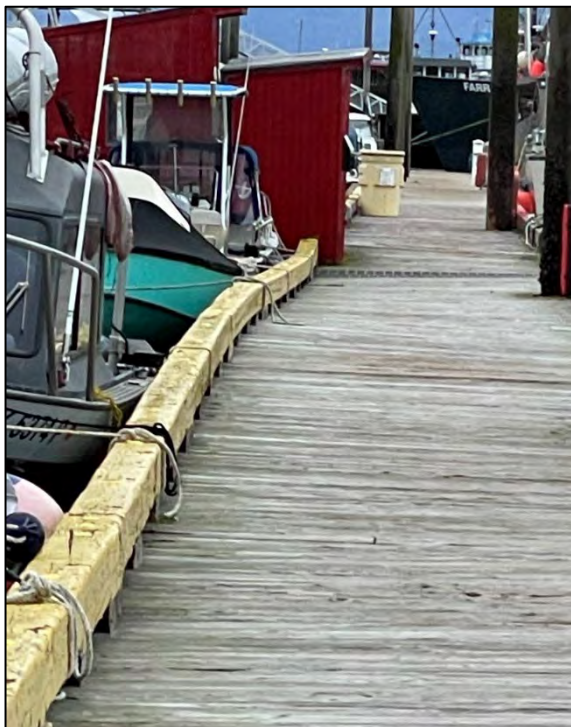
The headwalk Float AAA between Float EE and Float GG appears to be warped, suggesting a possible failure in structural members below the deck or lack of flotation or both (Figure 2.51). There are notably fewer piles on this section of Float AAA, which has contributed to this section of the float being overloaded.

Figure 2.51: Headwalk Float AAA between EE and GG Floats.

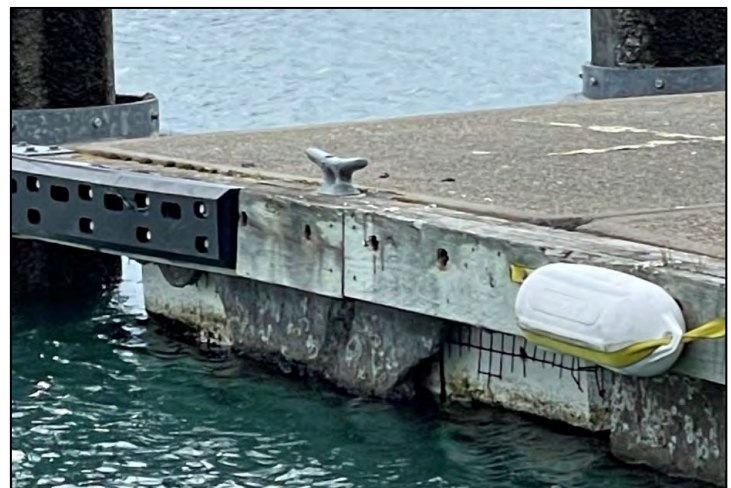
Concrete float modules located at the end of EE Float have spalled concrete, exposing the foam flotation and what may be a steel reinforcing mesh (Figure 2.52).

Figure 2.52: Spalled/missing concrete below deck with exposed foam and reinforcing.

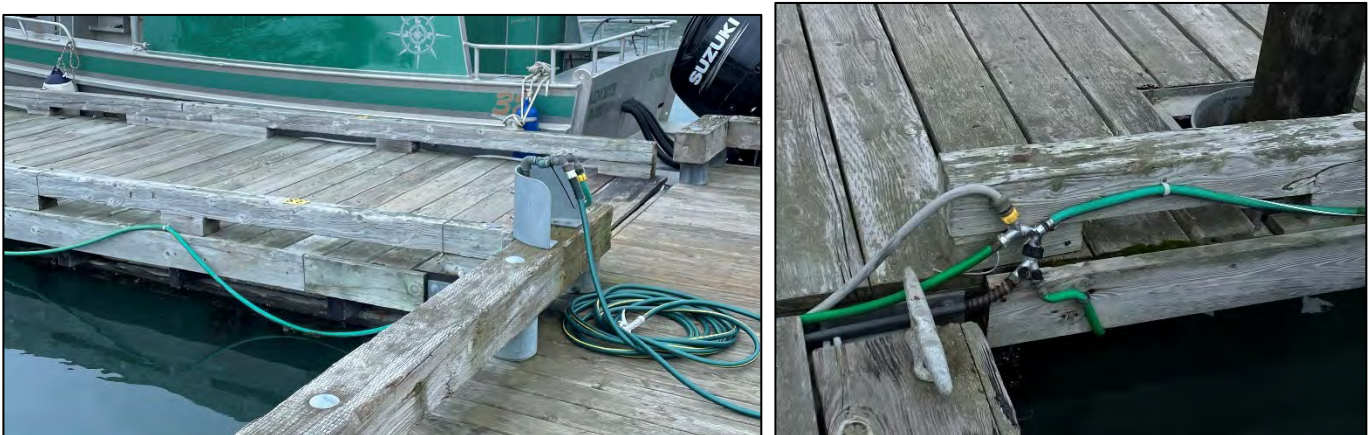
Note that the garden hoses are typically not NSF-approved materials and so would not satisfy the requirements of a public water system for potable water use. Given the various hose connections, backflow contamination is possible. Signs should be posted immediately to indicate the water is non-potable. When new floats are installed, the new water system should be constructed of materials suitable for drinking water and include proper backflow prevention, as regulated/permitted by ADEC.

Figure 2.54: Typical water service to main floats provided from headwalk float by various hoses/connections.

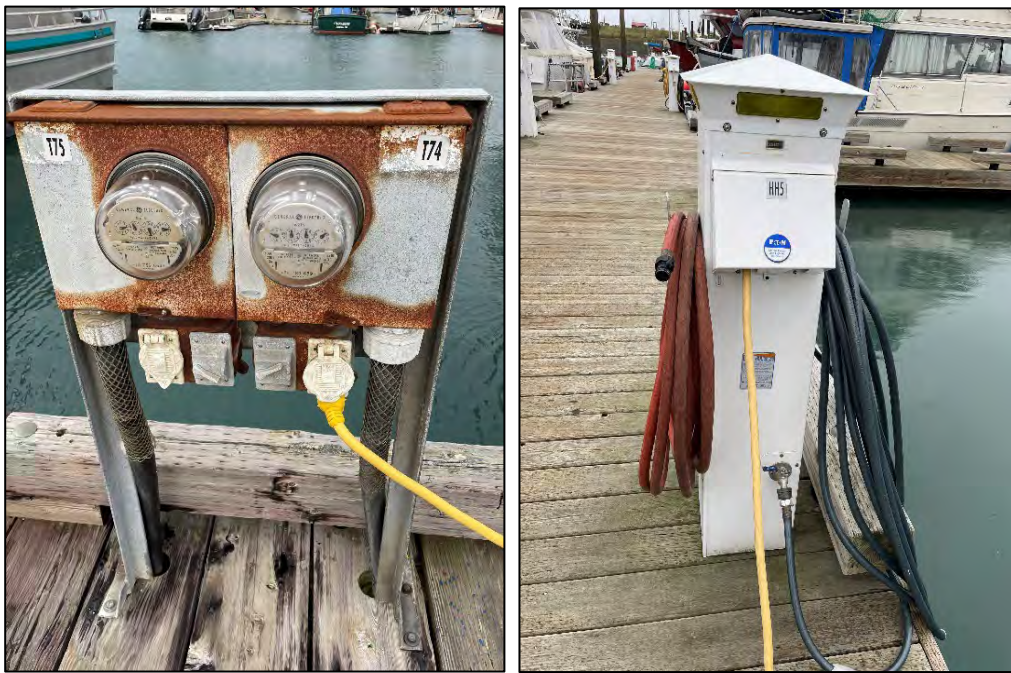
Figure 2.55: Electrical power service pedestals on EE Float (left) and typical of HH & JJ Floats (right). Note that the newer pedestal also incorporates water hose bibs.
