**Site Survey  
Old Homer Intermediate School  
Homer, Alaska**

July 1, 1998

**Condition Survey  
Old Homer Intermediate School**

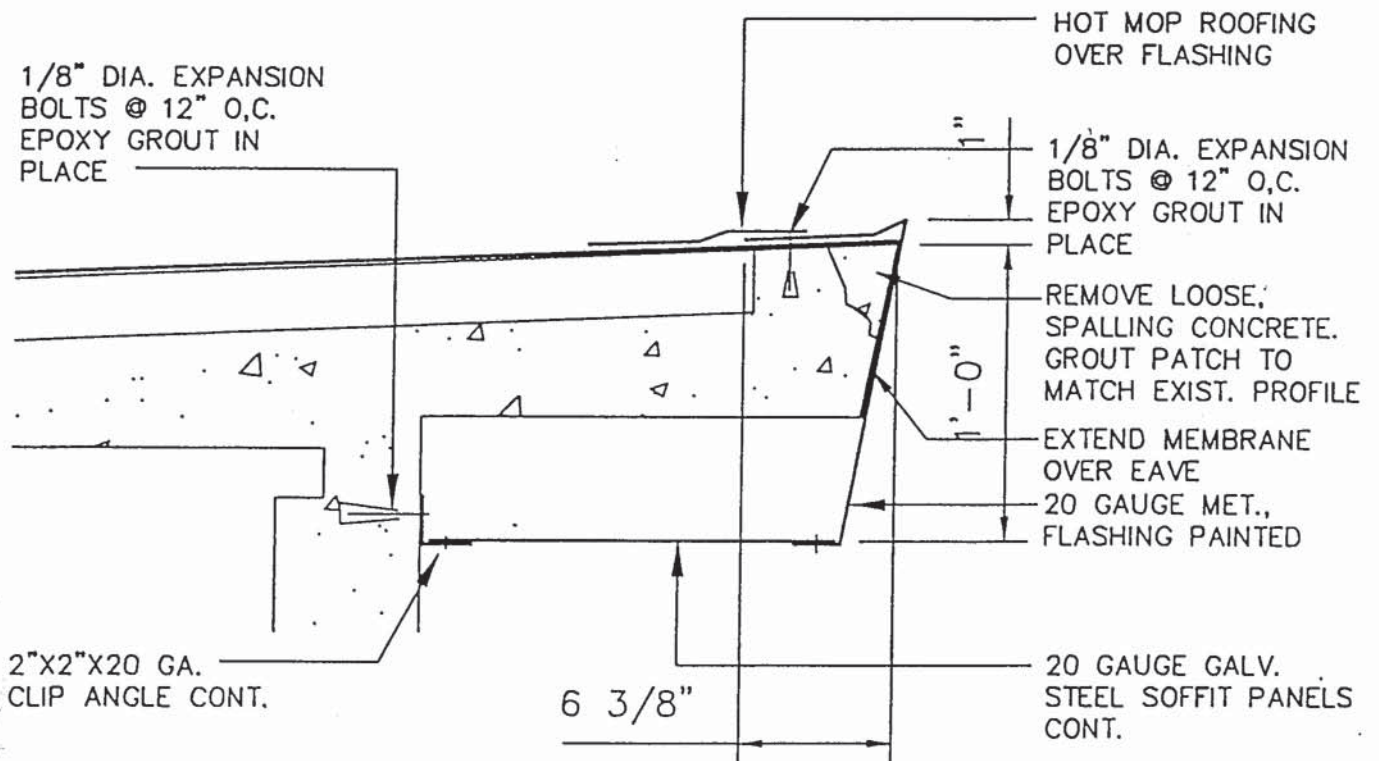
## ROOF FLASHING DETAIL

Existing Roof and Roofing Assembly: The existing roof structure is a cast-in-place concrete slab supported on steel beams. The existing roof structure appears to be in good condition except for at the roof edges where water has penetrated under the roof membrane and has gone through freeze and thaw cycles causing some concrete cracking and spalling at roof edges.

Based on observations of the Architect, and photographic documentation, the basic structure appears to be sound with no signs of distress in the existing framing system. However, the roof eaves are deteriorating due to exposure to water and freeze-thaw cycles in the exposed concrete. The concrete eave should have all loose concrete removed down to sound material and new concrete grout placed to reconstruct the eave. Reinforcing in the eave may need to be cleaned of rust to prevent future spalling. The roofing should be extended over the eave to provide protection to the concrete.

The concrete cracking and spalling is a condition that needs to be fixed. The roof edge needs to be flashed and repaired so that water doesn't penetrate to the concrete where it can go through freeze and thaw cycles. It may also make sense to install a metal soffit underneath the roof overhang, just to ensure that no one could be injured by a piece of falling concrete, should some of the existing loose concrete fall. Please reference Sketch No. 8, attached.

1. Remove the existing loose concrete at the roof edges down to sound material and place new concrete grout as required to reconstruct the eave. Reinforcing may need to be cleaned of rust to prevent future spalling. The roofing should be extended over the eave to provide protection to the concrete. A new prefinished roof edge flashing, and metal soffit should be installed and stripped in to provide a water tight roof edge system as shown on Sketch No. 8.

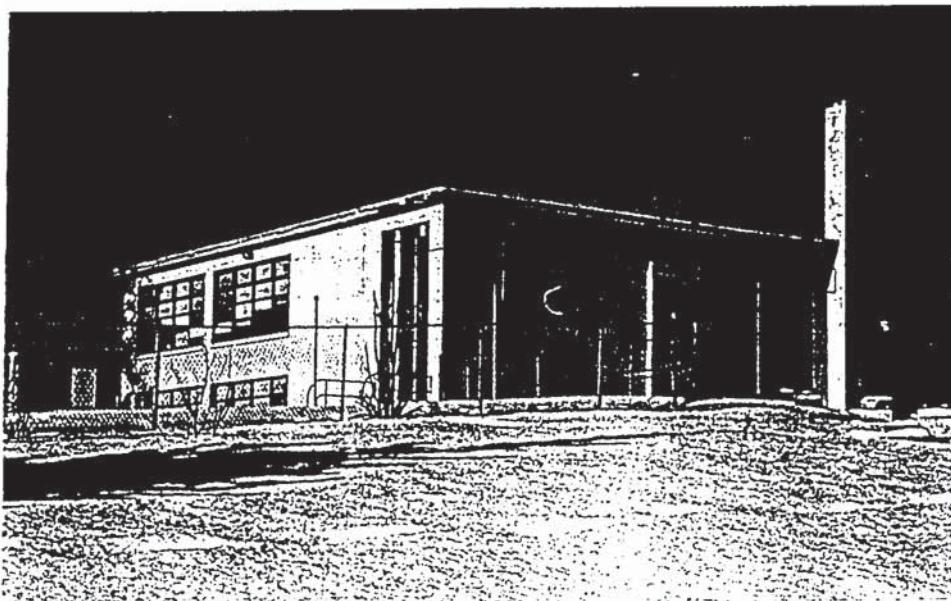
4.6.4 Accessible parking spaces shall be designated as reserved by a sign showing the symbol of accessibility. Van accessible spaces shall be designated "Van Accessible" mounted below symbol of access. Signs shall be located so they cannot be obscured by vehicle parked in space.

Solution: Two accessible parking spaces required. Provide the new accessible parking spaces, at the east end of the building, in a location where the grade is suitable for access without ramps (sidewalk with less than 1:20 slope). One of the two new accessible parking spaces to be van accessible and so designated. There will only be one accessible entrance added to the existing building, therefore the accessible spaces will not need to be dispersed. See Sketch 3 attached.

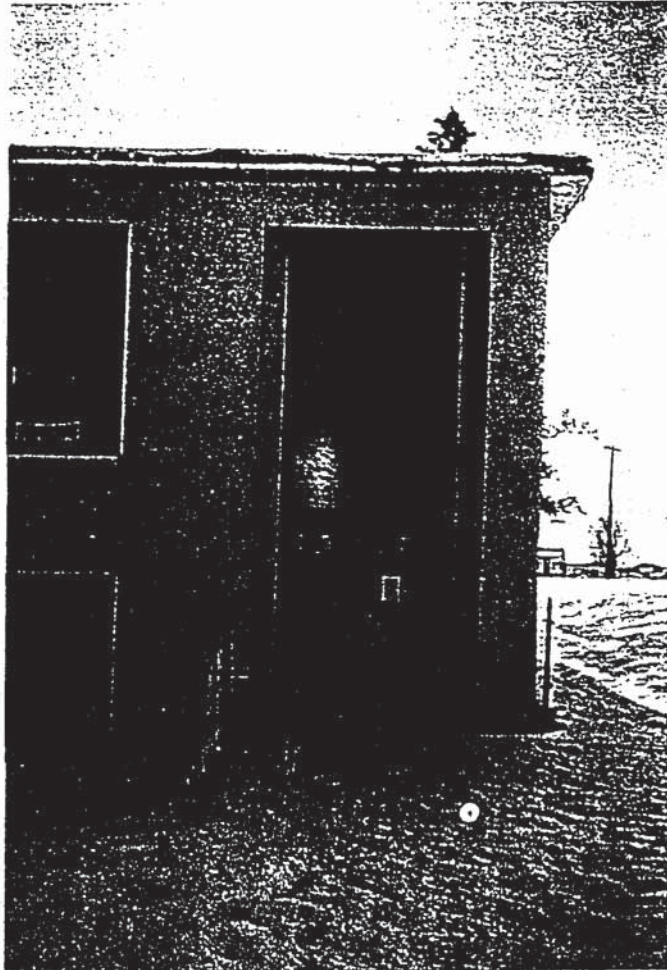
- (a) See Element 1. for Parking signage requirements.
- (c) Accessible entrances when not all are accessible. All inaccessible entrances shall have directional signage to indicate the route to the nearest accessible entrance, such that a person will not be required to retrace the approach route from the inaccessible entrance.

Solution: Provide directional signage at two non-accessible entries.

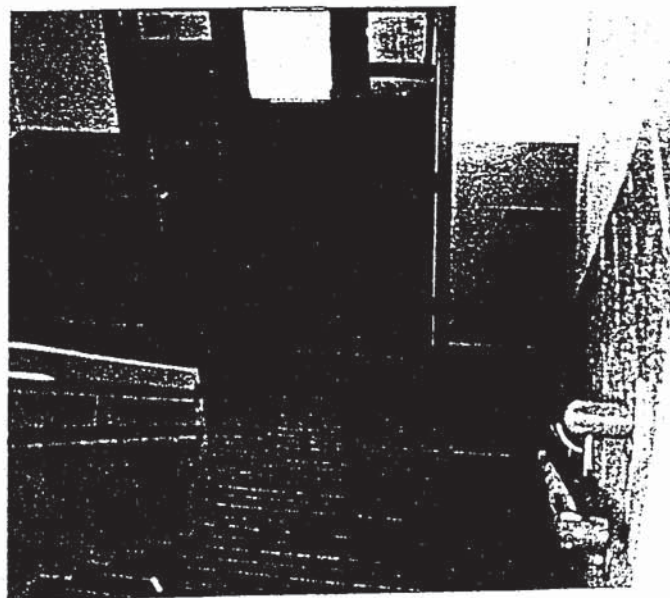
- 4.5.4 If gratings are located in walking surfaces, then they shall have spaces no greater than 1/2" wide in one direction. Long dimension shall be placed perpendicular to direction of travel.

**Solution:** The existing gratings should be replaced with compliant gratings even though they are not in the accessible route. This could help individuals with canes.

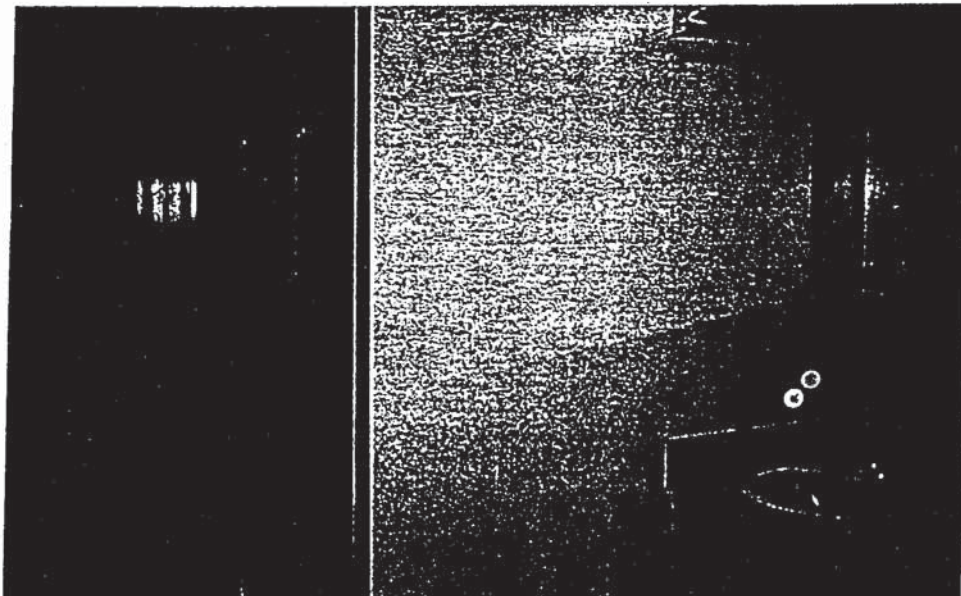
**Solution:** The access doors to the existing toilet rooms aren't wide enough. The vestibules aren't deep enough. There is not adequate maneuvering clearance at the boys toilet door adjacent to the sink wing wall. There is not adequate maneuvering clearance to the water closet area in the boys toilet room. The knee spaces are not adequate at the lavatories, etc.

Provide one unisex toilet per floor, located in the same general area as the existing toilet facilities, as shown on Sketch 6 and 7. This will be significantly less expensive than getting an accessible boys and girls toilet on each floor. Each unisex toilet room shall contain one water closet complying with 4.16 and one lavatory complying with 4.19, and the door shall have a privacy latch.

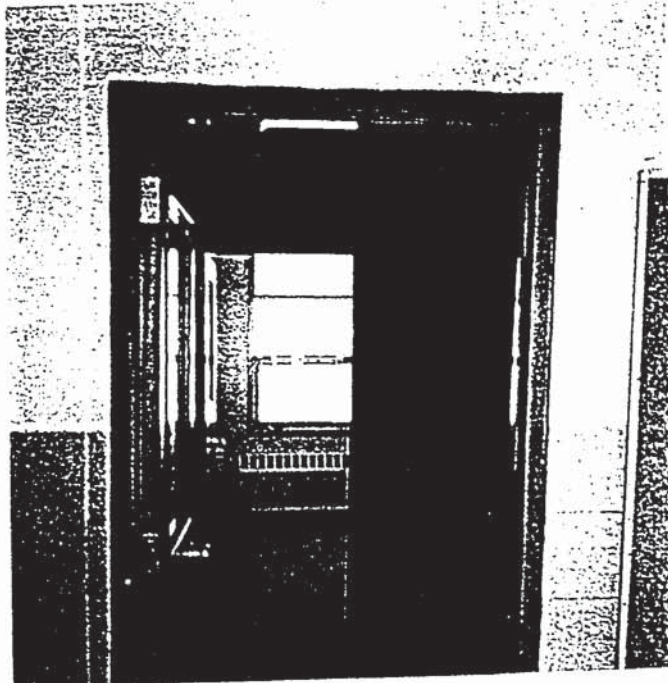
- 4.13.10 Door closers sweep time: 3 seconds max.
- 4.13.11 Door Opening Force:  
(3) Interior Doors: 5 lbs. max.
- 4.13.12 Automatic and power assisted doors, if used, shall comply with this section.

Solution: Provide lever handled latch or locksets as required at 4 classroom doors, 2 bathroom doors, and at the door to reception 103 and office 102. Adjust closers for a second sweep time (maximum) and for a 5 lb. max. door opening force.
