Homer Small Boat Harbor

System 4 Condition Report

Prepared by:
Kimberly Nielsen, PE
R&M Consultants Inc.
9101 Vanguard Drive
Anchorage, AK 99507

System 1 Condition Report

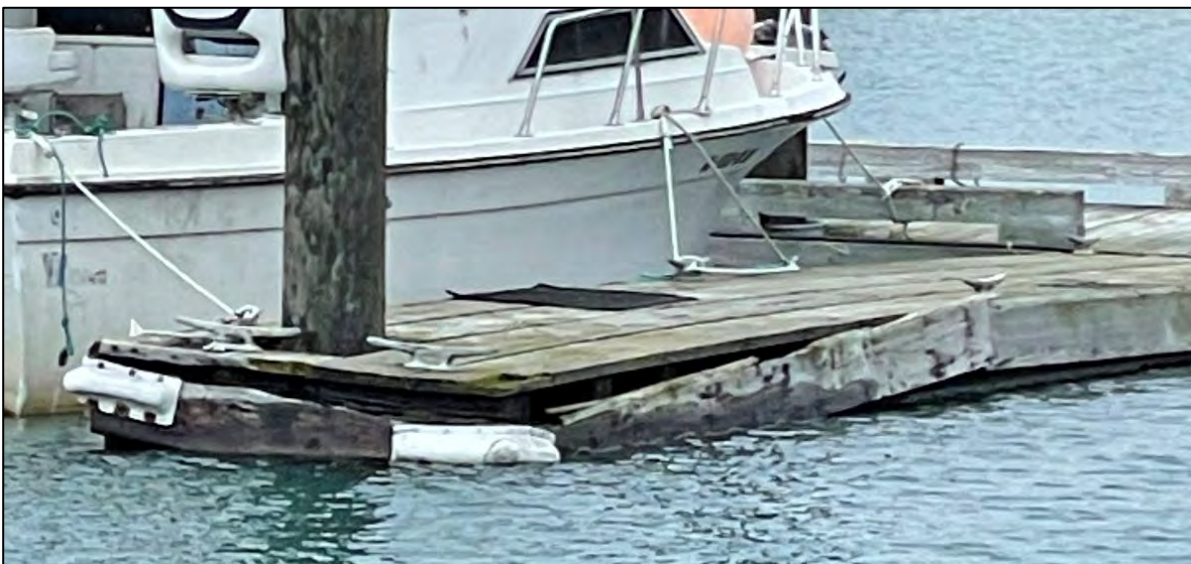
Figure 2.43: Stall Float on CC Float with damaged timber waler, rubboard, and decking.

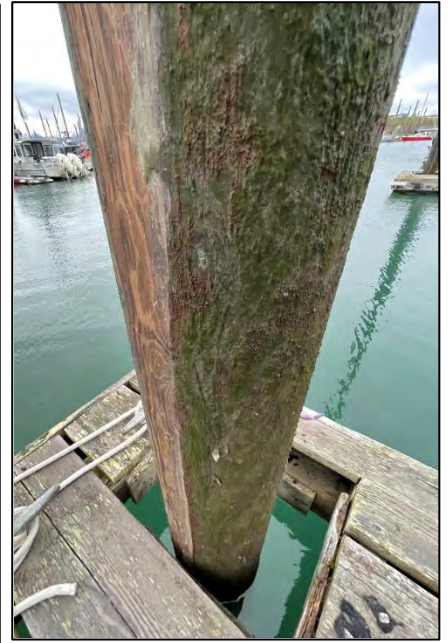
Figure 2.46: Moderate wear on timber piles.

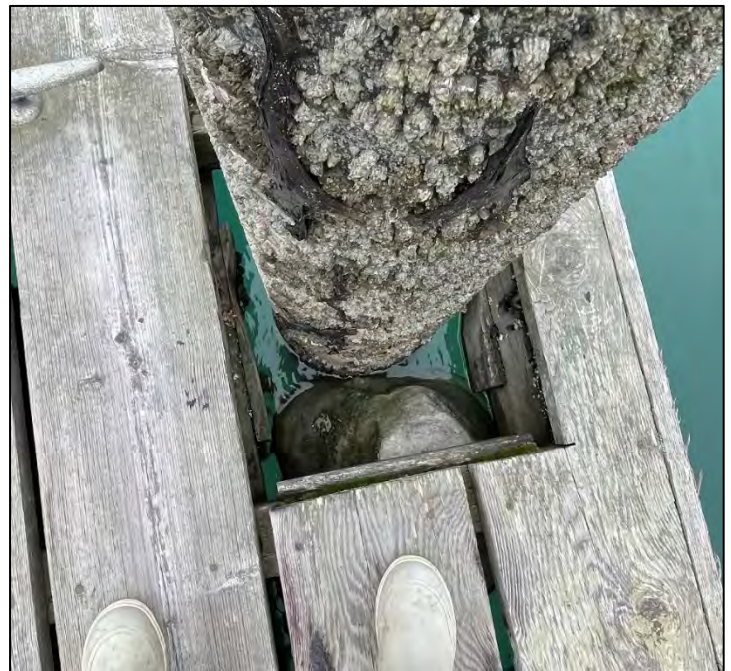
Figure 2.47: View under deck at a pile location. The odd shaped grey item floating between the pile and persons foot is very deteriorated flotation foam that is loose.

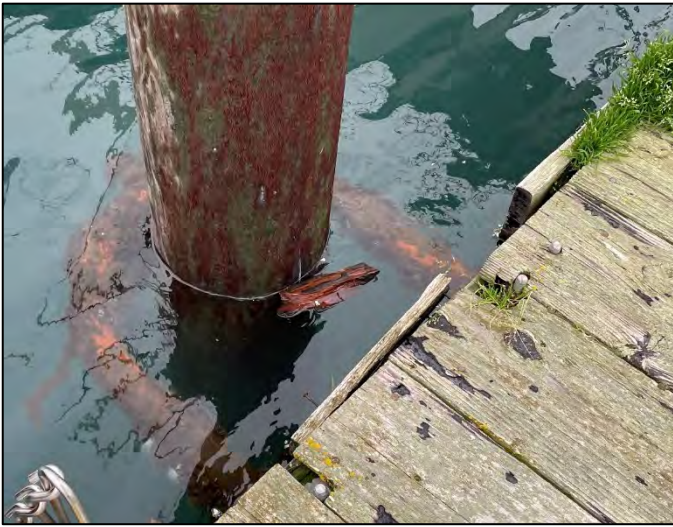
Figure 2.49: Low freeboard resulting in submerged pile collar. Also note hardware connections protruding through decking.

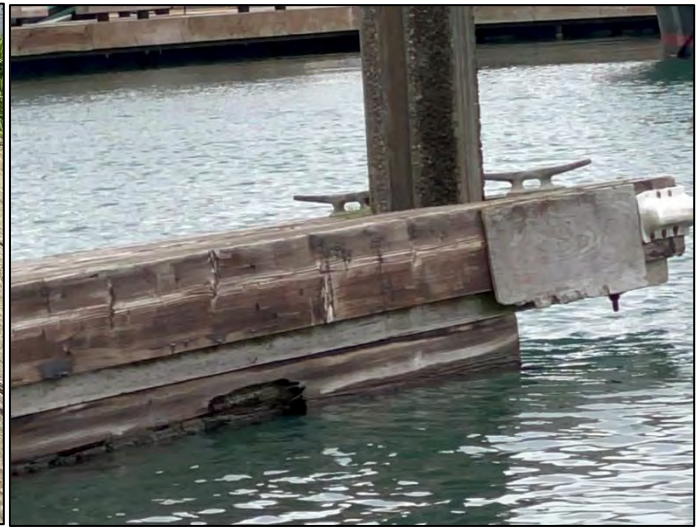
Figure 2.50: Example of a listing stall float (GG Float). Also note advanced rot/deterioration of below-deck timber.

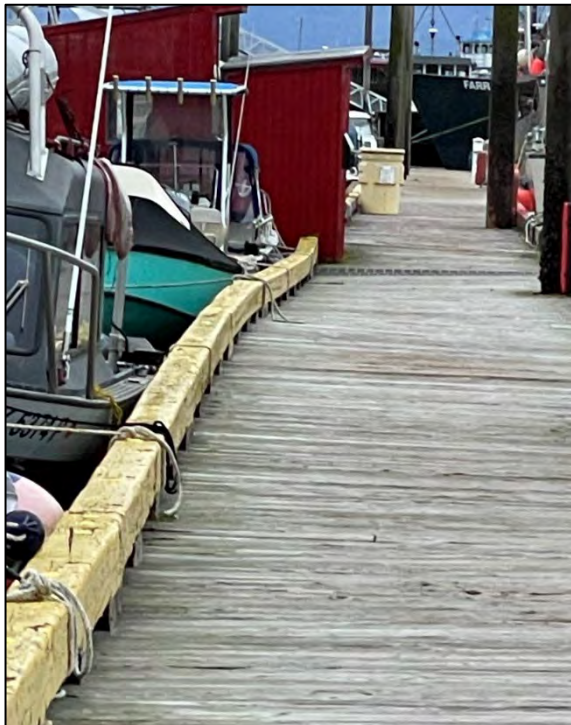
The headwalk Float AAA between Float EE and Float GG appears to be warped, suggesting a possible failure in structural members below the deck or lack of flotation or both (Figure 2.51). There are notably fewer piles on this section of Float AAA, which has contributed to this section of the float being overloaded.

Figure 2.51: Headwalk Float AAA between EE and GG Floats.

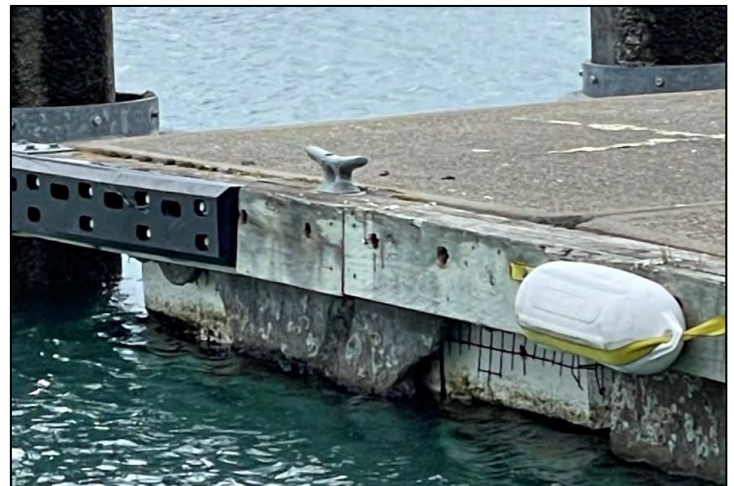
Concrete float modules located at the end of EE Float have spalled concrete, exposing the foam flotation and what may be a steel reinforcing mesh (Figure 2.52).

Figure 2.52: Spalled/missing concrete below deck with exposed foam and reinforcing.

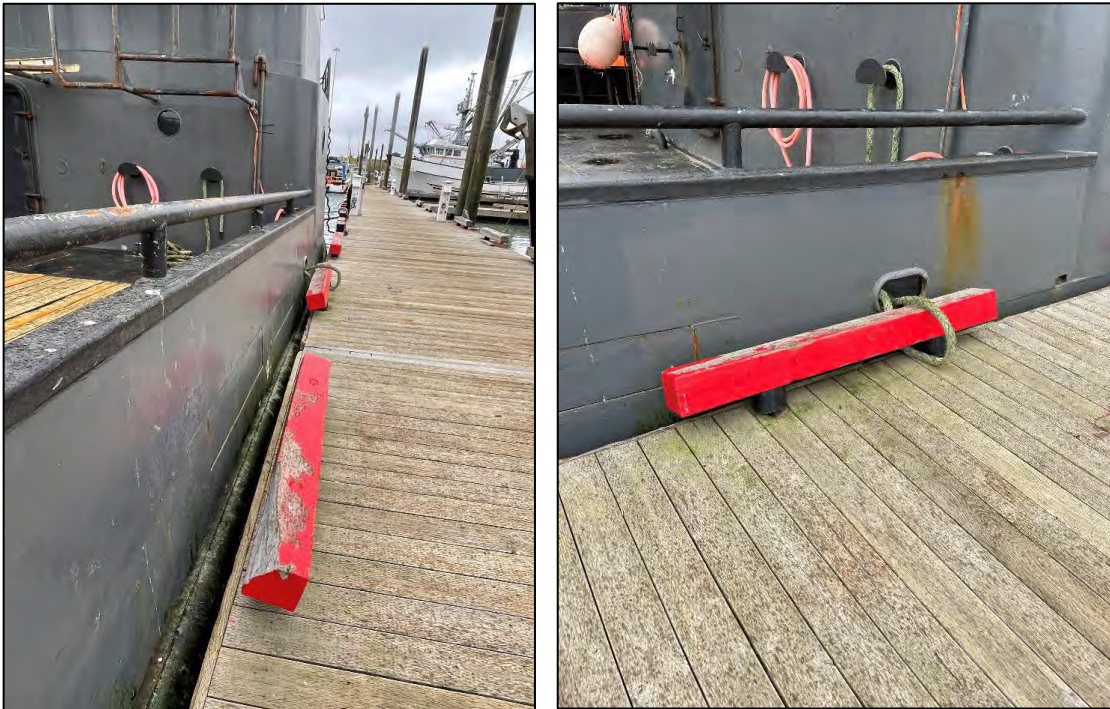
The FF Float system timber elements and steel piles and hardware show evidence of wear that is normal for a 20-year old facility with good maintenance. HH Floats and JJ Floats, along with the connecting AAA headwalk float were constructed in 2015 and appear to be good condition, with the exception of several bullrails, which appear to be overstressed. Several bullrails are damaged and bent at their mountings (Figure 2.53). Repairs might include more robust bullrail connections

Figure 2.53: Example of several bullrails that have been damaged on JJ Float.

that are more suitable for the vessels utilizing this float, possibly mounted to interior structural members offset from the edge of the float.

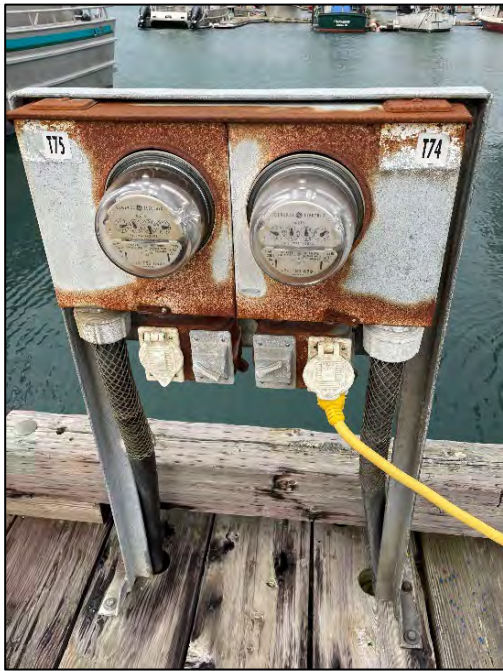
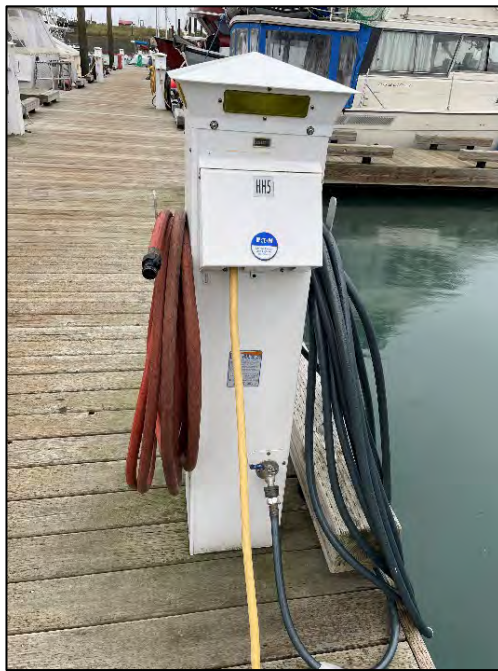
Float EE has electrical power pedestals that are older generation, while the power service on HH and JJ Floats is modern (Figure 2.55). Note that a specific electrical inspection was not conducted to check for code/safety issues.

Figure 2.55: Electrical power service pedestals on EE Float (left) and typical of HH & JJ Floats (right). Note that the newer pedestal also incorporates water hose bibs.

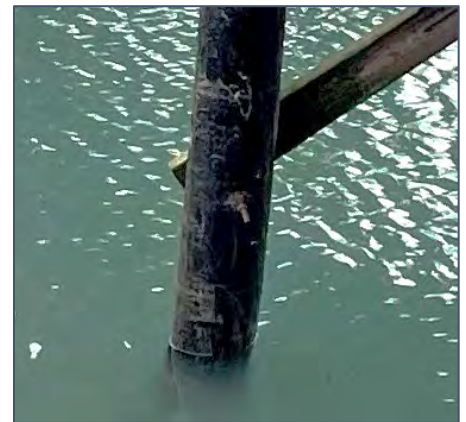
Figure 2.3: lower hardware connections appear corroded.

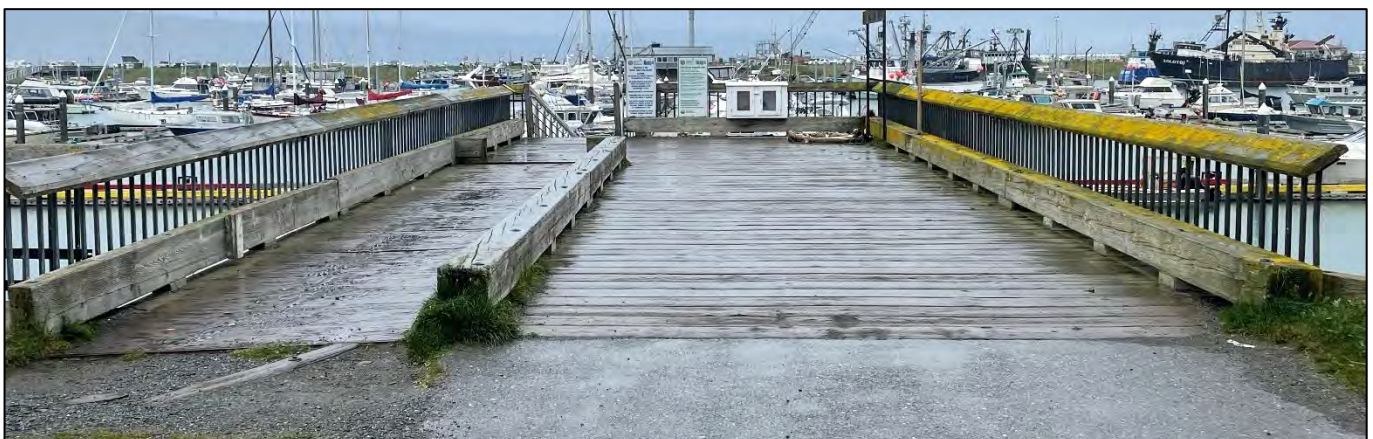
The Ramp 4 trestle has evidence of minor to moderate wear in decking as well as evidence of fungal decay and minor checks/splits in bullrails and handrails (Figure 2.7). The trestle appears to have had some modifications, with the shoreward end appearing older, more deteriorated than the seaward end. The steel piles at the seaward end are secured into the timber beams with steel plates and bolts, while the shoreward end of the timber structure appears to rest on the steel piles (Figure 2.8). Also noted, although not part of the harbor facilities being inspected, the adjacent timber retaining wall and steel piles that support the adjacent boardwalk appeared to be displaced and broken.

Figure 2.7: Ramp 4 trestle

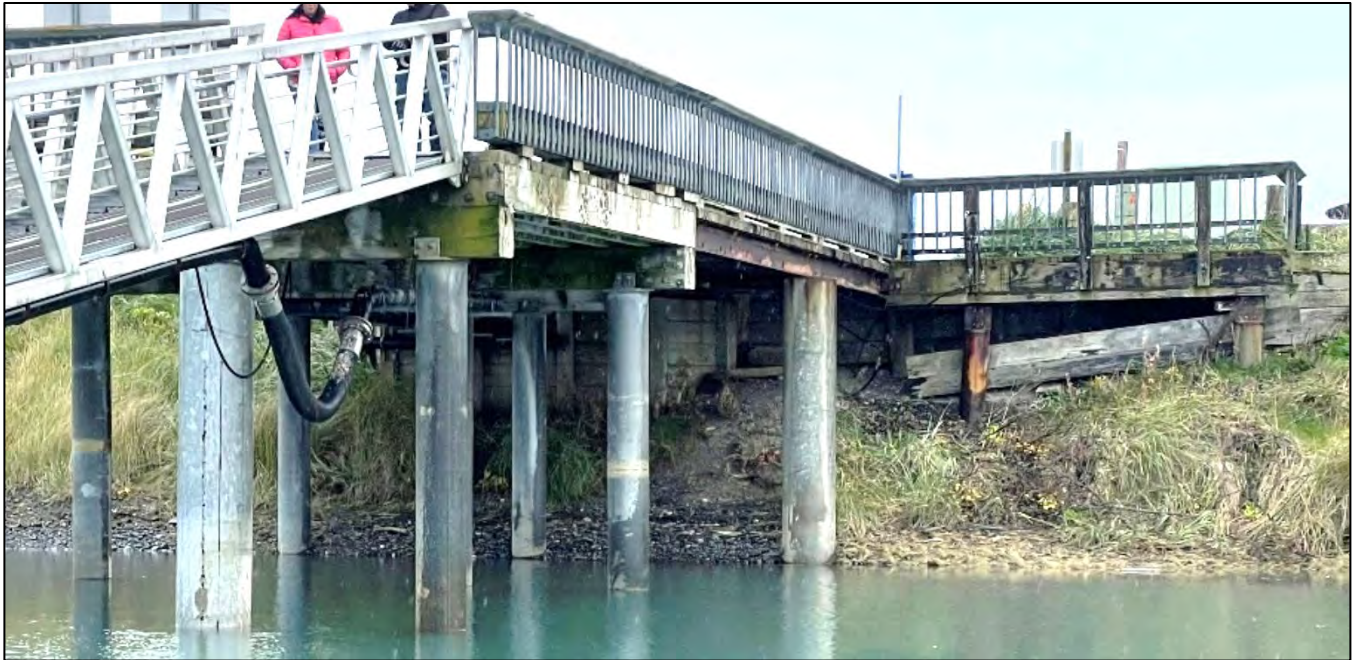
Figure 2.8: Ramp 4 trestle, noting newer/older portions of timber trestle and pile-to-beam attachments.

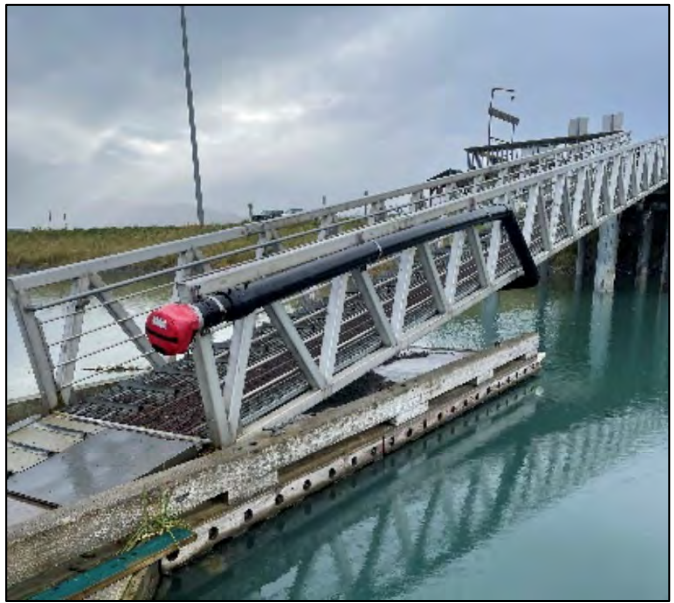
Fire suppression systems include fire extinguishers placed on the floats as well as a dry standpipe fire suppression system with an upland charging station for Fire Department use. According to the National Fire Protection Association (NFPA) 303 “*Fire Protection for Marinas and Boatyards*”, the fire suppression system appears to be inadequate because the above-water piping is HDPE which is not fire-resistant (Figures 2.12 and 2.13). A failure in part of the piping system due to melting during a fire could render the system useless or worse cause delay in fighting a fire. The above-water HDPE pipe should be replaced with metal pipe or it may be possible to install a suitable fireproof cover sleeve.

Figure 2.13: Fire system HDPE piping on Ramp 4.

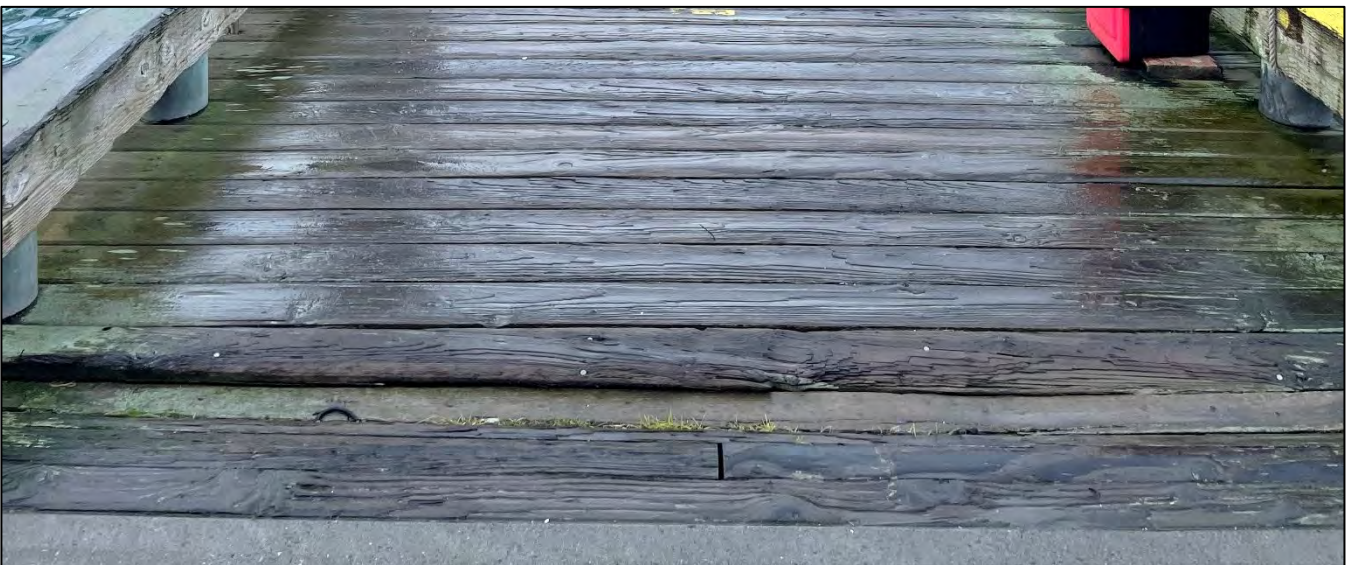
Figure 2.14: Typical decking wear at high traffic areas (float intersections)

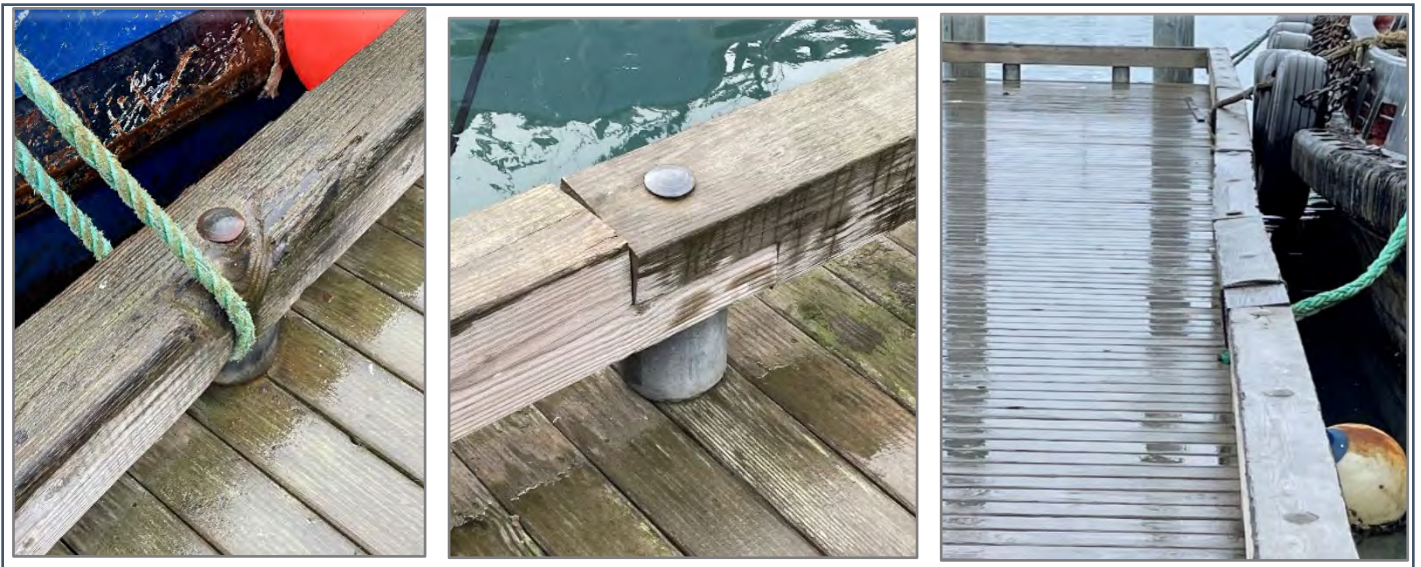
Figure 2.15: Bullrails worn, twisted out of position, and broken from supports.

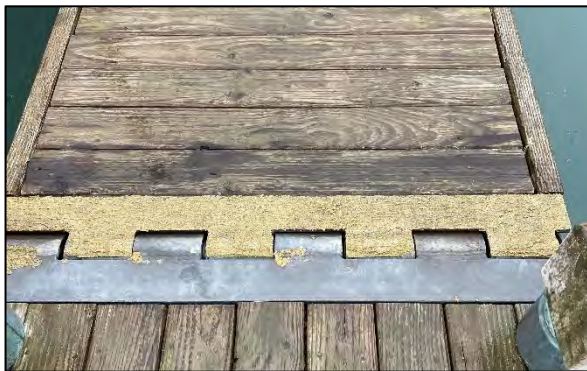
Figure 2.16: Worn non-skid coating at hinges.

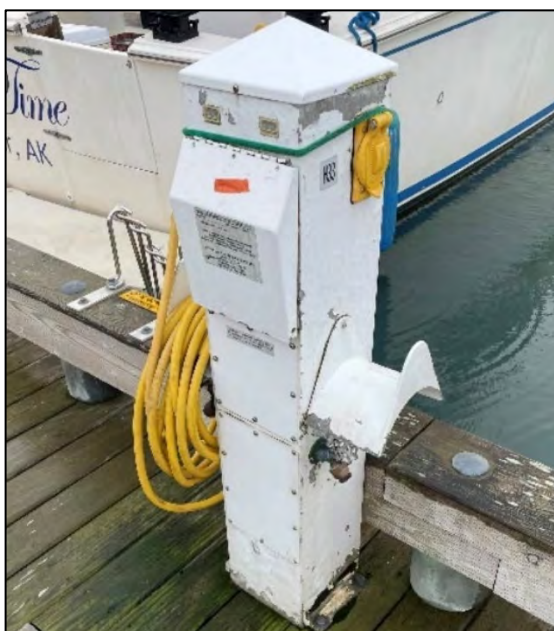
Potable water is piped within or under the floats and hose bibs are provided at each stall, along with power service in a combined pedestal, similar to that on J Float (Figure 2.3). However, the pedestals on these floats appeared to have a coating issue. The paint appeared bubbled and peeled in places, exposing the metal housing to corrosion (Figure 2.18).

Figure 2.18: Power/water pedestal coating damage

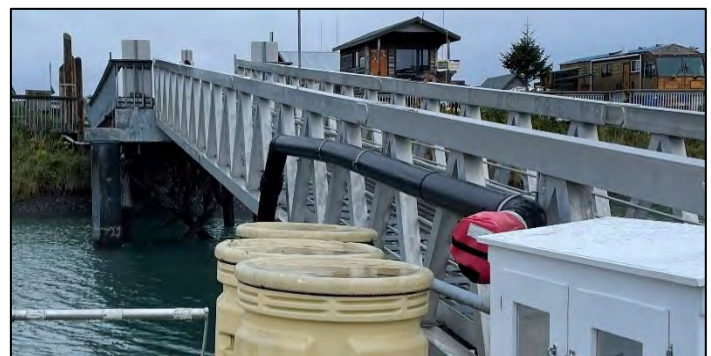
Fire suppression systems include fire extinguishers placed on the floats as well as a dry standpipe fire suppression system. The fire suppression system for these floats is supplied from Ramp 2 (Figure 2.17). The above-water piping for the fire suppression system is HDPE which is not a fire resistant material. The above-water HDPE pipe should be replaced with metal pipe or it may be possible to install a suitable fire resistant sleeve.

Figure 2.17: HDPE fire suppression piping at Ramp 2

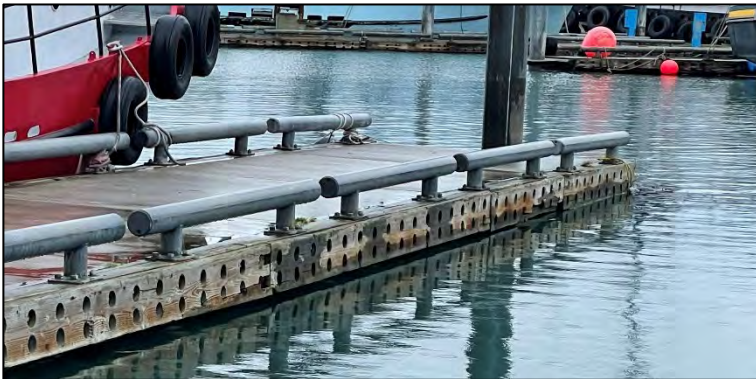
The floats were found to be in serious condition. The headwalk float A between B and D Floats appeared as well as the end of main Float C appeared to have a twist in the float suggesting possible broken concrete and/or through rods. In general, the freeboard was low throughout the facility indicating inadequate reserve flotation (Figure 2.19); moderate to major checks, splits, breaks and other damage to timber walers and rubboards (Figures 2.20 and 2.21), and corroded and missing through rods (Figure 2.22). Steel bullrails have been installed by mounting through damaged timber walers, which may result in loss of mooring.

Figure 2.19: Concrete stall float with low freeboard, and in the water at the end.

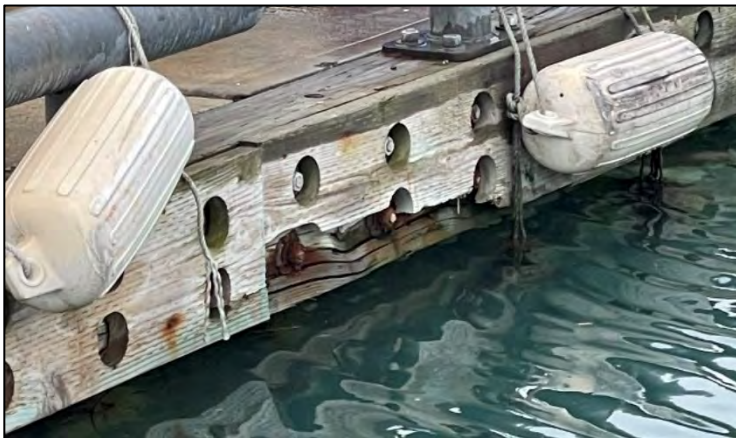
Figure 2.20: Broken rubboard and corroded through rods

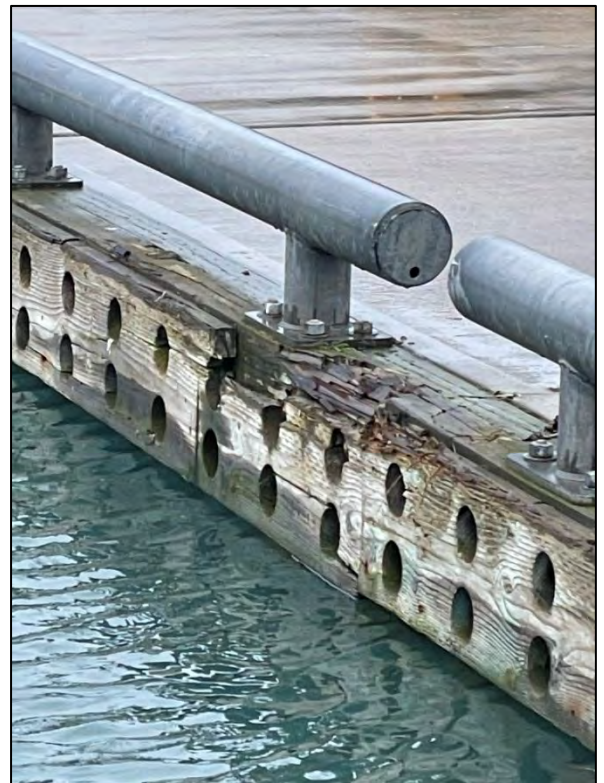
Figure 2.21: Deteriorated timber rubboard and waler. Steel bullrail mounted in waler.

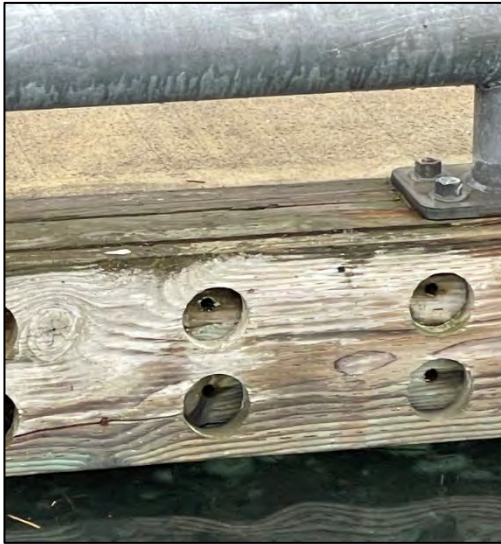
Figure 2.22: Missing through rods.

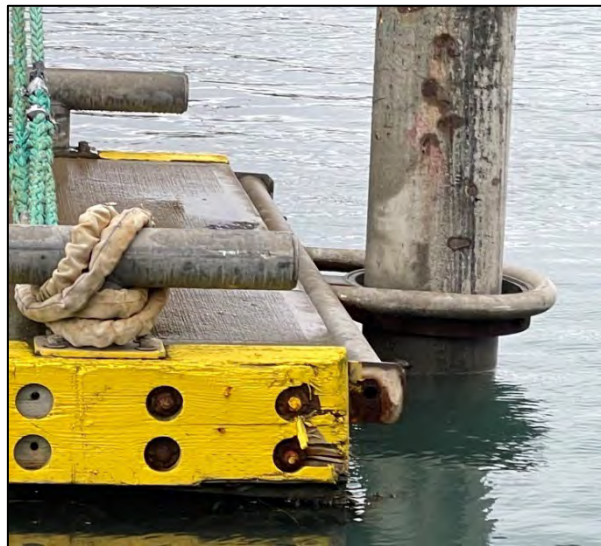
Piles generally had areas of consumed galvanizing within the tidal zone, and active corrosion was observed on some of the piles (Figure 2.23). The piles had new anodes installed in 2018.

Figure 2.23: Pit corrosion and other areas of active corrosion is evident on some piles

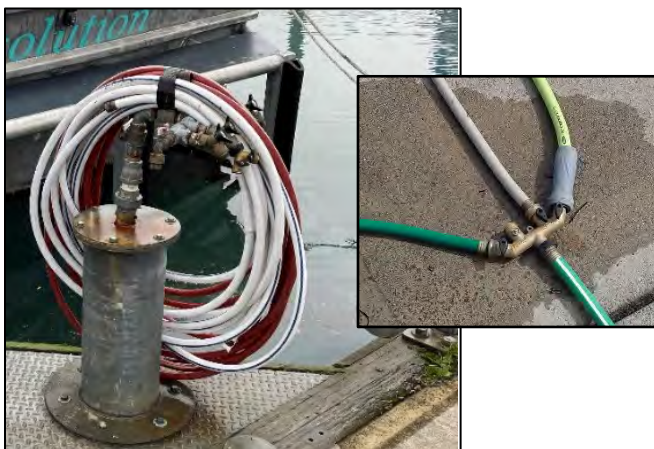
The water distribution system appears to be a piped system from the gangway ramp to the headwalk float, where a single riser with multiple hose bibs is provided near the intersection with each of the three main floats (Figure 2.24). In some locations hoses were attached to the outside of the main float to individual vessel slips. Garden hoses are typically not NSF-approved for potable water distribution and hence should not be used as part of a public water distribution system. Multiple hose connections indicate inadequate backflow protection (Figure 2.24).

Figure 2.25: Water service riser at the head of each main float (left) and multiple hose connections.

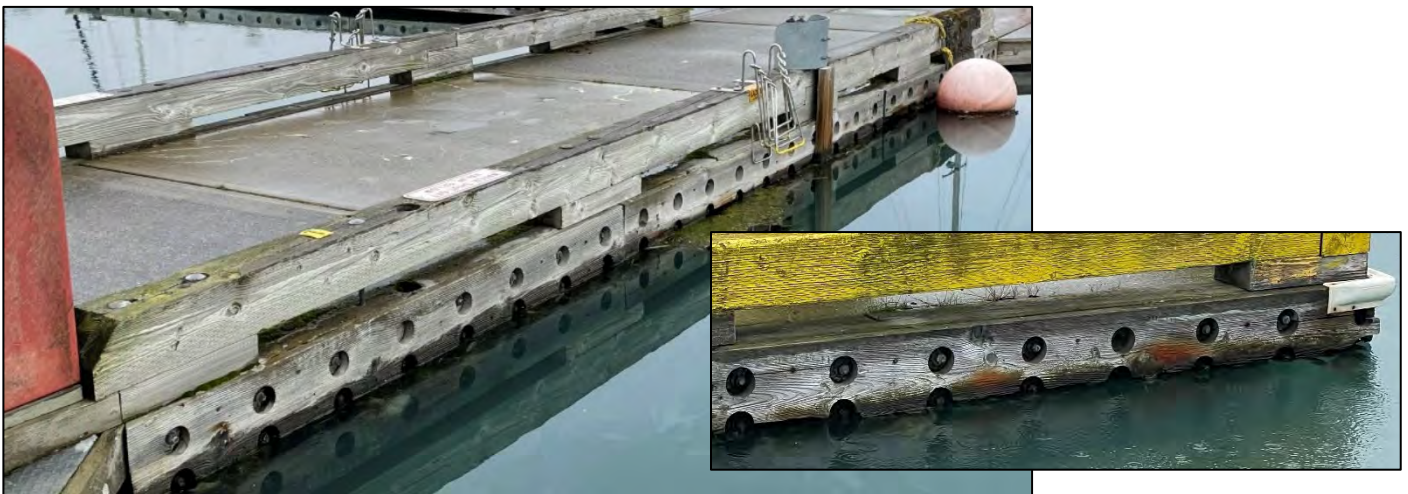
Figure 2.26: Concrete floats showing low freeboard and corroding and missing through rods.

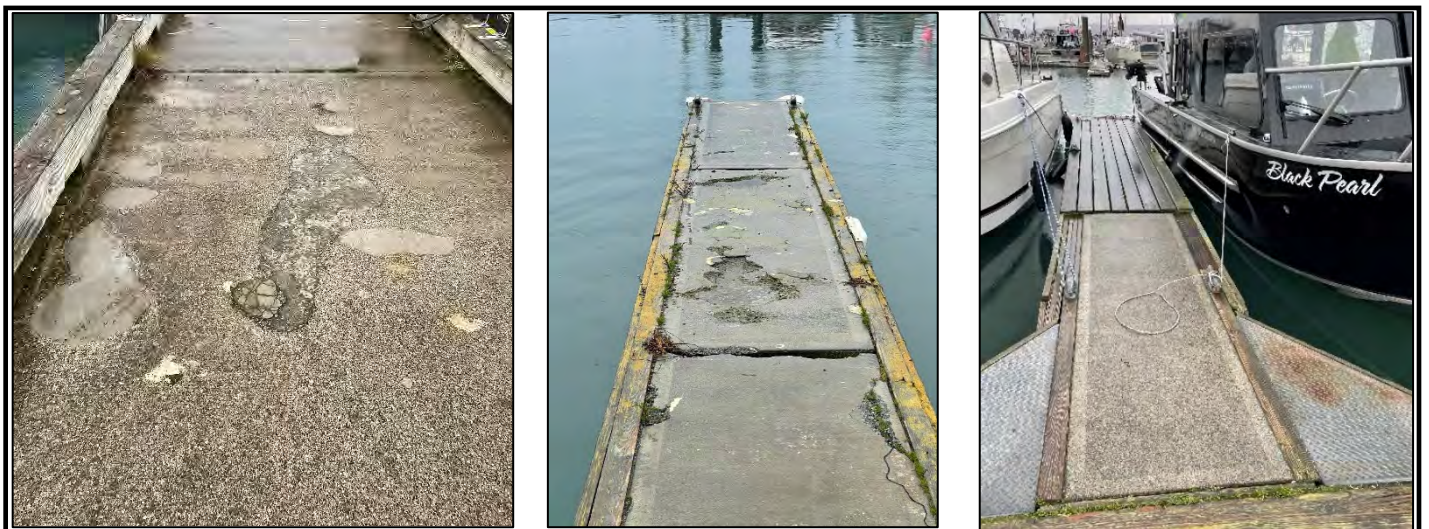
Figure 2.27: Deteriorated concrete surface and concrete repairs, including covering with timber decking.

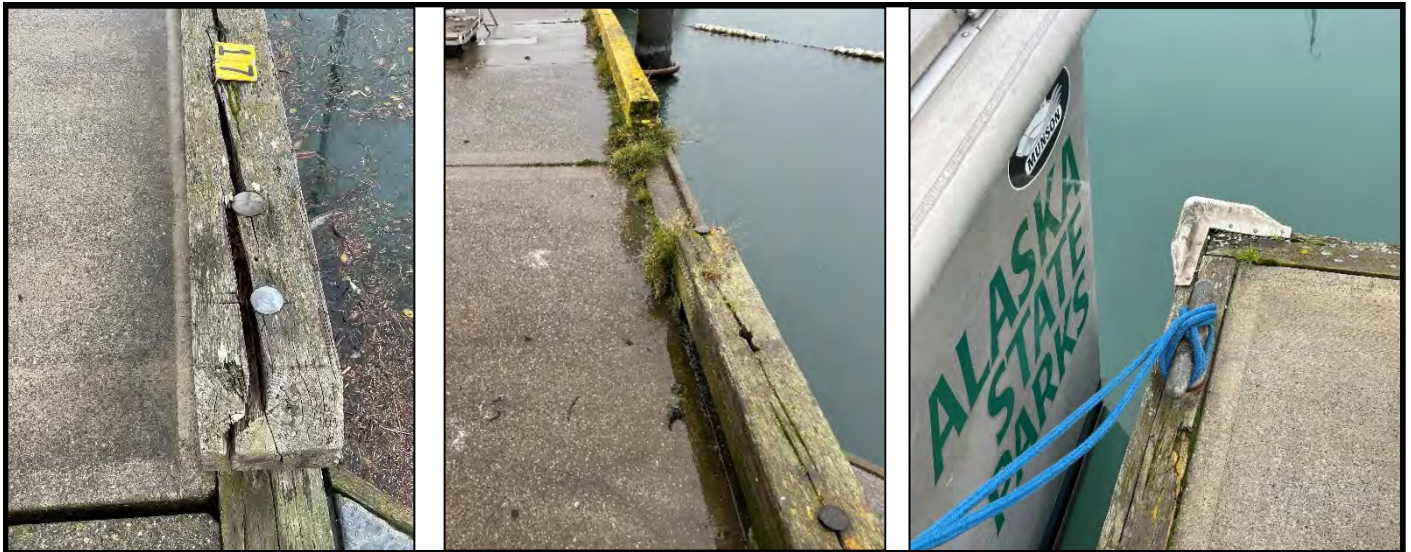
Figure 2.28: Bullrails will major splits and missing section, and cleat mounted in damaged timber waler.

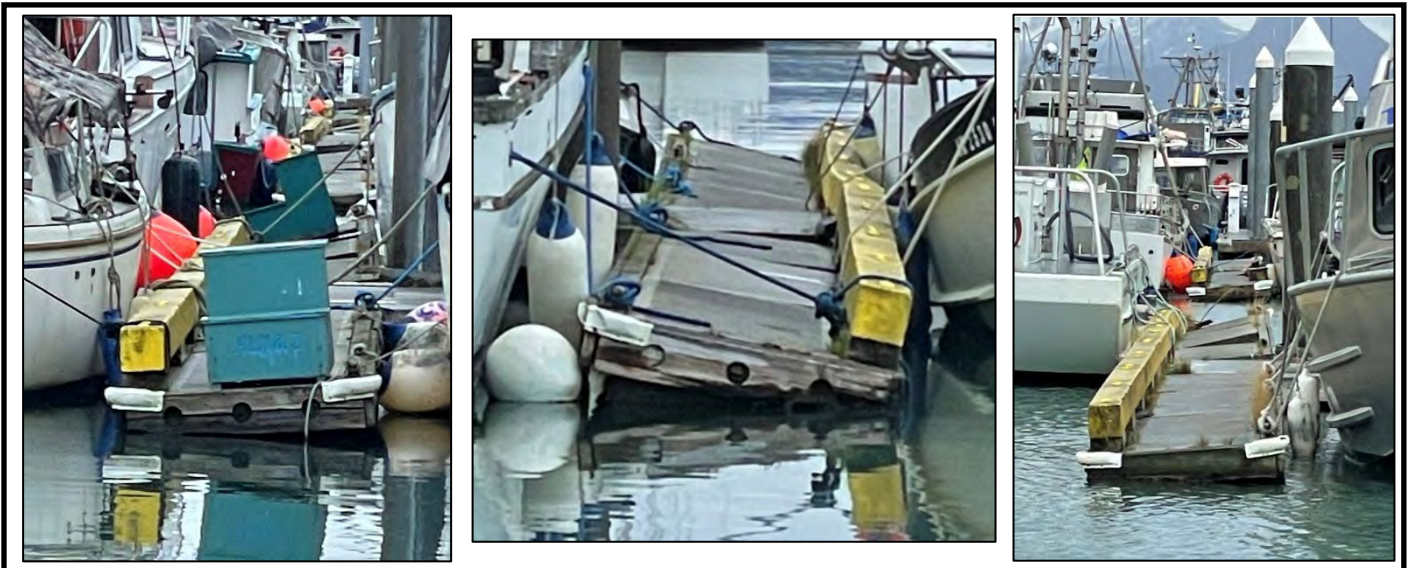
Stall flats on both sides of the Tee floats, at the end of each of the main float rows (Q, P, N, M, L, and K) nearest the main harbor navigation channel, are severely listing and broken loose from their connections to the main float (Figure 2.29). Walers on these floats have major deterioration. Modifications have been made to keep the floats from coming apart (Figure 2.30). It is thought that wave action in the channel acting on the moored vessels in the end slips has overstressed the end floats and caused breakage of the deteriorated structural members in these float connections. This is considered an area of critical condition and immediate repair or removal of the end floats and/or restrictions on use of these slips should be implemented as soon as practicable. Except for these end floats, the rest of these concrete floats in this area are considered to be in serious condition. When these floats are eventually replaced, the fairway distance between J and K Floats as well as between Q and R Floats should be increased to meet current standards (Drawing G2).

Figure 2.29: Tee floats, located along the harbor channel, are broken and severely listing.

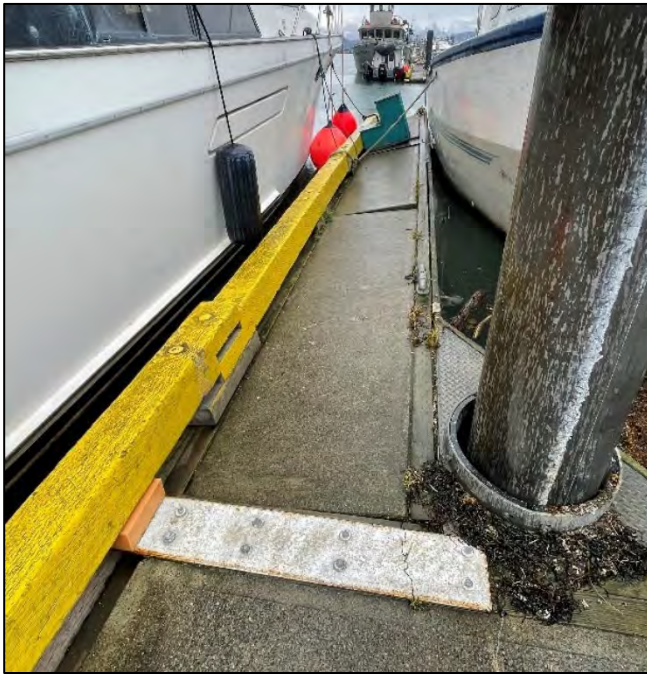
Figure 2.30: A metal plate has been installed to a broken Tee Float. Note the bullrail has come apart at the splice.

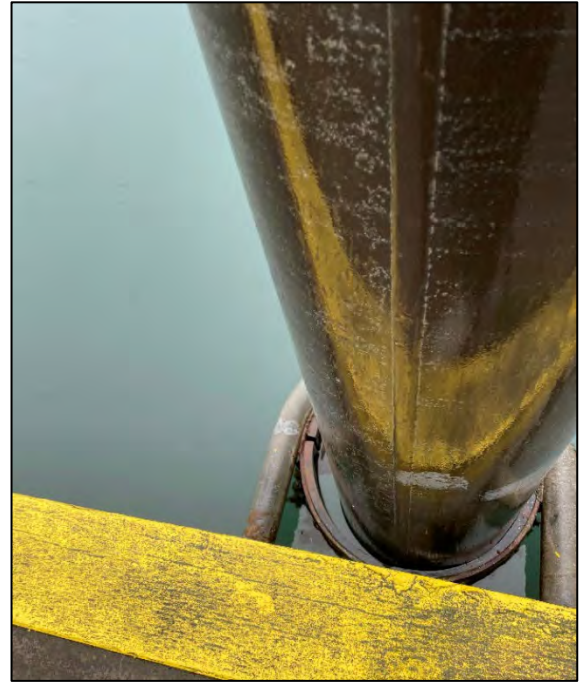
Steel piles are used to secure the floats, and in this area of System 1 the original galvanized coating on many of the piles has been consumed and there is evidence of corrosion (Figure 2.31). A project is underway to install anodes on the piles in this area.

Figure 2.31: Typical steel pile and exterior pile hoop. Note galvanized pile coating is consumed

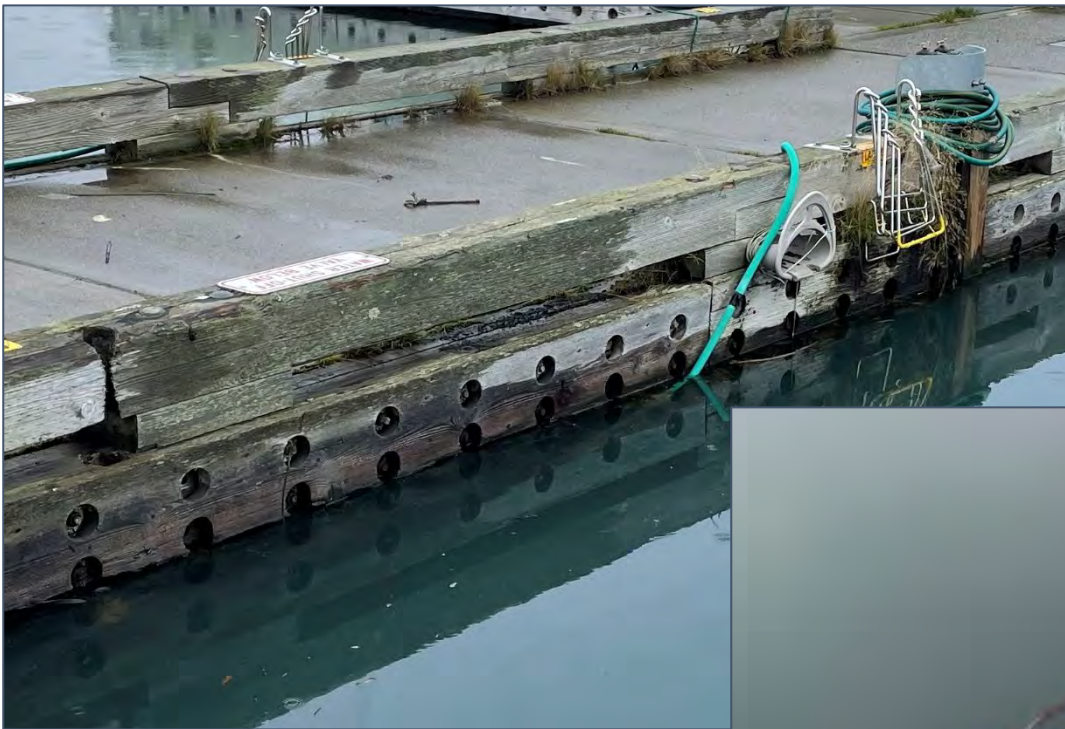
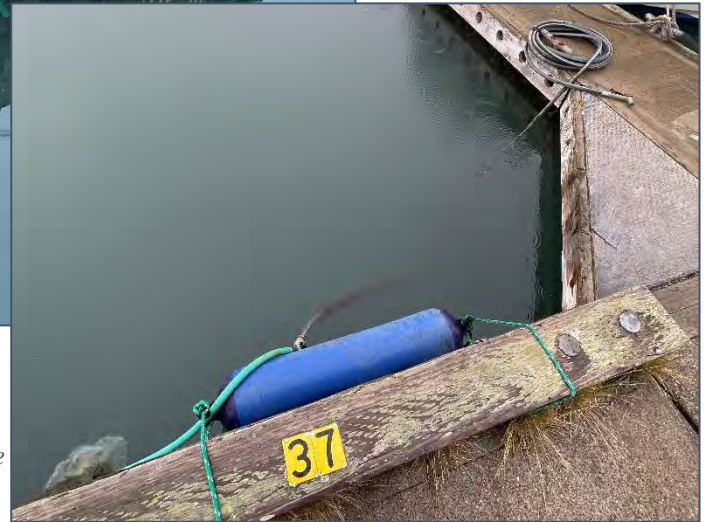
Water service to the 1986 concrete floats in System 1 appears to be distributed by a combination of piping and hoses. There have been many modifications and the exact piping and source to these floats was not clear from topside visual observation. No fixed water piping was visible on the gangway ramp; although there are hose bibs near the top of the trestle at Ramp 4. It is assumed that there is piping along the headwalk float, to the point of the shutoff valves which were observed at the intersection with the main floats. Hoses are attached to the sides of the floats, which may provide service to hose bibs that are located periodically along the main floats. Alternatively, the hose bibs may no longer be connected and hoses go direct to slips as shown in Figure 2.33.

Figure 2.33: Water distribution, with location of valve at the far left (photo above) and hose coming up from under the float. Photo to right shows a hose from under the float to a 3-way connection, with one end going under the float and the other to a nearby slip, with a sprayer attachment.

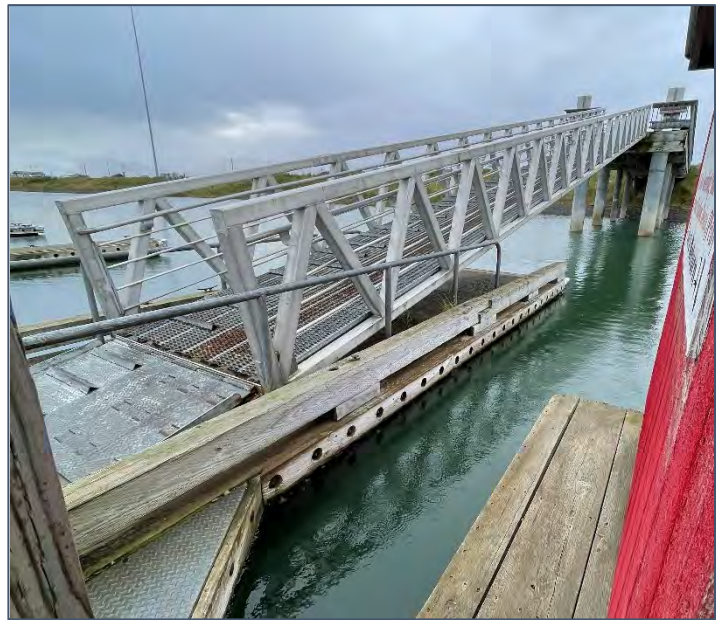
The Ramp 5 approach trestle and gangway have evidence of wear, typical of their age. Steel piles have evidence of corrosion in the tidal zone. Trestle timber treatment is reduced, some minor cracking in pile caps, and decking has evidence of wear. The gangway ramp, at 70-ft long does not meet ADA-guidelines; however, as long as there are sufficient ADA slips (5 total) in the 20-24-ft length available in the harbor (i.e., System 1), this is not required; although it is recommended to replace the ramp with an 80-ft minimum length ADA ramp when the trestle and/or floating docks are replaced. The gangway ramp bottom slide guides have evidence of wear and these as well as the steel floor grating have evidence of corrosion (Figure 2.34). However, there is no visible major damage or defects that immediately affect the capacity of these structures; other than the float on which the gangway ramp lands has low freeboard, as is noted by the timber walers in/near the water especially at the shoreward end (Figure 2.35).

Figure 2.35: Ramp 5 trestle and gangway. Note landing on concrete float with reduced freeboard.

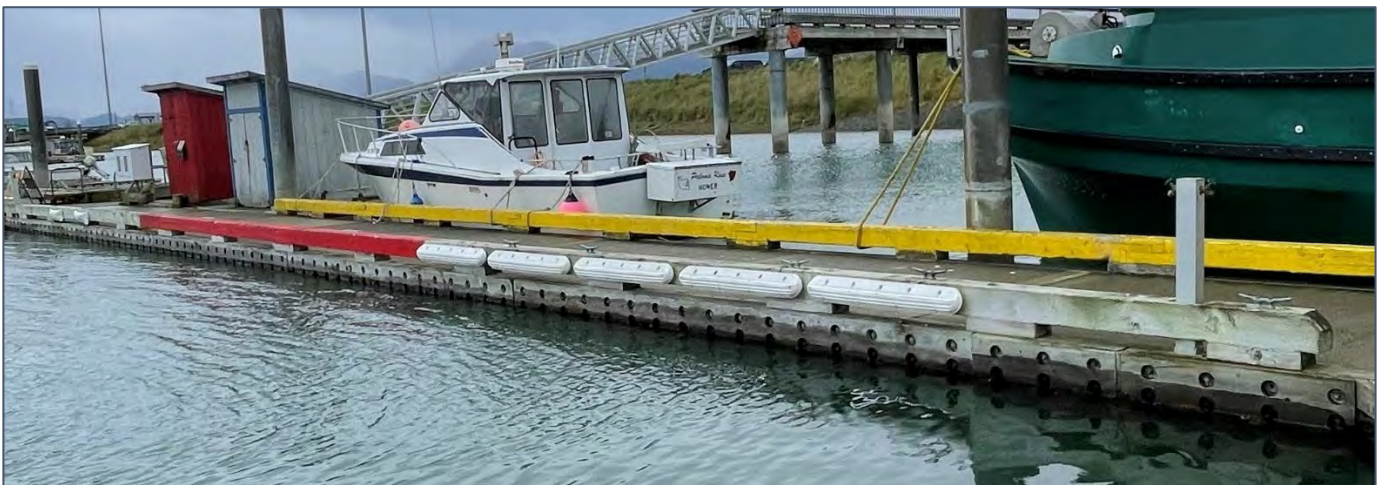
The concrete floating dock modules appear to be in serious condition. The floats throughout System 2 have reduced freeboard (Figure 2.36) due to a lack of flotation and/or saturated foam as a result of the concrete encasement having spalled or cracked. The City has added flotation tubs underneath to supplement the lack of flotation in the most severe locations. The structural through rods which connect the exterior walers have evidence of corrosion throughout the system and several are missing—as no rod/nut was visible on the sides of the floats (Figure 2.37). Many rubboards are cracked and many bullrails, used for securing mooring lines, are cracked or deteriorated due to fungal growth (Figure 2.38), resulting in loss of structural capacity in some locations.

Figure 2.36: System 2 Headwalk float has reduced freeboard and appears to be listing to one side, as noted by partially submerged rubboards.

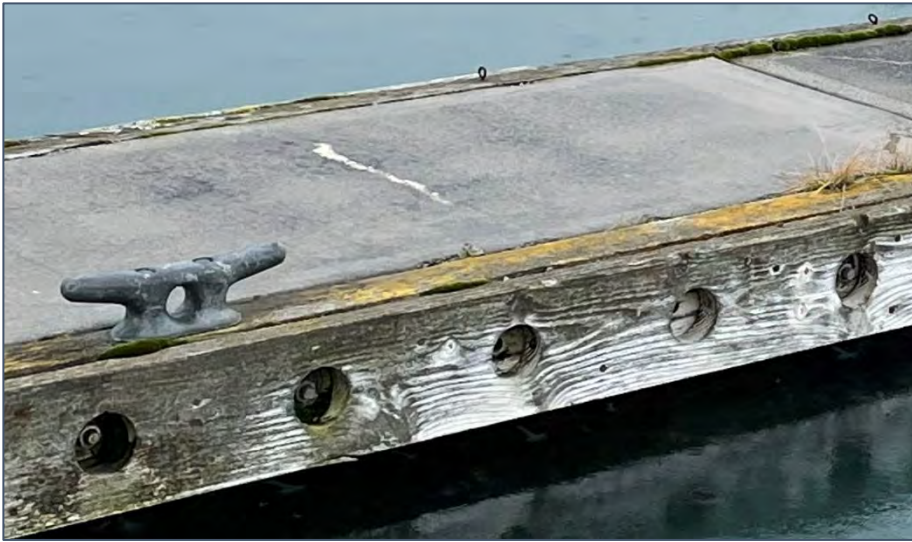
Figure 2.37: Through rods corroded or missing.

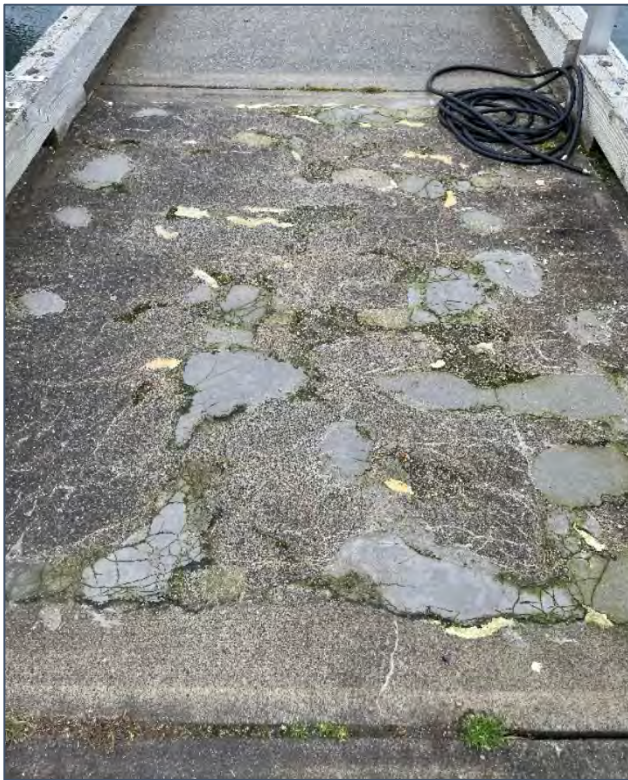
Years of maintenance is evident: patches over already patched concrete (Figure 2.39) decking over deteriorated concrete stall floats (Figure 2.41), replacing sections of timber bullrails and rubboards, and adding safety equipment including fire extinguishers and ladders is evident and have allowed continued use of these floats.

Figure 2.39: Deteriorated/patched concrete on main floats.

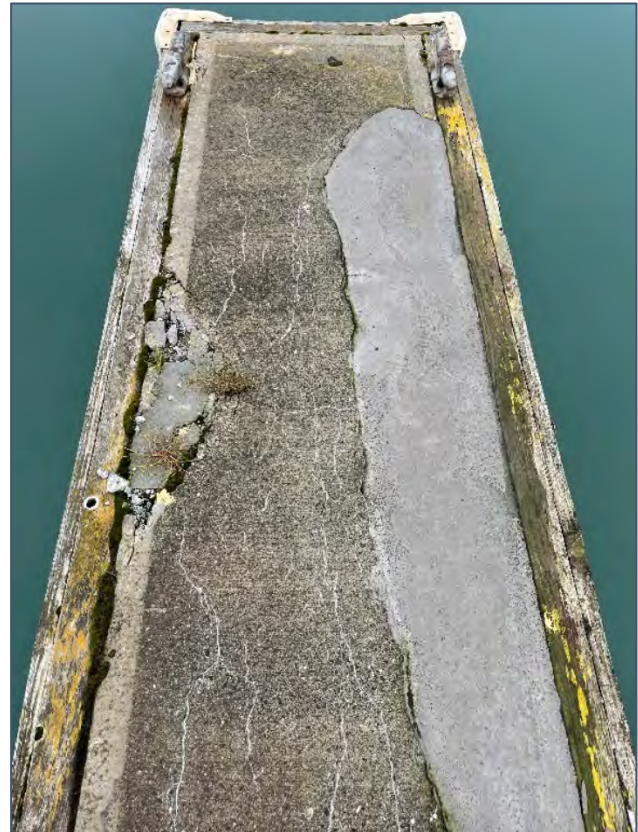
Figure 2.40: Patched concrete and deteriorated waler and rubboards on stall floats.

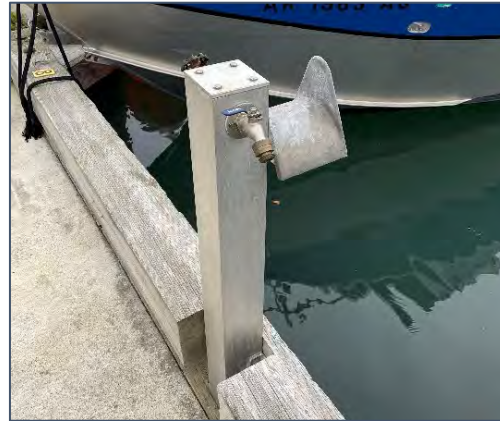
The water distribution system at System 2 appears to have been added and modified over the years. It is fed from System 1 (S Float) via an underwater flex hose. Hose bib stanchions are located periodically on the floats (Figure 2.42). Users run hoses across the floats to the nearest hose bib. A reduced pressure backflow prevention assembly was not evident/observed for this system. The hose bibs are equipped with vacuum breakers; however, these are not reliable or normally accepted as the only backflow prevention device in a public water system. In addition, some hoses had splitters to individual slips, and these did not have vacuum breakers.

Figure 2.42: water hose bib and hose stand.
