**CITY OF HOMER  
HOMER, ALASKA**

**ORDINANCE 25-34**

AN ORDINANCE OF THE CITY COUNCIL OF HOMER, ALASKA,  
AMENDING THE FY25 CAPITAL BUDGET BY APPROPRIATING  
\$45,500 FROM THE PORT RESERVES FUND FOR THE PURPOSE OF  
REPLACING A FENDER ON THE DEEP WATER DOCK AND  
AUTHORIZING SINGLE-SOURCE PROCUREMENT.

**Ordinance 25-34, An Ordinance of the City Council of Homer, Alaska Amending the FY25 Capital Budget by Appropriating \$45,500 from the Port Reserves Fund for the Purpose of Replacing a Fender on the Deep Water Dock and Authorizing Single-Source Procurement. City Manager/Port Director.**

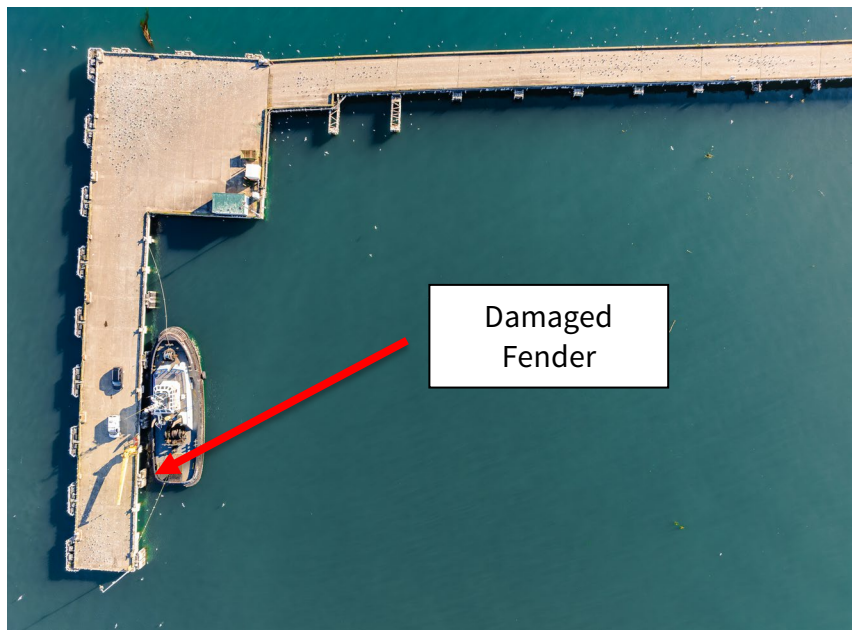
Port Maintenance discovered a damaged fender on the Deep Water Dock on the inside berth. Bolts that support the fender have corroded, and several timbers on the fender are damaged or broken.

Staff also noted that the fender unit had dropped by six inches and appeared to just be hanging from the dock fasteners.

The issue was traced to old piling infrastructure left during the original construction of the Deep Water Dock which is protruding from the seafloor and interfering with this fender unit.

Fortunately, Port Maintenance has a rebuilt spare fender for the inside berth, saving costs. However, because of the physical size (14' wide, 35' long, and almost 30,000 lbs) specialized crew and equipment are needed for its installation.

- A mobile crane will be necessary to be positioned on the dock to lift and remove the current fender and replace it with the “ready-to-go” rebuilt fender.
- A diver will be required to cut off and remove the derelict piling that was left from the original installation of the deep water dock.
- Drill and epoxy new anchoring bolts into the dock face to secure the fender brackets to the dock.
- Once the dock is ready, the new fender will be installed and bolted into place with the assistance of the mobile crane.
