Report of Investigation 2022-5

COASTAL BLUFF STABILITY ASSESSMENT FOR HOMER, ALASKA

Richard M. Buzard and Jacquelyn R. Overbeck

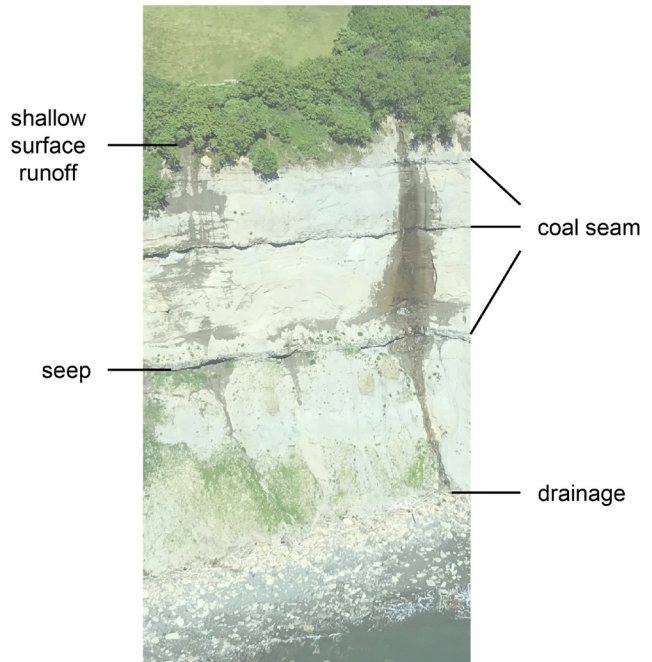
Figure 7. This 200-ft coastal bluff in Homer has surface runoff causing a continuous stream that drains to the beach. Groundwater also seeps from coal seams and other changes in the stratigraphy. Water causes channeling on the bluff face and undercuts coal seams, leading to instability.

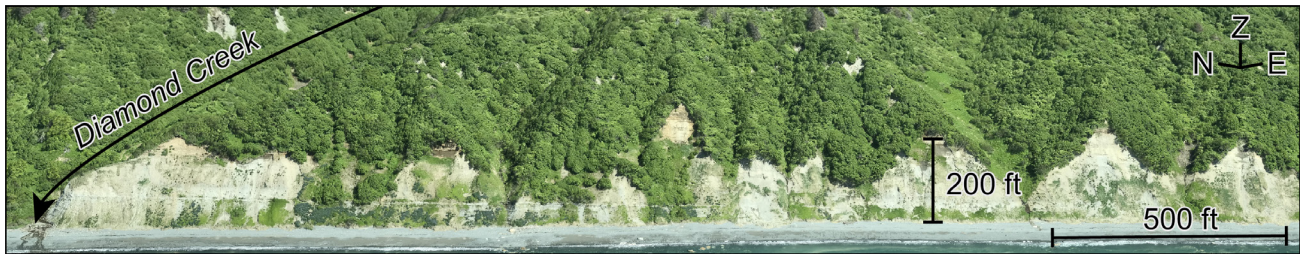
The coastal bluffs of the Diamond Creek area reach from 250 to 500 ft (75 to 150 m) above MSL with an average slope of 17 ± 4 degrees (23 to 39 percent). They are typically exposed, with grass near the coast and denser vegetation on the flanks leading to a plateau above (fig. 10). Water seeps and surface water runoff are common. Much of the

**Figure 10.** Looking northeast at the coastal bluffs of Diamond Creek. The bluffs are tall, exposed, and undercut, leading to higher instability. This is a screenshot from our oblique image-derived 3D model.

area has a low to medium bluff instability score, mainly due to fast erosion rates and high drainage.

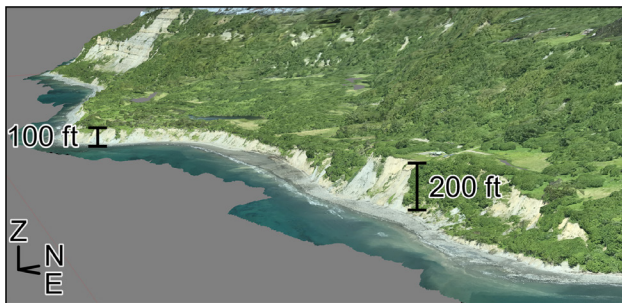
**Figure 11.** Looking northwest at the Bluff Point landslide area. The coastal bluffs are the seaward-most bluffs in this screenshot from our oblique image-derived 3D model. Unlike the larger bluffs in the background, these coastal bluffs are mostly unvegetated and experience significant erosion.

The Bluff Point landslide area is most notable for the tallest coastal relief in Homer, reaching up to 800 ft (240 m) above MSL. The lower landscape

is formed from a widespread landslide deposit (Reger, 1979). The entire bluff complex is influenced by coastal processes over geologic timescales. Reger (1979) explains that the inland bluffs are relatively stable because wave action only reaches the landslide deposit, therefore we did not consider the larger landward bluffs to be coastal bluffs. The landslide deposit is so large that there are structures and small roads built upon it, and it has its own coastal bluffs about 30 to 100 ft (10 to 30 m) tall (fig. 11). These slopes are the second steepest in Homer, averaging 74 percent (36 degrees). This region has the fastest average erosion in Homer of -1.7 ft/yr (0.52 m/yr), reaching up to -3.7 ft/yr (-1.1 m/yr). The combined instability score of 2.0 (medium) is largely driven by these rapid erosion rates and the lack of vegetation on slopes. Despite steep slopes, the hazard due to slope failure is lower because they are relatively short (there is less inland erosion due to slope failure).

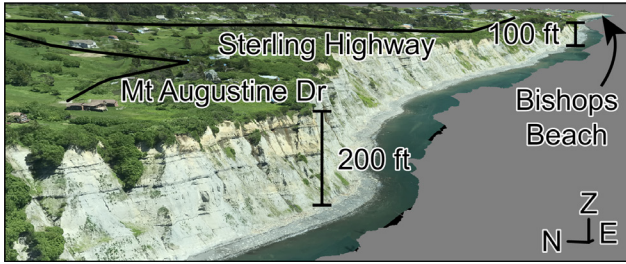
Figure 12. Looking east at the steep, exposed bluffs near Mount Augustine Drive in the oblique image-derived 3D model. The bluffs gradually shorten and become less steep toward Bishop's Beach.

Coastal bluffs gradually transition from tall, steep, and exposed bluffs around Mount Augustine Drive to short and vegetated slopes at Bishop's Beach (fig. 12). This region has a high coastal bluff instability score due to tall, steep slopes, considerable erosion, and little to no vegetation. Even though the Bishop's Beach area has much lower bluffs, there are still hazards due to rapid erosion. In general, the exposed bluffs have greater erosion at the toe than the top, indicating bluff steepening. The greatest toe erosion occurred between 1951 and 1964, likely in the aftermath of the earthquake (Stanley, 1968).

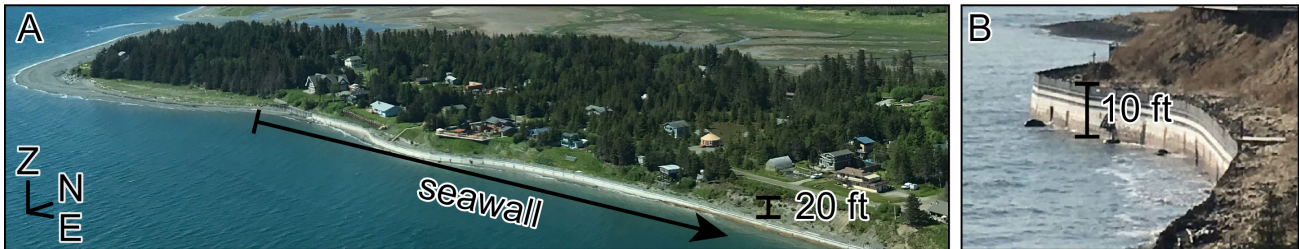
Figure 13. A. This 2019 photo looking northwest at Munson Point (left) shows the seawall protecting grassy and exposed bluffs. **B.** This closeup photo shows how water comes right up to the seawall and would surely undercut the bluffs.

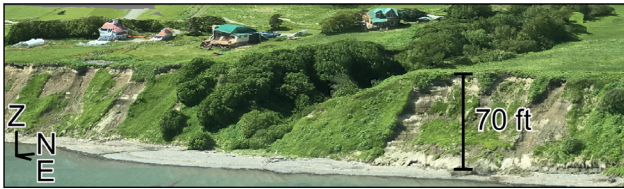
Figure 15. Looking west toward the grassy-to-exposed bluffs and a densely vegetated creek near East End Road in the oblique image-derived 3D model. Exposed slopes show groundwater flow.

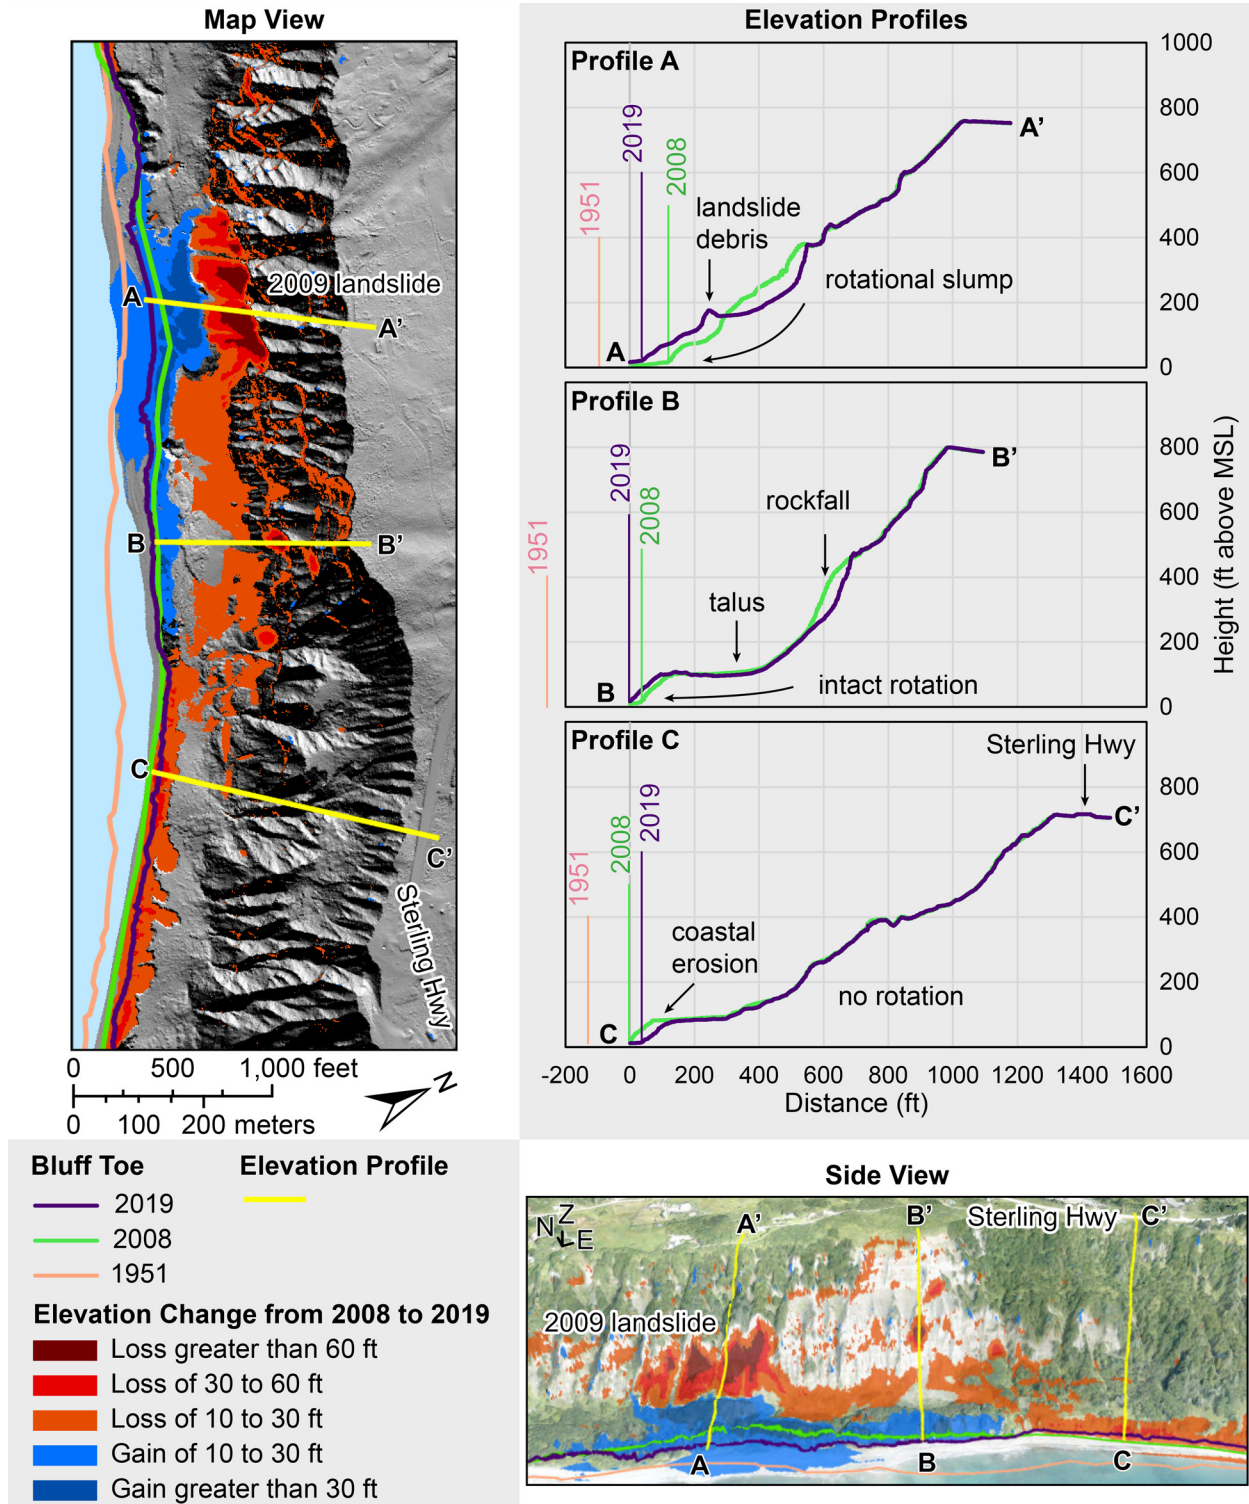
After completing this assessment, we found evidence that the 2009 landslide in the Bluff Point landslide area likely complicated erosion rates while providing insights into the connection between the coastal and inland bluffs. Between July 2 and July 3, 2009, two flanks collapsed in the Bluff Point landslide area and the beach uplifted as much as 15 ft (4.6 m), indicating a rotational slump occurred (Berg, 2009). Reger (1979) explains how these coastal bluffs are the eroded toes of rotated slump blocks from one or multiple ancient landslides. There are wide, underground shear planes connecting the inland bluffs to the coastal bluffs and beach (Berg, 2009). After a rotation, the uplifted area erodes. This process redistributes stress in the slump block back toward the bluff until another rotation occurs (fig. 2). The history of coastal erosion likely played a major role in destabilizing the bluff.

The 2009 landslide occurred across 800 ft (250 m) of shoreline, but comparisons of the 2008 and 2019 lidar reveal that the 2,500 ft (760 m) of coastal bluffs was translated seaward as far as 80 ft (25 m; fig. 17). The coastal bluffs remained mostly intact. Berg (2009) identified fissures in the slide mass that indicated active creeping. This suggests that the mass is debutting from the inland bluff, leading to greater instability (B. Higman, written comm., 2021). Salisbury (in prep.) estimates that as far as 1,200 ft (366 m) inland from the bluff top edge is highly susceptible to a continued, retrogressive failure of the existing deep-seated rotational landslide block.

Where the Sterling Highway comes closest to the bluff edge (fig. 17, profile C), we did not find evidence of rotation from the 2009 landslide. The erosion history is similar to the nearby failure area, but the bluff is less steep. Continued erosion and bluff steepening decreases stability.

Figure 17. Map and side view of the region where the 2009 landslide occurred. The vertical change between the 2008 and 2019 lidar DTMs shows where the inland portion of the slump block lowered (warm colors) and rotated, uplifting the seaward section (cool colors). The bluff toe moved seaward between 2008 (green) and 2019 (purple). This is most apparent along profile A where the flank collapse occurred. On profile B, a smaller rockfall left a wide talus debris fan, and the coastal bluffs migrated seaward while remaining intact (carrying upright vegetation with them). Southeast of this area the rotation appears to end, and profile C has regular coastal erosion (also indicated by warm colors).
