**City of Homer Port and Harbor Accessibility Site Survey
Final Report**

The following report contains the findings and recommendations of the ADA Site-Survey performed at the City of Homer Alaska - Port and Harbor Facilities.

Date of on-site assessment: August 15, 2017

Facility Name: City of Homer	Date of Assessment: 08/15/2017
BUILDING/AREA(s): Note: Port and Harbor including harbor and port office, transient/reserved moorage, parking, path of travel, benches, viewing areas, pioneer dock shelter, boat load/launch ramp, ice and bait automated machines, disposal sheds, fish stations, Nick Dudiak fishing hole lagoon. (Interior bathrooms' access not included within this summary)	
Team Member(s) Performing the Assessment(s): University of Washington, NW ADA CENTER STAFF

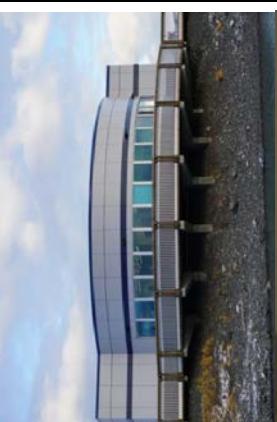
CHECKLIST PAGE/NO. OR 2010 ADA STANDARD S SECTION NUMBER	ACCESSIBILITY ISSUE	COMMENTS/ SUGGESTIONS	BUILDING NUMBER AND LOCATION OR OTHER IDENTIFIER	PICTURE/IMAGE	PRIORITY	TIMING	COST
307.2 Protruding Objects	Protruding element 4" or greater at doorways or dominant path of travel.	Eliminate shelf to provide clear floor space to approach in opening the door.	Harbor/Port Office

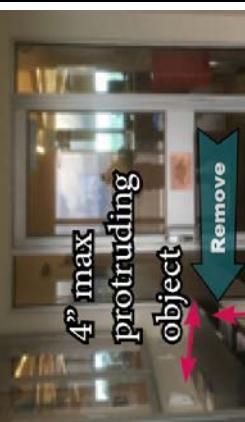
1		
305 Clear Floor or Ground Space	Clear passage into doorway is obstructed due to protruding element.	Provide a clear floor space of at least 30" by 48" for either forward or parallel

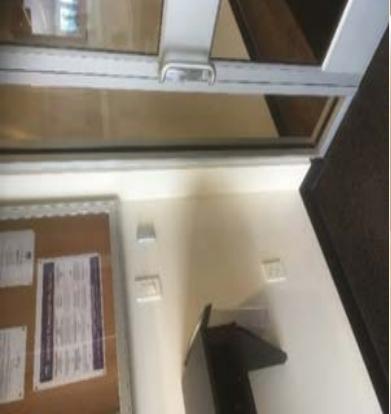
703.4.1 Installation and Location	Exterior Notification Board: Too high for visibility for anyone using a wheelchair	For greater access, lower access to bottom edge of the information boards to 48" to 60" maximum.

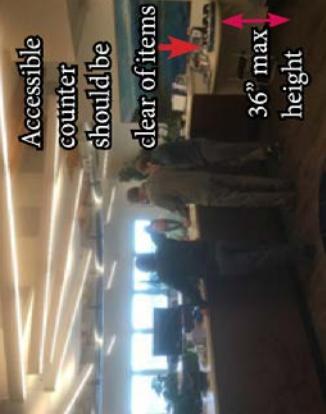
904.4 Sales and service counters	Accessible sales and service counter is clustered with multiple items rendering the purpose of its design moot.	<p>Provide clear surface counter that can be utilized by providing accessible counter with a surface area of 30" width in the dominant section of service counter.</p> <p>Provide a chair for patrons in case standing for longer period is a challenge.</p>

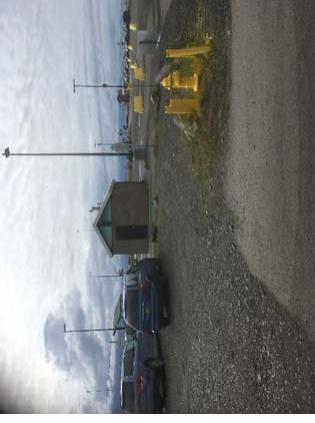
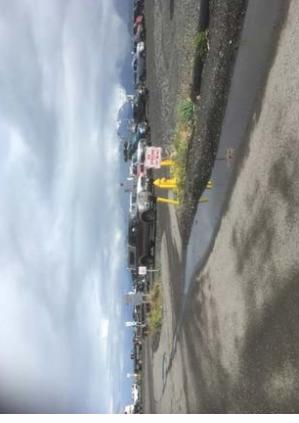
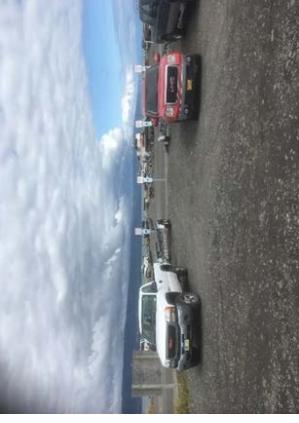
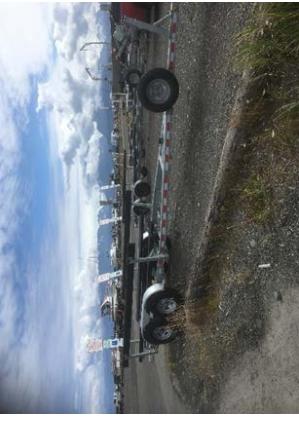
1
302 Floor or Ground Surfaces	The Small Boat Launch area parking lot also serves accessible restrooms, a trash dumpster, and a roof covered lookout rest shelter that contains the Kid's Don't Float Program Personal Flotation Device's storage.	Small Boat Launch Ramp	Improving access for this primary function area would be a high priority. Recommend <u>immediately</u> improving the accessible route by relocating some accessible parking spaces to the open asphalt surfacing already adjacent to and around the restroom building, if practical.

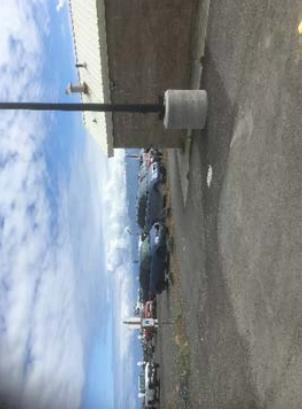
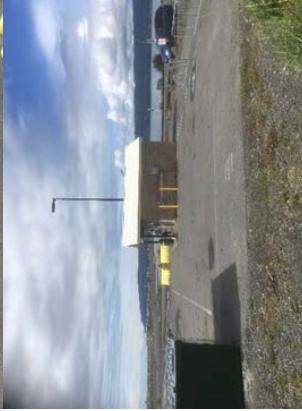
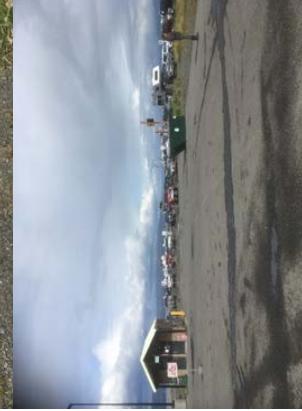
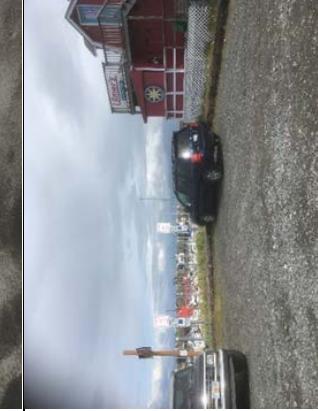
403 Walking Surfaces	502.2; 502.3 502.6 Accessible Parking Dimensions	There are eight (8) signed accessible parking spaces designated for individuals with disabilities (4) and their vehicles with boat trailers (4). The surface material is loose gravel and fill which may not be firm, stable, and slip resistant or have additional change in level issues throughout a season.	Overall recommendation is replacing the surface material with interlocking compacted gravel, asphalt, or concrete surfacing in all the designated accessible parking areas. If using gravel with no painted lines; consider adding

additional signage to designate the access aisle's portion of each accessible parking space to ensure these paths-of-travel remain open and clear.

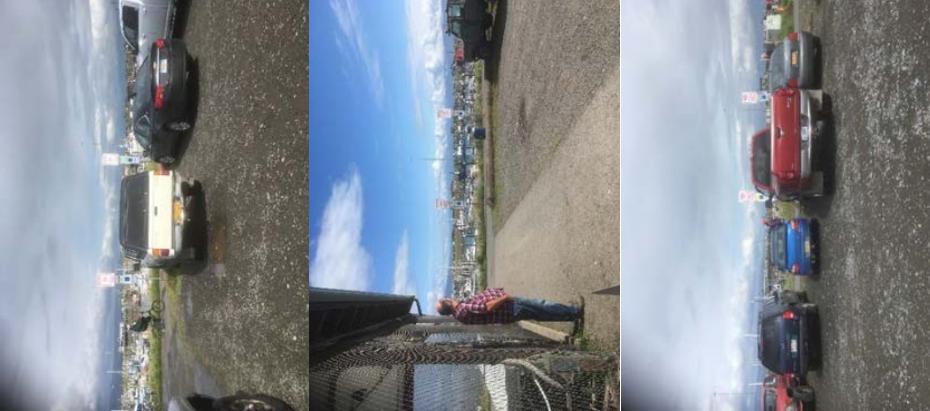
403.5.3 Clear Widths and Slopes for Walking Surfaces	<p>providing at least 5% or greater accessible parking stalls.</p> <p>Almost all accessible spaces are located within gravel lots.</p>	<p>most amount of tourism foot traffic and access to all the diverse boat class slips available.</p> <p>Walking and floor surfaces must be firm, stable, and slip resistant.</p> <p>At least one accessible parking space has been designated for each primary function area (including restrooms, fish cleaning tables, ramp(s) access, harbor office, etc.).</p>

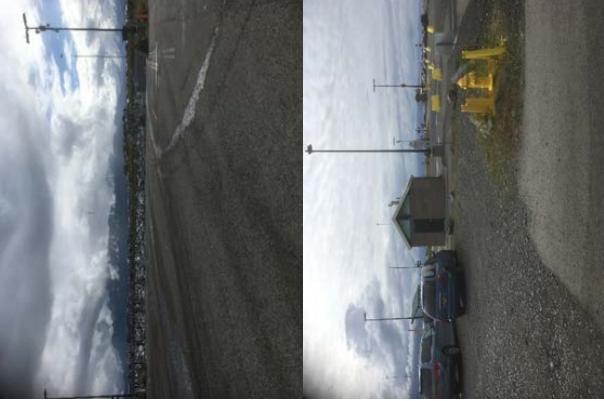
1
	<p>502.2; 502.3 Undetermined total number of spaces.</p> <p>502.6 Accessible Parking Dimensions Parking space areas are located in gravel and fill surface lots with no clear ground marking delineations or documentation of all areas.</p> <p>302 Floor or Ground Surfaces There is a total of 28 accessible parking sign designations located in all the parking lots.</p> <p>403 Walking Surfaces</p>	<p>Designate accessible parking spaces that serve a primary function areas that is connected with an even, stable, firm, and slip resistant surface.</p> <p>Improve the gravel surfacing and connecting paths of travel at each of these primary function parking areas.</p> <p>Accessible route or approach must be free of abrupt changes in surface level and should have a circulation</p>	<p>Parking and Path of travel (Small Boat Launch area)</p>

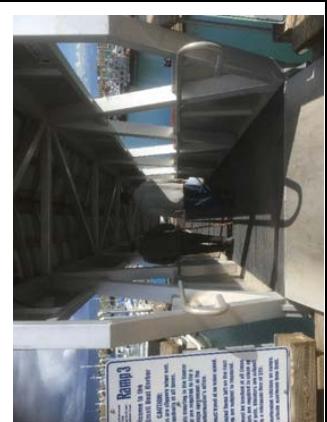
1003.2 Accessible Routes	**Good features**	area of less than 2% in all directions.	RAMP 3 is 100ft long and serves as the most accessible pedestrian way for any individual with a mobility challenge to traverse to sea level.	Parking and Primary Path of travel (RAMP 3)
1003.2.2 Boarding Piers at Boat Ramps

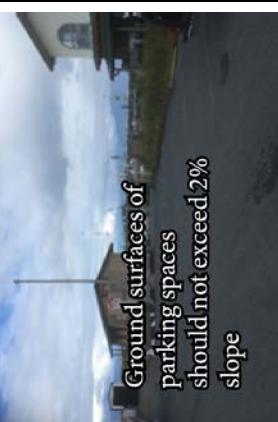
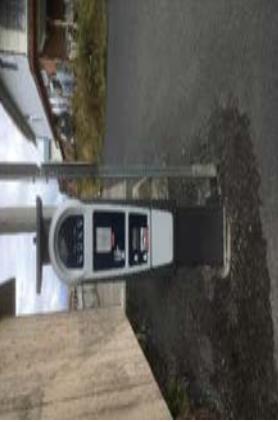
302.1 302.3 Ground Floor Surfaces	Clear floor space and asphalt-to-gravel transition issues. The clear floor space to use the automated parking meter that serves Ramp 3 parking lot can become uneven with foot-traffic use and ongoing weathering due to the asphalt-to-gravel transition.	Accessible route or approach must be free of abrupt changes in surface level and should have a cross slope of less than 2% in all directions. This change-in-level barrier could be easily remedied and likely	Parking and Path of travel (RAMP 3) Automated Parking Meter

<p>permanently maintained with a little additional asphalt around the base of the meter.</p> <p>In order to facilitate a smooth payment interchange create an even, stable, slip-resistant surface for a forward or side approach by someone using a wheelchair.</p>

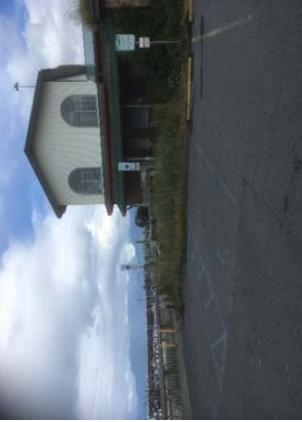
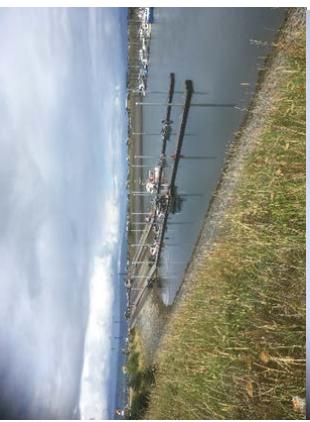
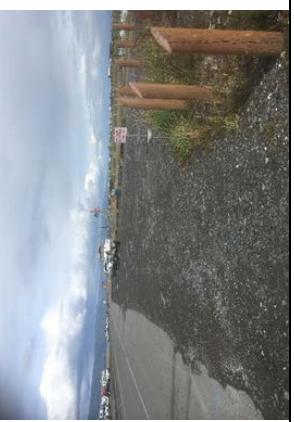
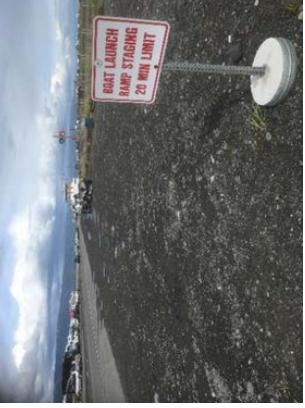
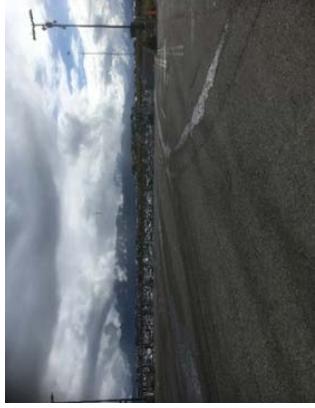
2
302 Ground and Floor Surfaces	<p>The designated boat launch ramp staging area's surface material is loose gravel and fill.</p> <p>Note: There is adequate space and accessible surface material provided nearer the top of the launch ramp area as an alternative.</p>	<p>Provide ground surface that is firm, stable, and slip resistant.</p> <p>Maintain to ensure changes in level issues do not occur throughout a season.</p>	<p>Small Boat Launch Ramp</p>

303 Changes in Surface Level			<p>For greatest accessibility, improve the surface material at the currently</p>

<p>signed and designated staging area or provide additional signage and notification (website/harbor maps) to patrons with disabilities of any alternative accessible staging area(s) for “equivalent facilitation.”</p>

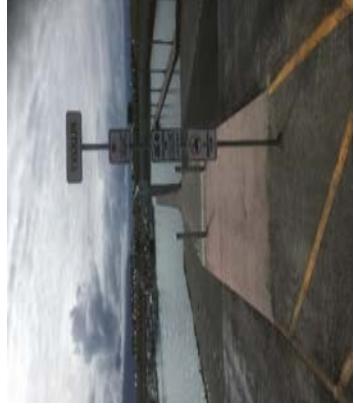
<p>1003.2.2 Boarding Piers at Boat Launch Ramps.</p> <p>Gangways connecting floating boarding piers may exceed the maximum slope specified in the guidelines, if the total length of the gangway is at least 30 feet.</p> <p><i>NOTE: Where the accessible route serving a floating boarding pier or skid pier is located within a boat launch ramp, the portion of the accessible route</i></p>
	<p>Not required or prioritized; but recommend due to the steeper slope consider enhancing and improving the ramp safety features and texture of the surface to improve safety, ambulation, and traction during inclement weather.</p>	<p>Small Boat Launch Ramp</p> <p>Gangways</p>

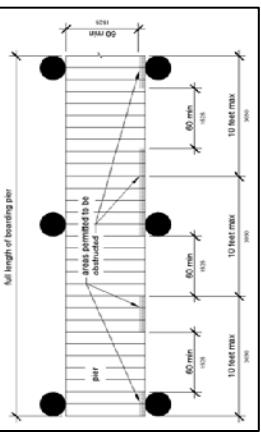
<p>Figure 1003.3.1 Boat Slip Clearance</p>

<i>located within the boat launch ramp shall <u>not</u> be required to comply with Section 405 Ramps requirements.</i>	<p>For tourists, the general public, and boat operators RAMP 3 is the shortest connecting accessible route and central point of travel to all of the varied accessible moorage slip sizes and loading/unloading zones available at sea level.</p> <p>Operators, guests, and visitors who come to the Homer boating harbor facilities will find a total of 875 total boat slips.</p> <p>There are seven (7) different classes or stall sizes available for boats ranging from 20-75 feet (see Transient Moorage Map).</p>	<p>Formally commit to designating the required eleven (11) accessible stalls by slip locations.</p> <p>Designate at least one accessible slip location for each of the available classes, then locate the remaining four slips in the most widely utilized and popular boat sizes used and moored in the harbor.</p> <p>Place them on the shortest accessible route to the RAMP 3 arrival point.</p>	<p>Transient / Reserved Moorage</p>

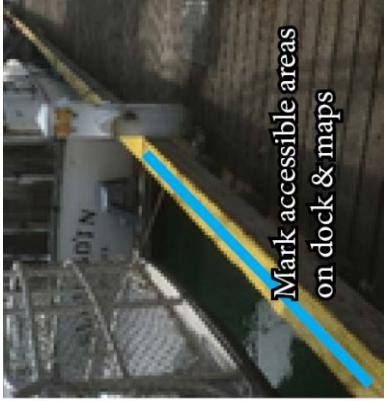
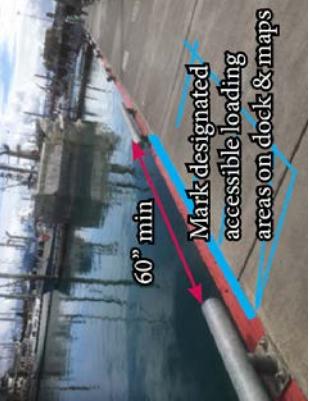
1
305 Clear Floor or Ground Space	Accessible path of travel and clear floor space for boarding is not provided.	Transient/ Reserved Moorage	<p>Ensure an accessible path of travel and clear floor space for boarding at each accessible slip.</p> <p>Provide a clear floor space of at least 30" by 48" for either forward or parallel.</p> <p>Modify any pier barriers or edge protection that may hinder access.</p>

<p>Mark accessible areas on dock & maps</p>

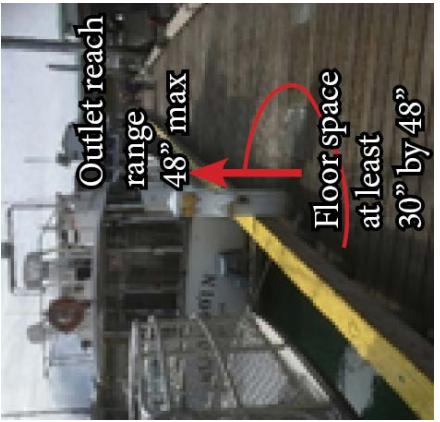
1003.3.1 Boat Slip Clearance	Designated accessible clear opening is not provided.	<p>For every 120 inches (10 ft.) of linear pier edge serving these accessible slips there is a clear opening at least 60 inches wide.</p> <p>Pier barrier and edge protection of 4" high max and 2" wide max</p>

Examples such as water supply facets and hoses, outlets for electricity and cable TV, etc. will require:

- Proper clear floor space of at least 30" by 48",
- Reach ranges from floor surface of minimally 15" to 48" maximum,
- Operating controls shall be operable with one hand and shall not require tight grasping, pinching, or

Outlet reach range 48" max

Floor space at least 30" by 48"

Ensure all the surrounding amenities and services that serve these specific accessible slips are made accessible.

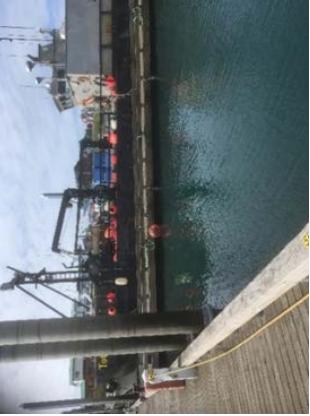
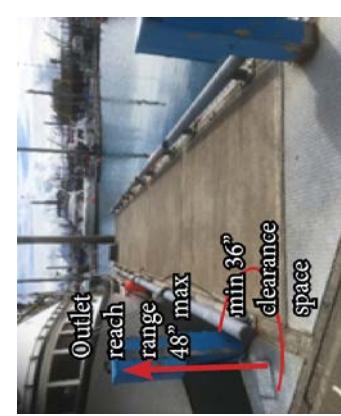
twisting of the wrist. The force required to activate operable parts shall be 5 lbs. maximum.

Replace spigot controls with lever mechanism Where an obstruction occurs there should be a clearance of minimum 36" clear passing space	2

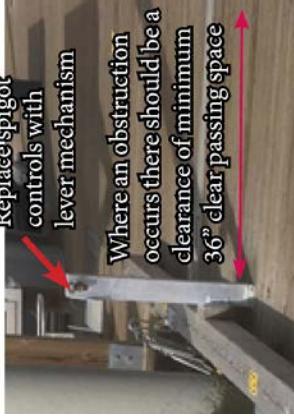
CHECKLIST PAGE/NO. OR 2010 ADA STANDARD SECTION NUMBER	ACCESSIBILITY ISSUE	COMMENTS/ SUGGESTIONS	BUILDING NUMBER AND LOCATION OR OTHER IDENTIFIER	PICTURE/IMAGE	PRIORITY	TIMING	COST
404.2.7 Door Hardware 309 Operable Parts	Round water spigot control(s).	Replace controls with lever mechanisms	Transient/ Reserved Moorage

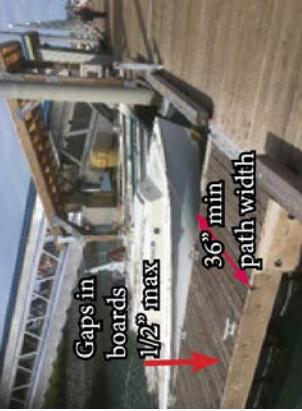
<p>606.2 Clear Floor Space</p> <p>Limited maneuvering or clear floor space.</p>	<p>Provide a clear floor space of at least 30" by 48" for either forward or parallel to access other available amenities like electricity.</p> <p>(NOTE: Cleats or other boat securing devices can be at any height and do not have to comply with reach range requirements.)</p>

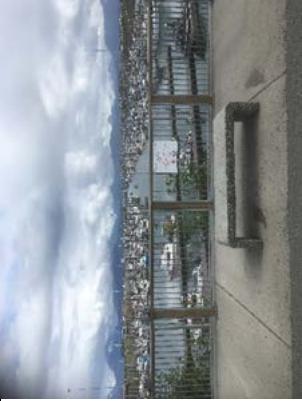
<p>703.4.1 Installation and Location</p> <p>Informational sign and marking accessible zone/area.</p>	<p>Provide clear markings on all designated accessible slips and loading zone area(s). For example, painting a thin blue line inside the yellow transient moorage area lines or red loading zone lines for easier</p>

detection and recognition of these accessible areas/features.	
Information sign and marking accessible Loading/Unloading Zone.	<p>For the designated accessible loading zone area mount signage and paint an additional blue pattern and/or harbor logo-type image for easy detection on the ground. One suggested purpose to use a logo or selected image is to clearly connect this pattern and image with harbor published resource notification material too.</p> <p>Boating charters and their customers with disabilities along with the general</p>

<p>public usage will then have a readily detectible, consistent, and recognizable rally point for loading and unloading.</p> <p>Note: Once modifications and changes are made, update and maintain all harbor and port resource information and website highlighting all the facility's accessible features and processes.</p>	<p>To improve accessibility, provide an additional bench or accessible seating area-benches that meet ADA standard (i.e. seating with back support).</p>

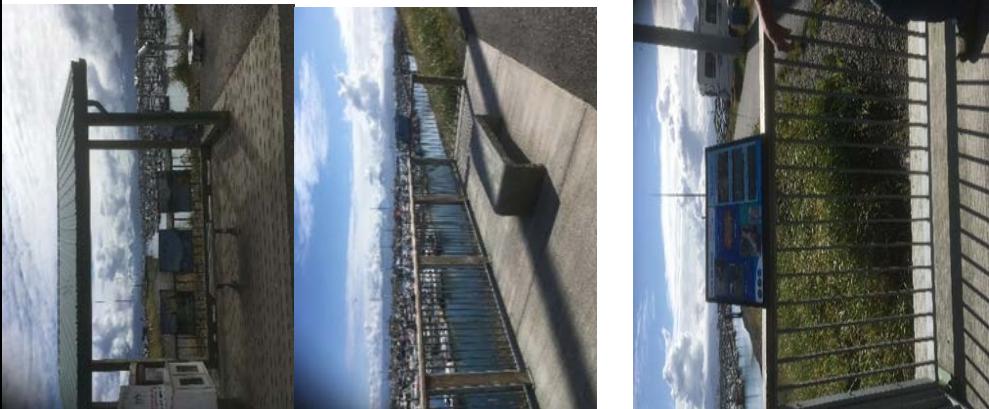
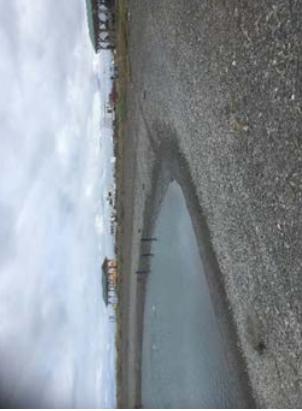
1
405 Ramp	The ramped paths-of-travel to the water line in either two directions have significant barriers being filled with rocks and mud.	Remove washed in material and rocks. Recommend these paths should be scheduled to be checked and cleared at reasonable and regular intervals especially during prime fishing season if this remains a constant maintenance issue to maintain a clear pathway.	Nick Dudiak Fishing Hole Lagoon
403 Walking Surfaces

Ground/walking surfaces should be stable, firm, smooth, and slip-resistant

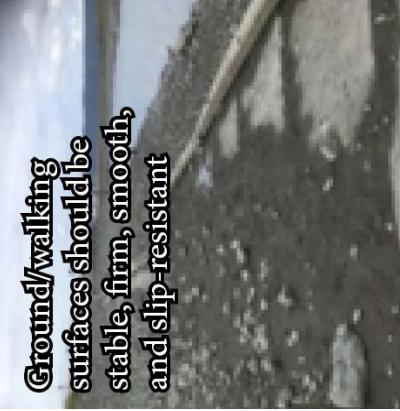
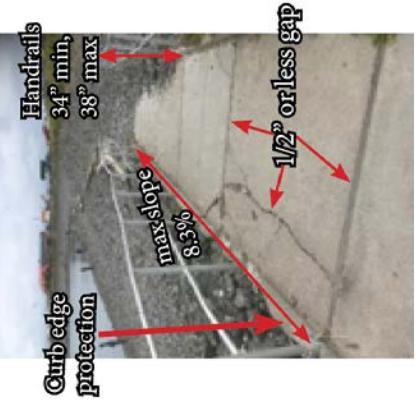
405 Ramp	The ramps' slopes were measured every 3-4 feet consistently and measured within ADA compliance for the most part. There were only two sections approximately 3 feet in length in either the North or the South ramp sections that measured beyond the ADA 1:12 standard. Both the South side noncompliant ramp	Ramp running maximum slope must not exceed 8.3%. A curb or barrier protection of at least 4" high horizontal railing is required at the bottom to prevent any wheels from going off the ramp

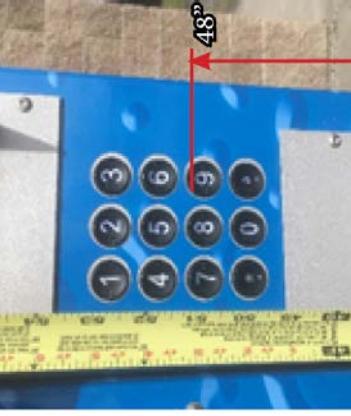
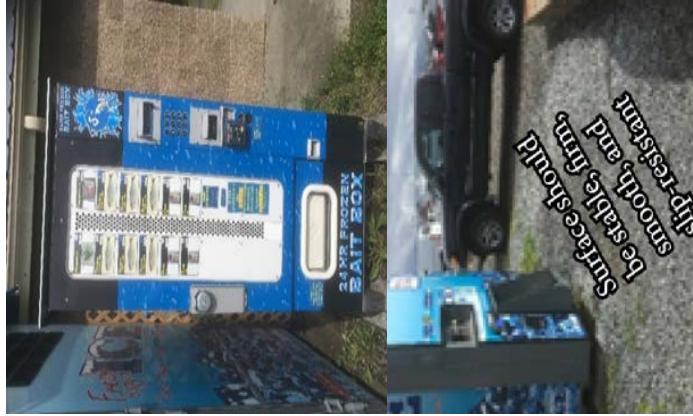
308 Reach Range	sections are located at the very bottom last 9-10 feet.	edge of the ramp.	If the machine is lowered to accommodate this part of the standard, then it is likely the lower dispensing outlet portion may fall below the lower threshold of the reach range of 15 inches.	<p>Ice Bait and Automated Machines</p>

<p>Recommend replacing this automated machine with one that does comply with the 2010 ADA Standards in the design and operation of the control mechanisms.</p>

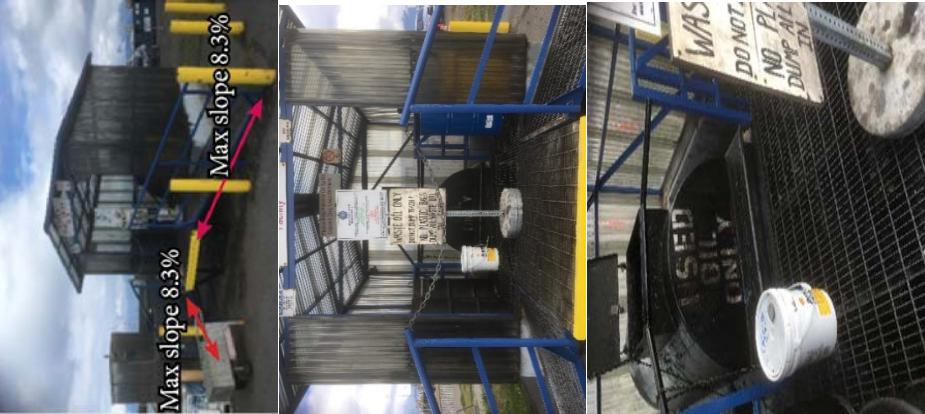
2
303 Changes in Surface Level	<p>Used oil collection sites are located on the uplands at RAMP 2 and RAMP 8 for small quantities of boat generated oil, filters, oily rags, and absorbents.</p> <p>There is no proper accessible route to either shed dumping facilities due mainly to the change in level barriers.</p>	<p>Provide a proper accessible route and reach ranges to at least one of the two locations designated for chemical waste dumping or dumping or</p> <p>provides some sort of “equivalent facilitation.”</p>	<p>Disposal Sheds (used oils, filters, batteries, solvents, oily rags)</p>

405 Ramps	<p>RAMP 2 Oil Shed has two steel grated ramps with slopes as steep as 30 degrees with no clear floor space to maneuver or reach any of the three different disposal opportunities. In addition, the ramp and floor grates are not in compliance as they allow passage of a sphere more than $\frac{1}{2}$ (13 mm) diameter through a grate opening.</p>	<p>302.3 Openings</p>

303 Changes in Surface Level	RAMP 8 Oil Shed has a concrete perimeter barrier with a change in level that is more than 1/4" with no clear floor space to maneuver or reach any of the different disposal opportunities	Surface level along accessible route must be free of changes in surface level.	Surface level changes cannot exceed 1/4" in height.	Disposal Sheds
302 Floor or Ground Surfaces	There is at least one accessible vehicular parking space designated near each of the three independent stations;	Ground and surface level in any directions of parking spaces must be firm,	Fish Cleaning Station/ Tables (Locations: Ramp 4, 6, Nick Dudiak)	2

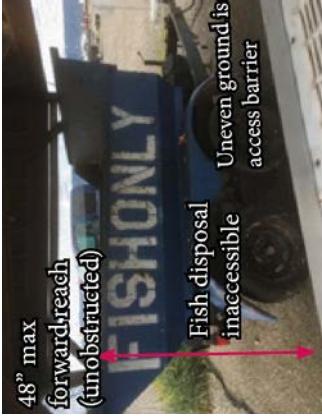
Fishing Lagoon)	
however, as reported in the parking section the path-of-travel surface material is loose gravel and may not be firm, stable, and slip resistant unless it is inter-locking compacted gravel.	level, and slip resistance.		
308 Reach Ranges	<p>It is not allowed to fillet a catch in the harbor basin and to properly dispose of fish guts there are wagons parked at each of the three fish cleaning stations; however, the reach to dispose gut material into these wagons is too high and beyond the maximum reach range of 48 inches.</p>

<p>Recommend as an alternative for equivalent facilitation to add a fish disposal bucket under each accessible table section at all three locations. If needed, place the blue international symbol for accessibility on the bucket and/or signage to discourage improper usage or thievery.</p>

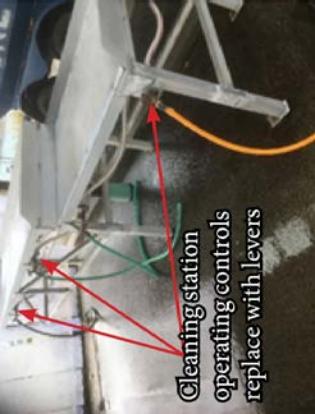
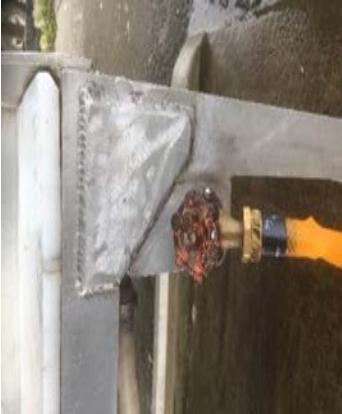
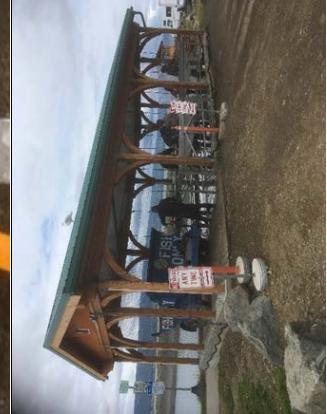
309.4 Operation	At the RAMP 6 Fish Cleaning Station, the operating controls for the water hoses at the accessible table sections are round.	Replaced with lever action facets.	(Locations: Ramp 4, 6, Nick Dudiak Fishing Lagoon)	2
606.4 Faucets

Cleaning station operating controls replace with levers

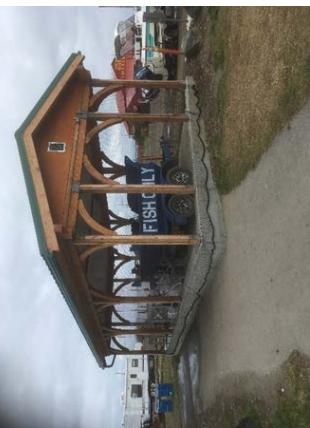
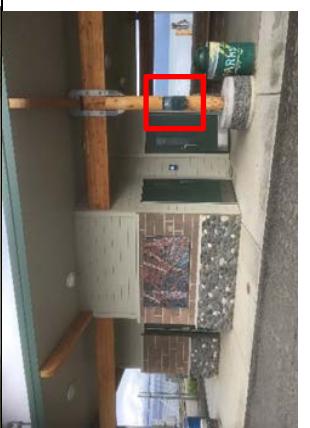
2	
	<p>308 Reach Range</p> <p>Dog waste bag dispenser's operable part is measured at 54" above the floor and located above a seating area.</p>	<p>Pioneer Dock Shelter and Restroom</p> <p>Lower dispenser operable part to 48" above the floor; relocate away from the circular stone bench as not to protrude into a sitting person's headspace.</p>

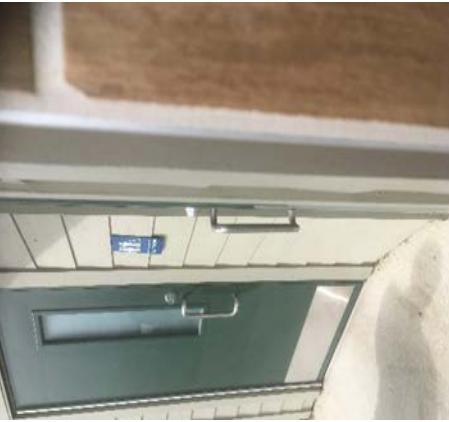
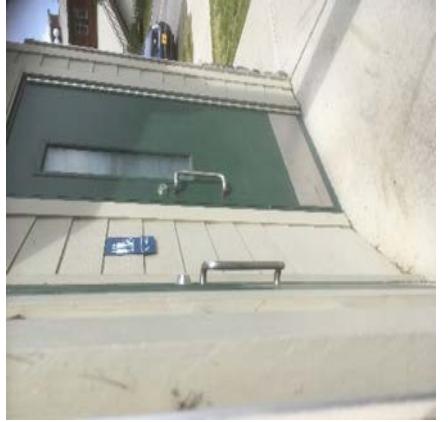
<p>30" x 48"</p>

<p>latch to provide greater maneuvering clearance for entering and exiting. Another alternative is the door swinging inward if proper clear floor space is provided beyond the arc of the door.</p>
