Memorandum

TO: Mayor Lord and Homer City Council
FROM: Melissa Jacobsen, City Manager
DATE: January 8, 2025
SUBJECT: City Manager's Report for January 13, 2025 Council Meeting

Landslide Hazards Susceptibility Mapping in Homer, Alaska—Executive Summary

LANDSLIDE HAZARD SUSCEPTIBILITY MAPPING IN HOMER, ALASKA

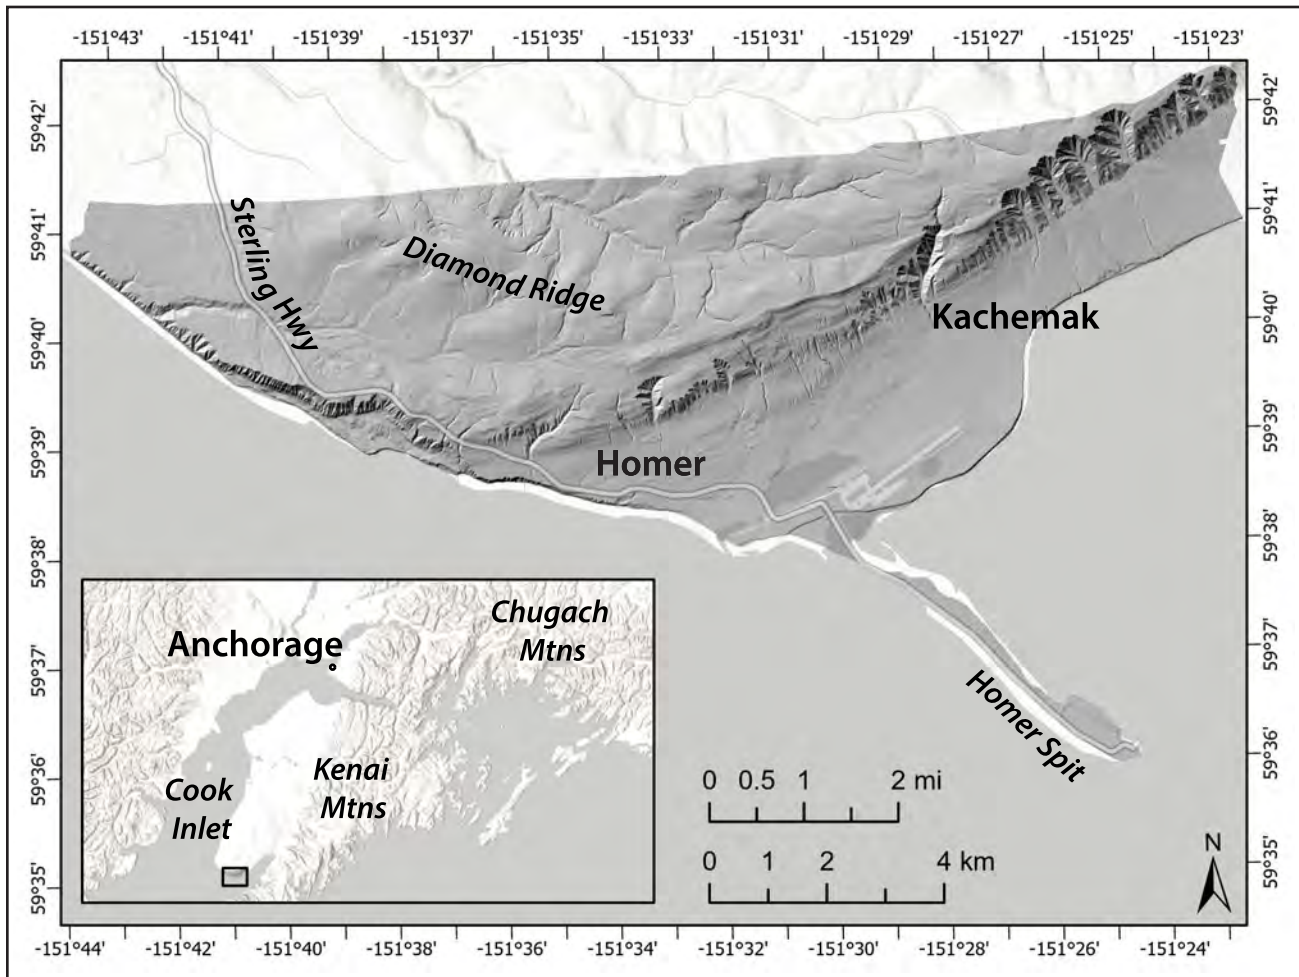
Figure 1. 2019 lidar extent (visible as a gray hillshade) and area of interest for Homer slope failure susceptibility assessment. Inset map shows study location on the western Kenai Peninsula.

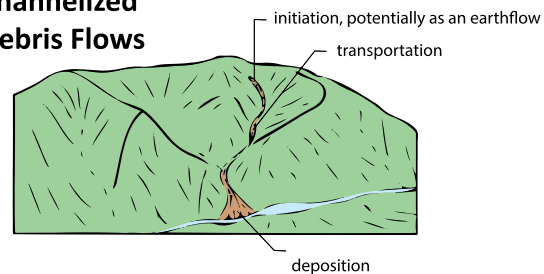
Figure 2. Types of slope failures as classified by Varnes (1978). Illustrations modified from Cruden and Varnes (1996) and Highland and Johnson (2004).

The term “landslide” is a commonly used catch-all term for gravity-driven mass movements. However, “landslide” refers to a range of movements, including slides, flows, falls, topples, and spreads (Cruden and Varnes, 1996) (fig. 2). A “slide” typically moves downslope along one or more failure planes, sometimes without much internal deformation. “Flows” move rapidly downslope as a viscous

Channelized debris flows occur on steep, concave slopes and are initiated as earthflows (or other types of landslides) that run into a channel and gain momentum by picking up more debris, water, or speed (fig. 2). Channelized debris flows are prevalent in steep gullies, particularly in areas of weak soil. These types of movements are typically initiated by heavy surface-water flow or in areas where earthflow conditions are common; they can move downslope rapidly, approaching 35 miles per hour (56 km per hour) (Cruden and Varnes, 1996; Highland and Bobrowsky, 2008). Even though channelized debris flows may be thin and watery, they can incorporate large boulders, vegetation, and other objects. Coupled with their sudden onset, even small debris flows can be lethal.

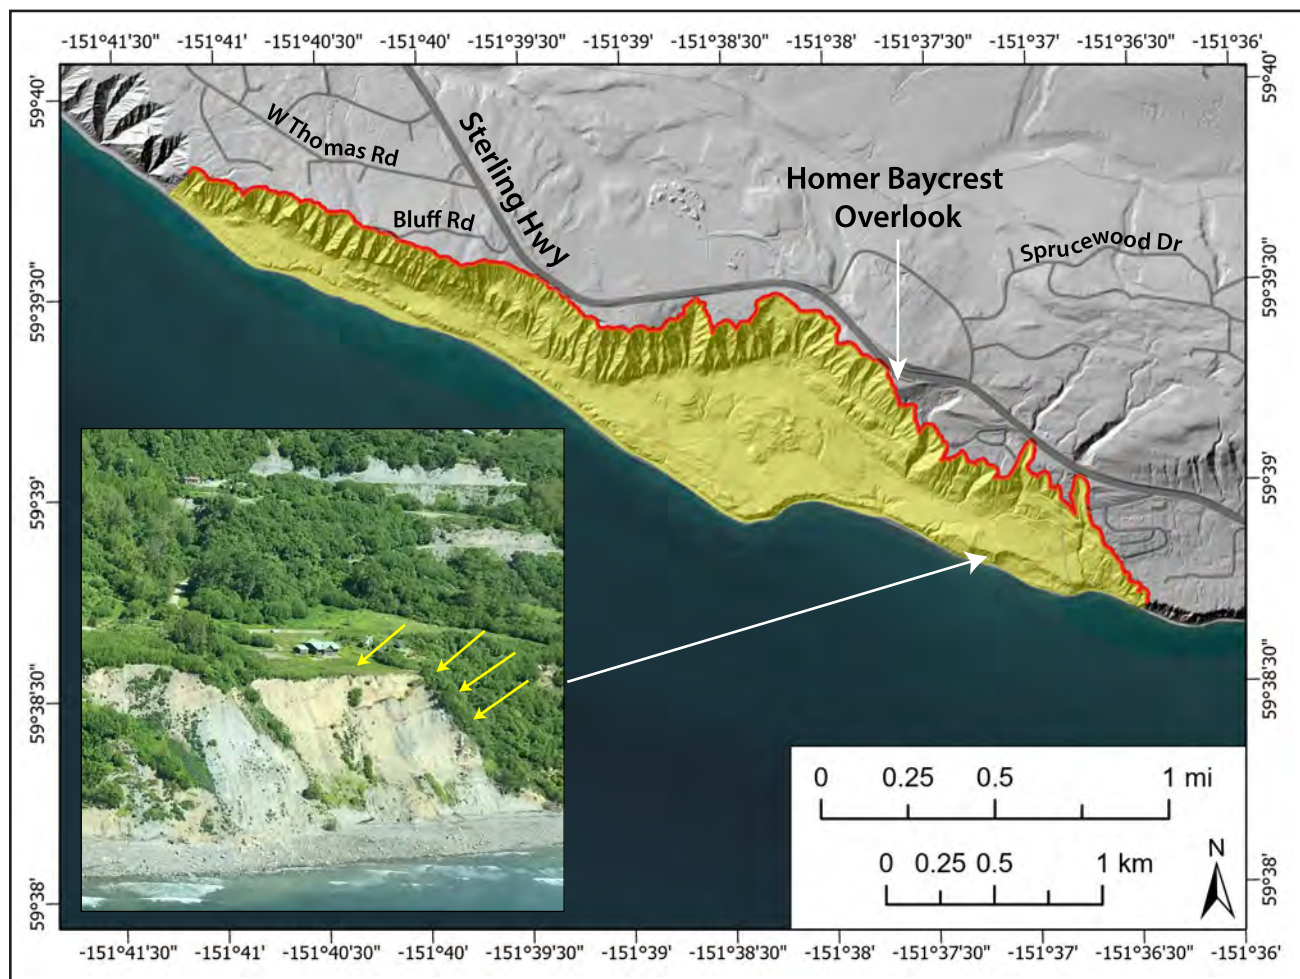
Figure 3. Bluff Point landslide headscarp extent (red line) along the Sterling Highway in the 2019 lidar-derived hillshade (Salisbury and others, 2021). Note that the headscarp has undergone significant erosion since formation ~2,250 years ago. The yellow area represents the headscarp wall and back-tilted landslide block. Inset: oblique aerial photograph of back-tilted coal seams within the landslide mass.

Baycrest/Homer Overlook Point offers a view to the southwest, down across the ponded area of the back-tilted landslide block (fig. 3, yellow area) that formed as the mass slid along one or more spoon-shaped failure planes at depth. Bathymetry of the seafloor in this area suggests that the main body of the landslide could have extended up to 1.2 mi (2 km) out from the modern shore (Reger, 1978), as also evidenced by exposures of basal shear surfaces in the beach far out from the modern bluff. Sediment layers at the modern shoreline are noticeably back-tilted, as opposed to the relatively flat-lying layers of the main bluff (figs. 2 and 3).

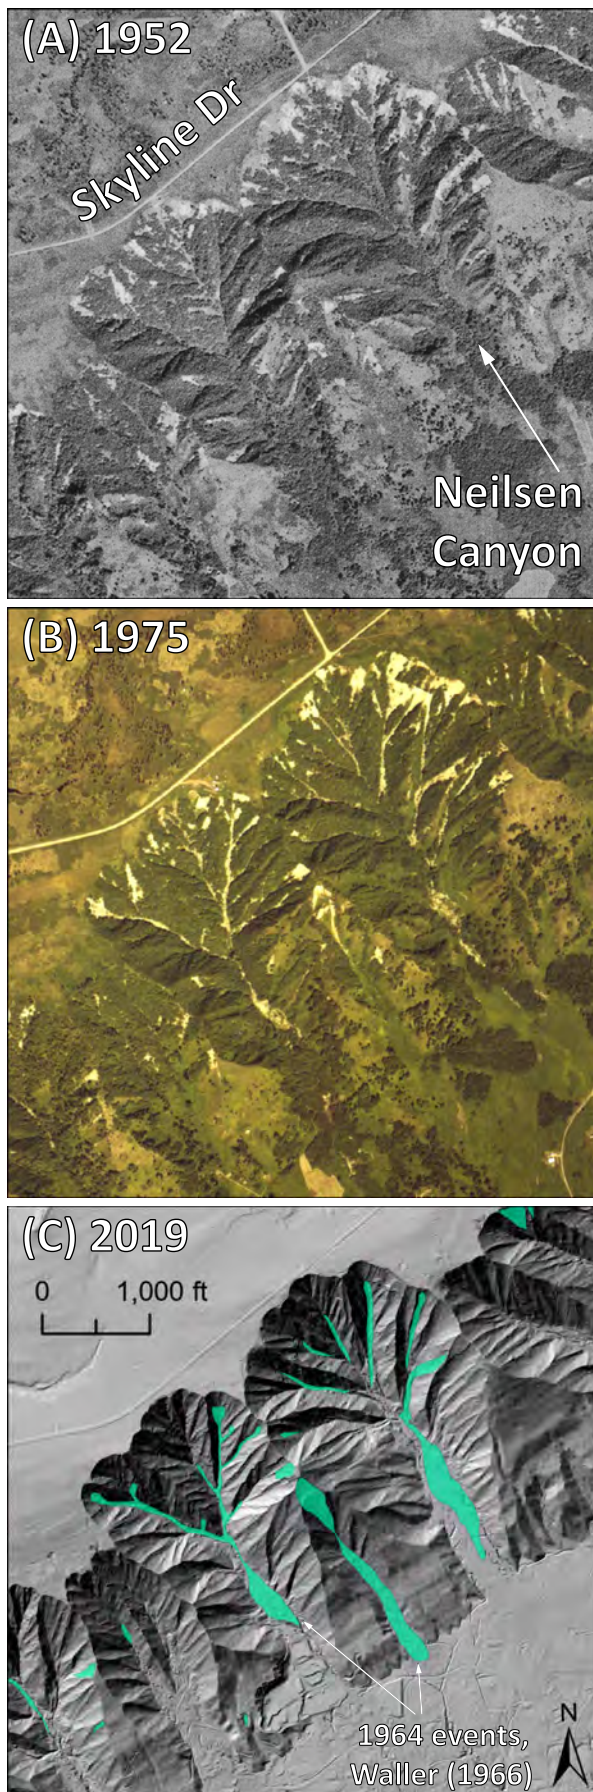
Figure 4. A, B. Examples of georeferenced aerial photographs for two steep upland catchments where landslides were mapped by Waller (1966) after the 1964 Great Alaska Earthquake. We used changes in vegetation between air photo pairs to identify landslide, earthflow, and channelized debris flow scars. **C.** Slope failures that were identified between air photo sets were digitized in the 2019 lidar elevation data using geomorphic characteristics. Note: the channelized debris flow deposit polygons include both the source areas and runout zones (deposits). Though only two of the major events shown here are known to have occurred in the 1964 earthquake, it is likely that the channelized debris flow in Neilsen Canyon also occurred at the same time.

or debris flow event (fig. 4). We initially calibrated earthflow and debris flow identification using aerial photographs by analyzing the topographic expression of the slides that are known to have occurred during the 1964 Great Alaska Earthquake (fig. 4). This mapping strategy could underestimate the total number of individual slides, because the length of time required for vegetation to re-establish itself (a few years) is far exceeded by the average photo interval (~13 years). However, areas that remain unvegetated because they are oversteepened by failure or are channelized may have hosted several slides between one aerial photo epoch to the next.

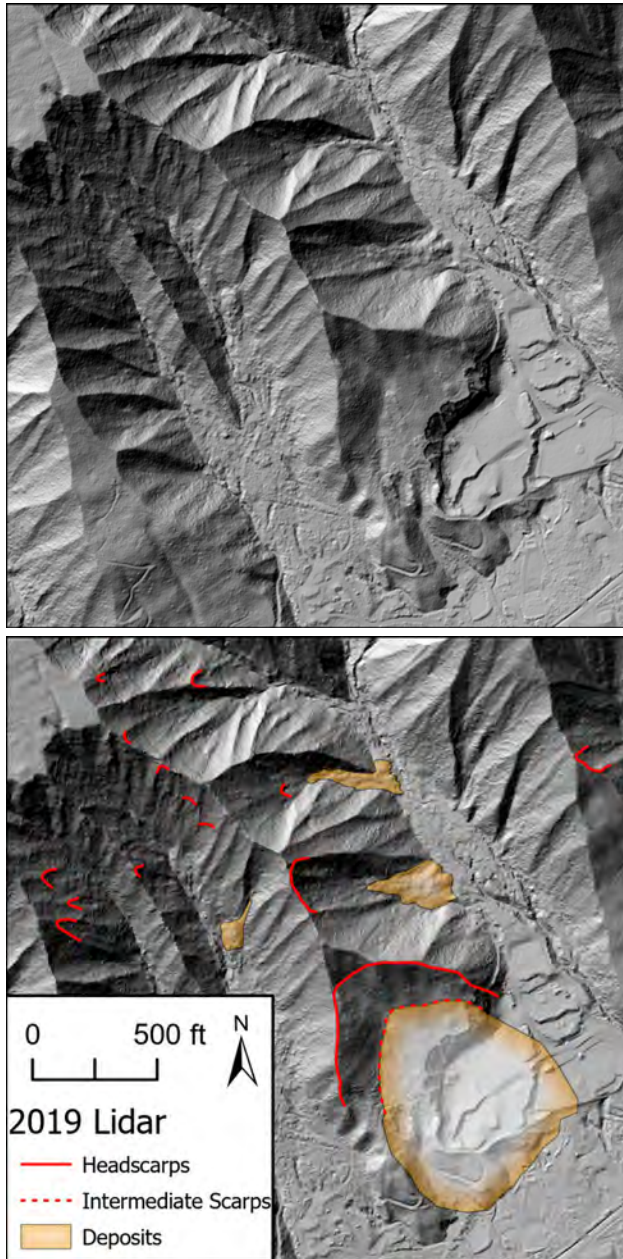
Figure 5. Excerpt of 2019 lidar landslide mapping near the end of China Poot Street. Headscarps, intermediate scarps, and deposits are only identifiable using bare-earth lidar and are not visible in aerial photographs. Some headscarps have no accompanying deposits and vice versa.

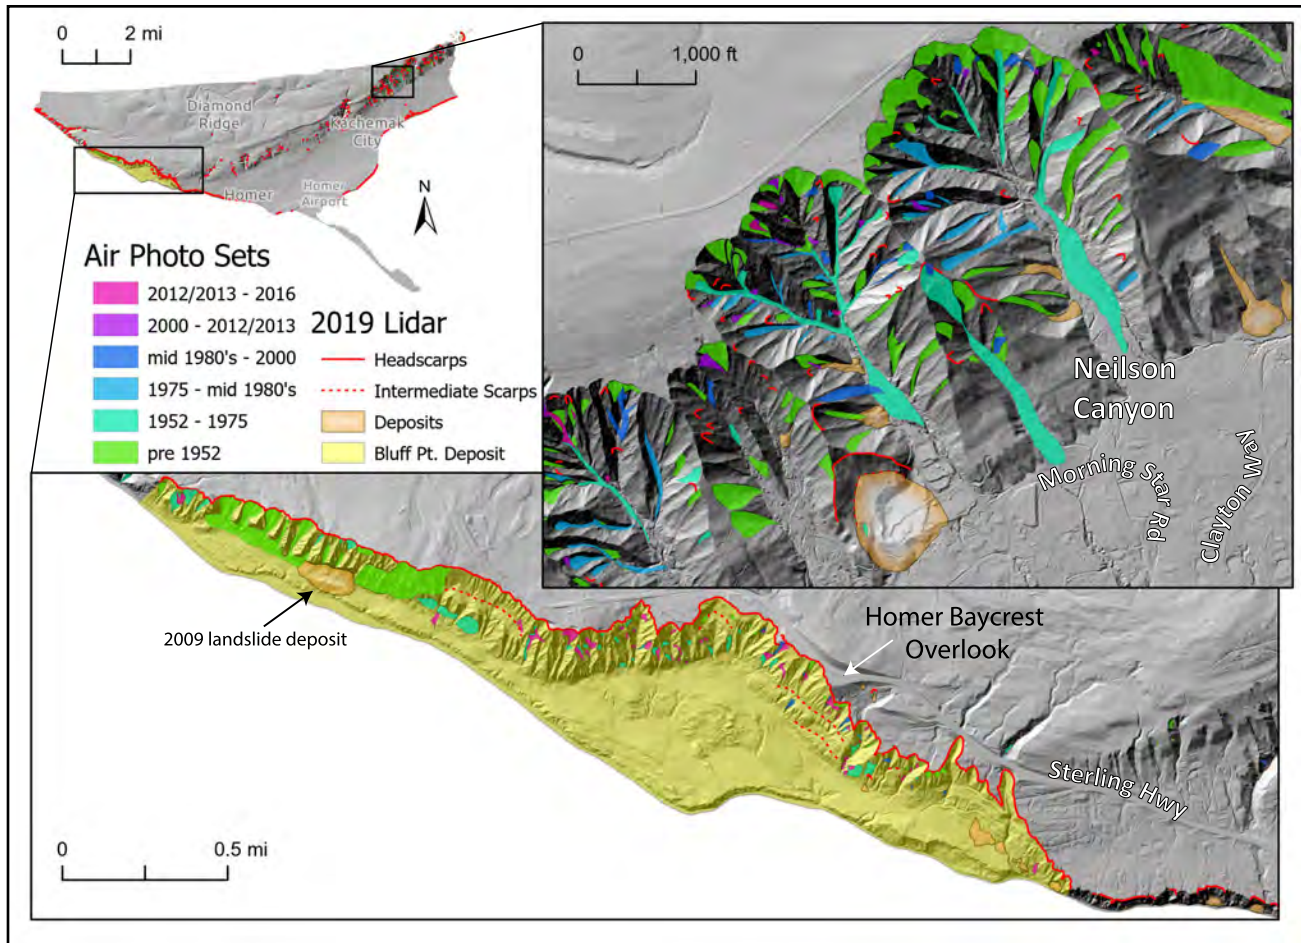
Figure 6. Excerpts from the complete landslide inventory database for the Bluff Point area (bottom) and Neilson Canyon area (top right). Earthflow and channelized debris flow scar polygons include both the source area and any associated deposit. The digital landslide inventory extends northeast of the 2019 lidar coverage into Thurston Canyon.

Figure 10. Deep-seated paleo-landslide on the east flank of Thurston Canyon, immediately east of the 2019 lidar coverage (2019 lidar extent delineated by green line). See figure 6 for symbol explanation.

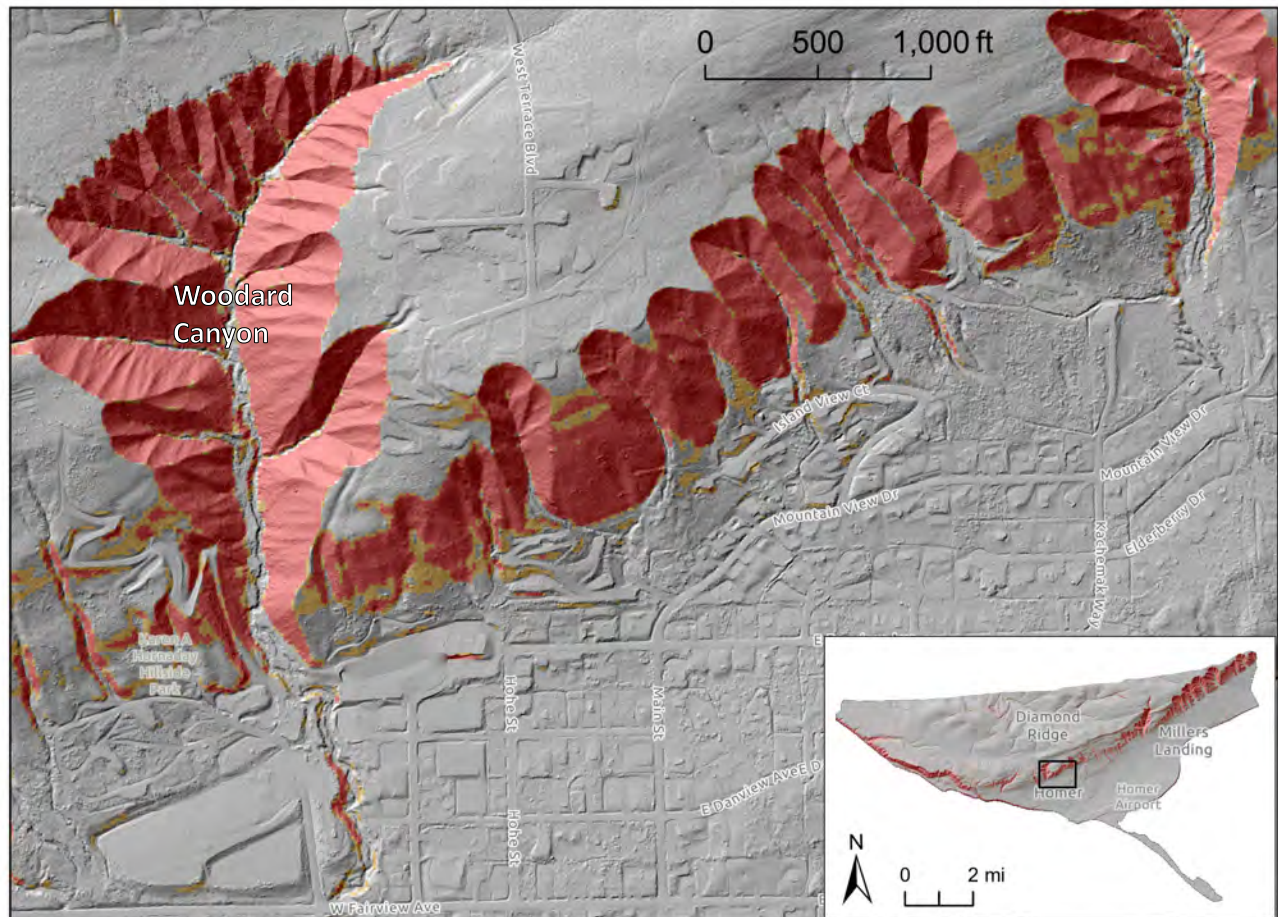
Figure 7. Excerpt from the Factor of Safety map (map sheet 2) highlighting areas of moderate (FOS 1.25–1.5, orange) and high (FOS 1–1.25, red) shallow landslide susceptibility at saturated conditions for the area near Woodard Canyon.

Areas with an $FOS < 1$ are theoretically unstable because downslope stress is greater than the shear strength of the soil. FOS values equal to 1 are regarded as “critically stable”—meaning the driving and resisting forces are more-or-less balanced and the slope could fail at the slightest disturbance (e.g., a change in the water table position, vibration). Importantly, the FOS calculation involves several major assumptions regarding conditions present within a slope, so typically engineering geologists consider slopes with an $FOS < 1.5$ to be potentially unstable. Therefore, we classify FOS values from 1.0 to < 1.25 as highly susceptible to failure, values from 1.25 to 1.5 as moderately susceptible, and values > 1.5 as having low susceptibility of failure (Burns and others, 2012) (fig. 7; red, orange, and no color areas, respectively).

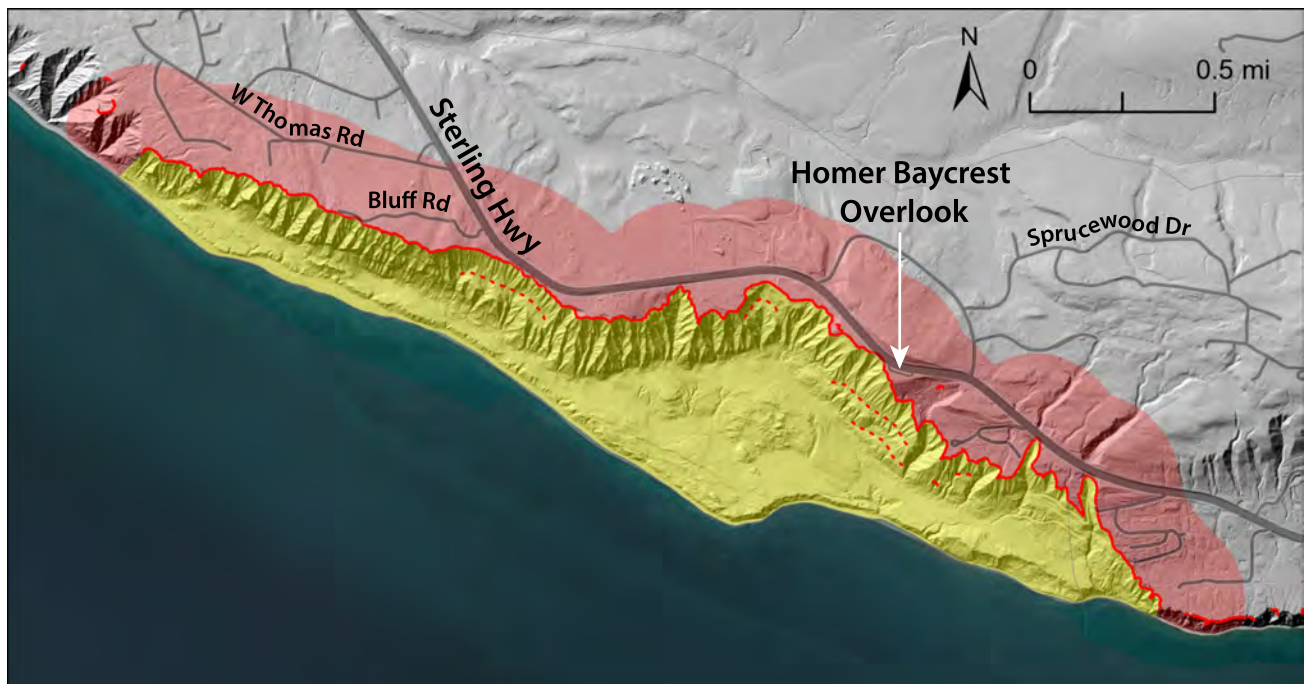
Figure 8. Deep-seated landslide susceptibility near the Bluff Point landslide (red polygon). The landslide body (yellow area, south of the red headscarp line) is the landslide deposit and is also susceptible to repeated failure.

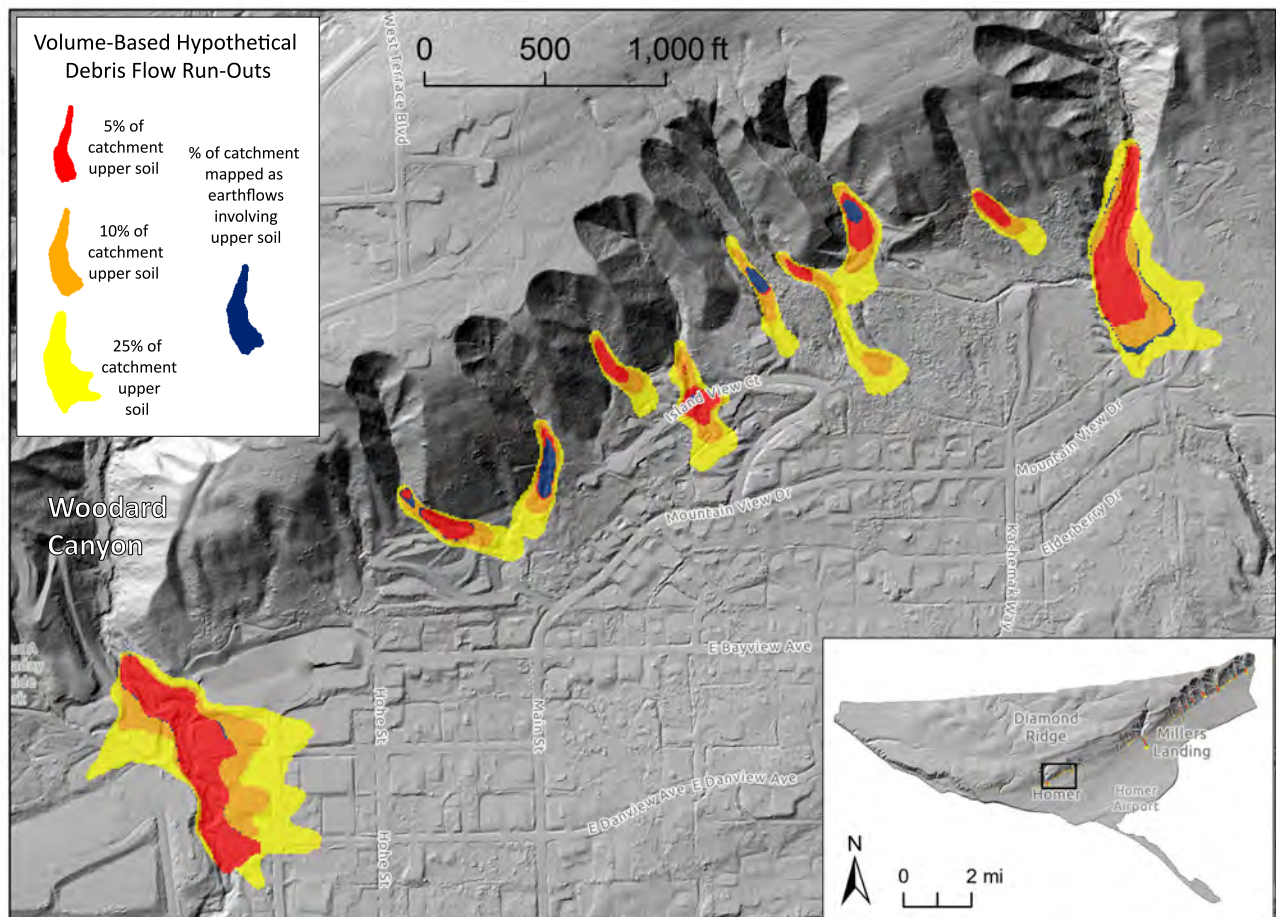
Figure 9. Excerpt from the Channelized Debris Flow runout map (map sheet 3). The percent of the Woodard Canyon catchment mapped as earthflows involving the upper soil column is just over five percent, and therefore, it is only barely visible between the red and the orange polygons.

photos and lidar and use this as an additional debris flow volume input (fig. 9). The maximum amount of topsoil in a catchment identified as having moved since 1952 is about 25 percent of the total catchment area; thus, we assume 25 percent of the total volume is an appropriate upper limit to the amount of sediment that might be available for mobilization in a saturated debris flow. However, one major assumption regarding potential sediment volumes is that none of the available sediment (from mapped earthflows) has already left the catchment via fluvial transport or channelized debris flows. The volumes we use are rough estimates of the potential available material. Of course, it is possible that 100 percent of the total soil volume in a catchment fails in a debris flow, but historical aerial photographs do not indicate that this has happened recently.
