CGS MEMO 2/13/25

RE: Slope Stability Hydrology Assessment: Review for Homeowner
1355 Sterling Hwy - Water Re-Direct and Slump Assessment
Homer, Alaska 99603
KPB Parcel #17508236

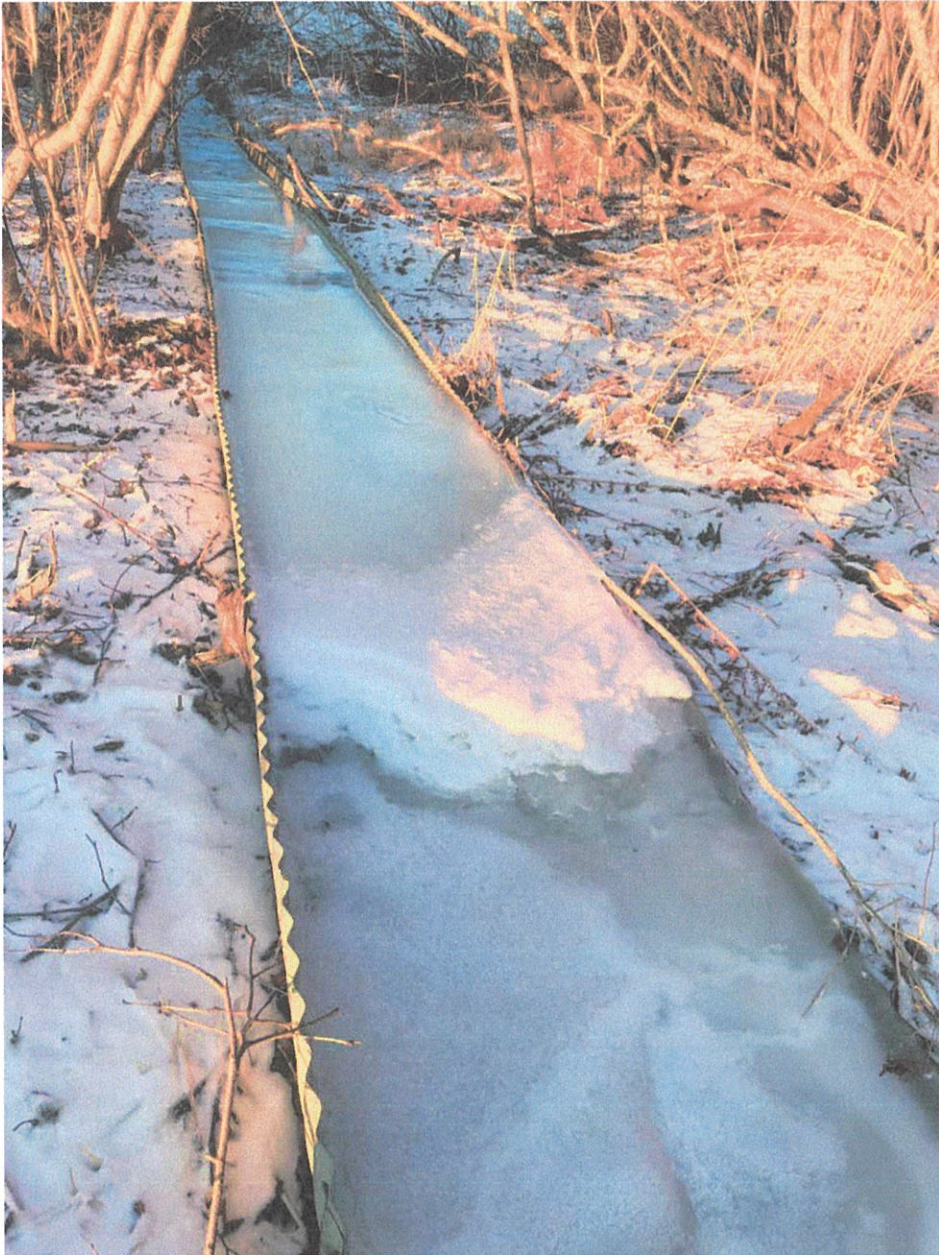
In the Metz,' stormwater is guided into a half-culvert shown in Photo 1. The purpose of this design was to protect the subject property from surface erosion by confining the water to the half-culvert. However, this system failed to contain the surface water. In addition to breaching when full and frozen, the half-culvert also leaked, and a stream formed *underneath* it as shown in Photo 2. Leakage also occurs at the headwall outlet as shown in Photo 3 near the Sterling Highway. As a result, water continually saturates this corridor despite the attempts to contain the stormwater.

Photo 1. Iced full and breached half-culvert stormwater discharge alongside the Metz subject property.

In the world of bluff erosion, this is an emergency. The half-culvert design needs significant updating to bring water over the bluff to the beach without impacting this portion of the bluff.

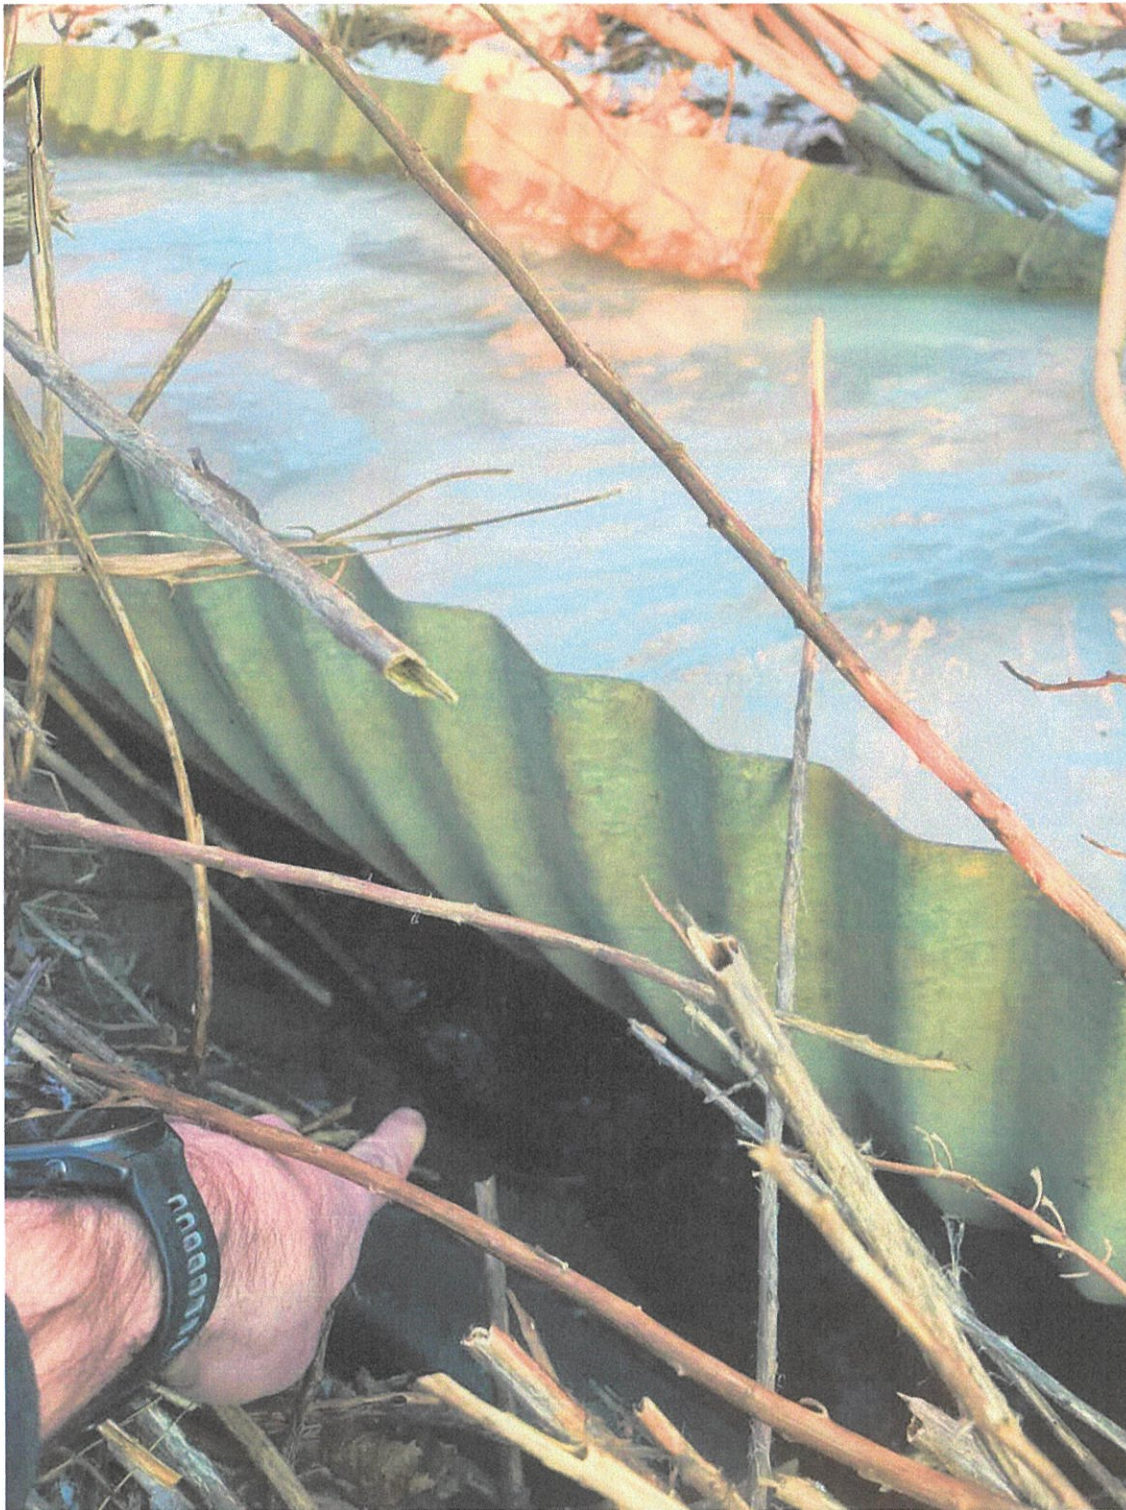
Photo 2. A significant cavity and audible streamflow underneath the half-culvert, shown midway to the bluff discharge

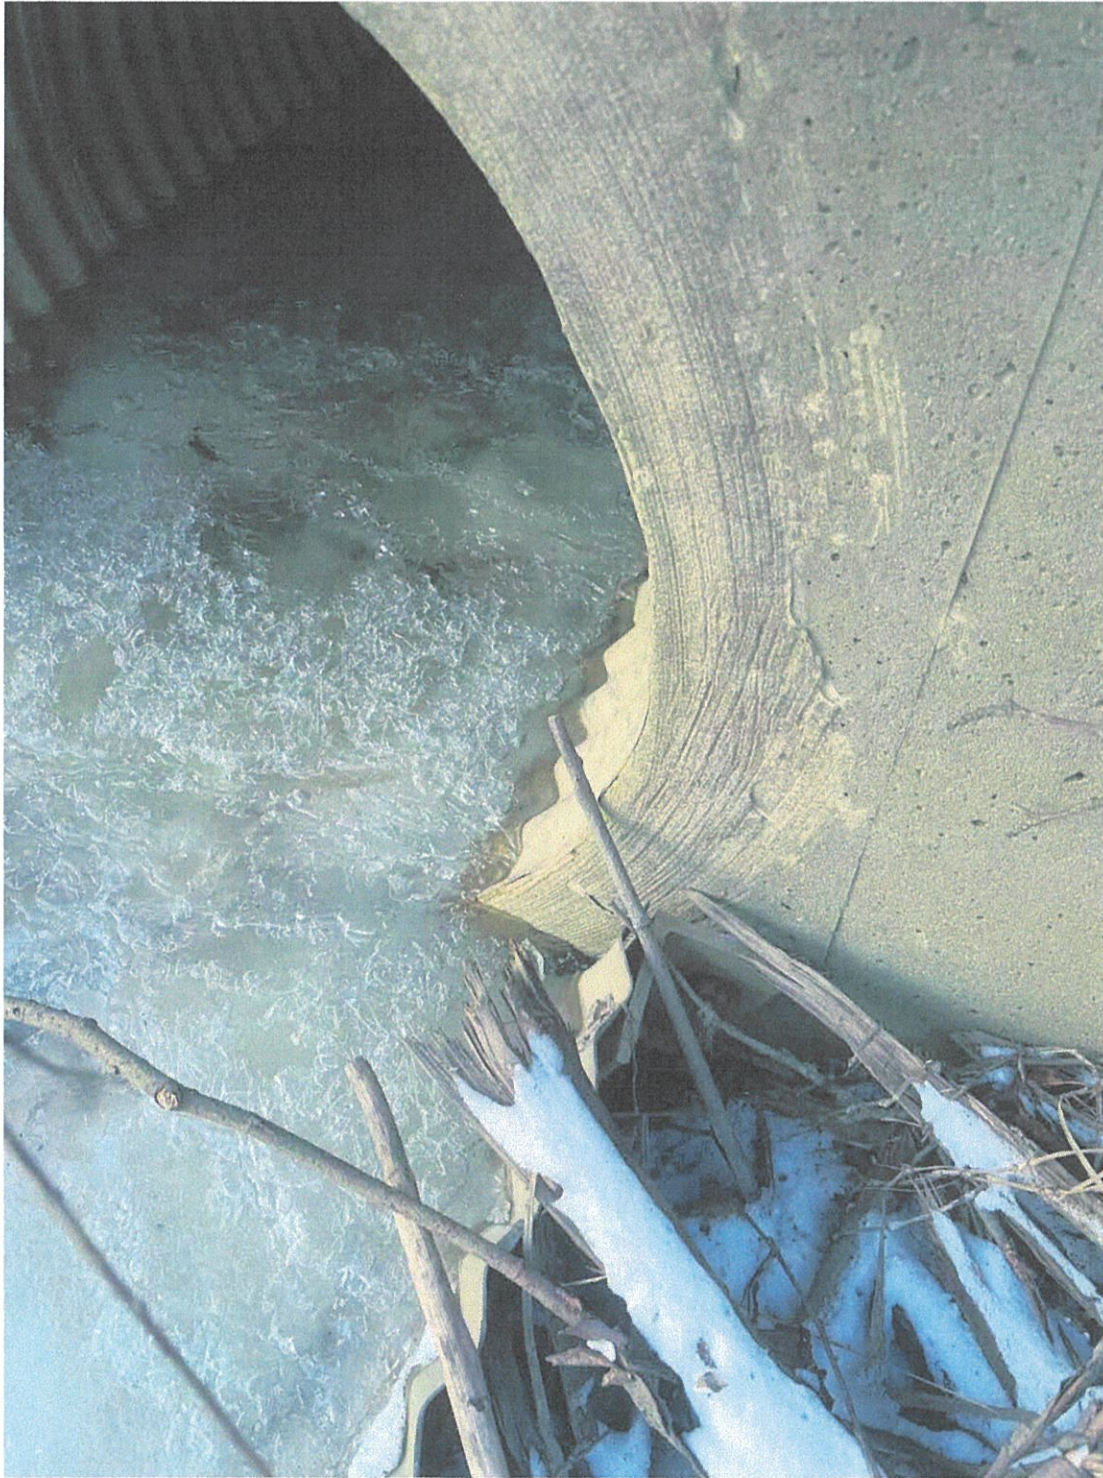
Photo 3. Outlet headwall leakage presumably begins the streamflow component underneath the half-culvert system

The leaking half-culvert became an open channel (Photo 3) and then, carved a cavity in the bluff and undermines any attempts at guiding surface water down the bluff by other culverts (Photo 4). It is clear that surface water has been running outside the half-culvert for some time.

A bluff stormwater discharge system needs to be designed so as to prevent water from saturating back-fractures close to the bluff edge. The current system looks to have failed for many years based on erosion underneath the half-culvert (Photo 3), providing a continuous source for saturation through near-bluff fractures.

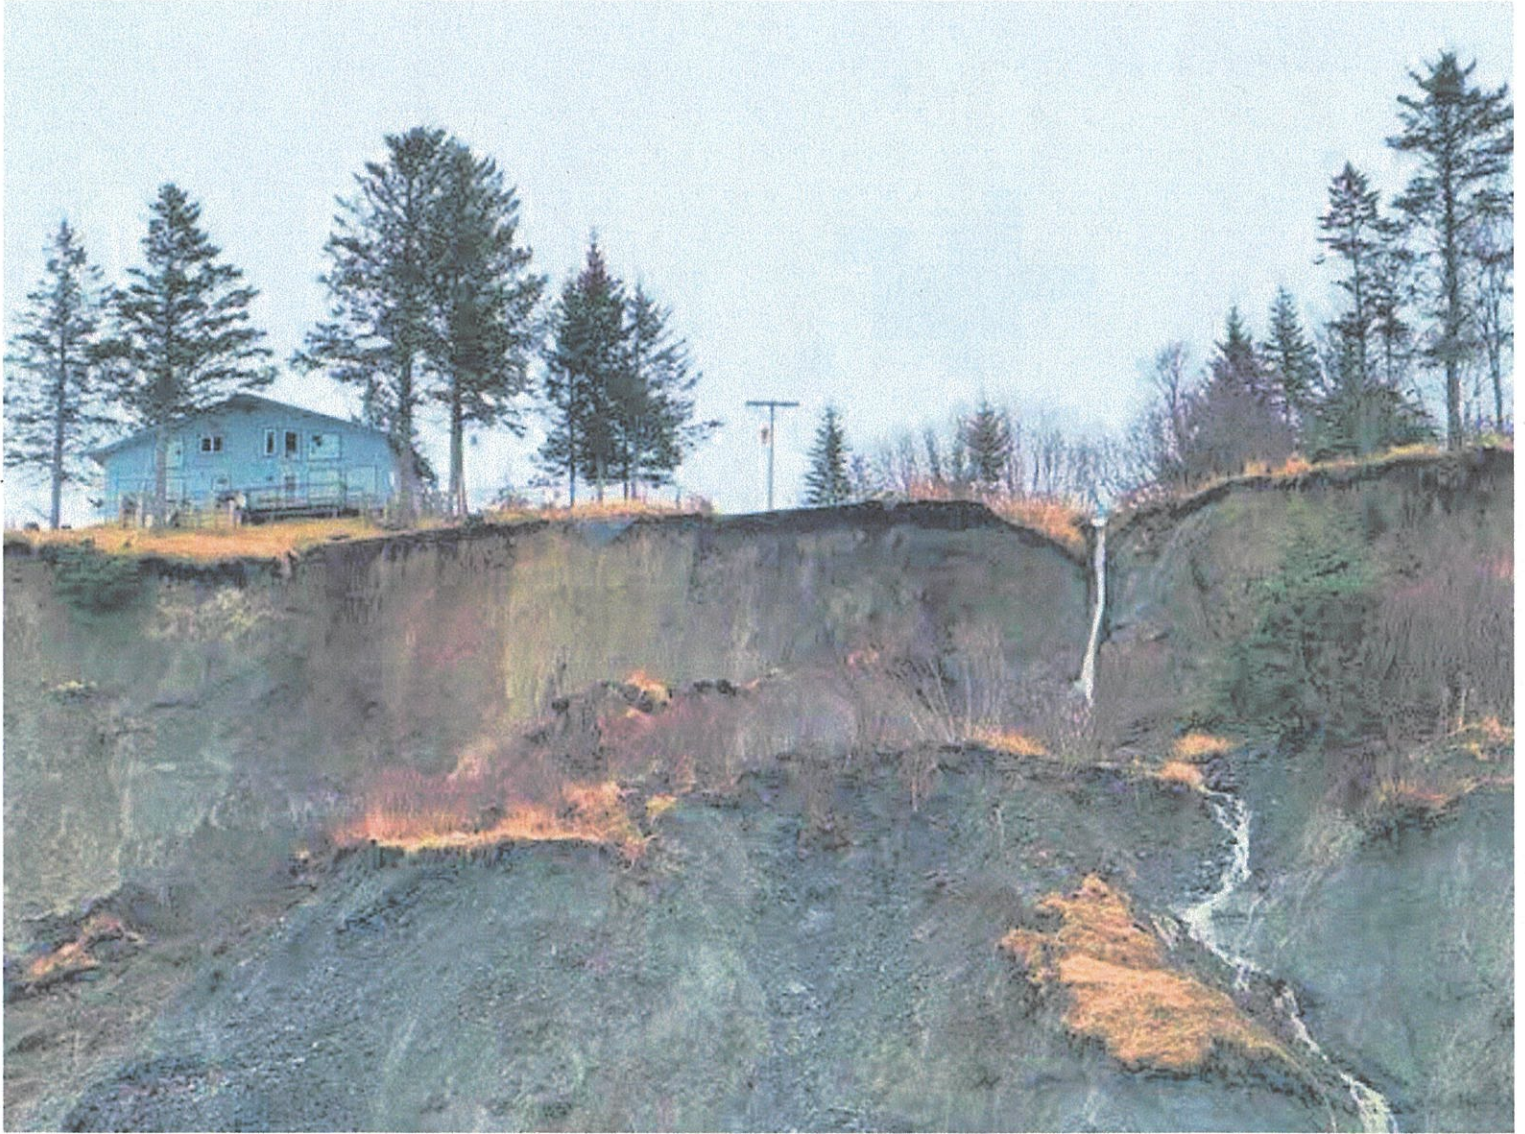
Photo 4. Stormwater discharge from the previous bluff-side half-culvert system now dumping into sloughed material and flowing both in front of the Metz house shown as well as to the right of the sloughed material.

As this memo is being written, a significant amount of this stormwater discharge is being diverted into the recently slumped material, ensuring this material becomes oversaturated and likely will cause another major mass loss if nothing is done. This is because when the bench material sloughs, it will cut back into the bluff base and steepen it towards the Metz home at the next 'breakup.' The next 'breakup' could be at any time.

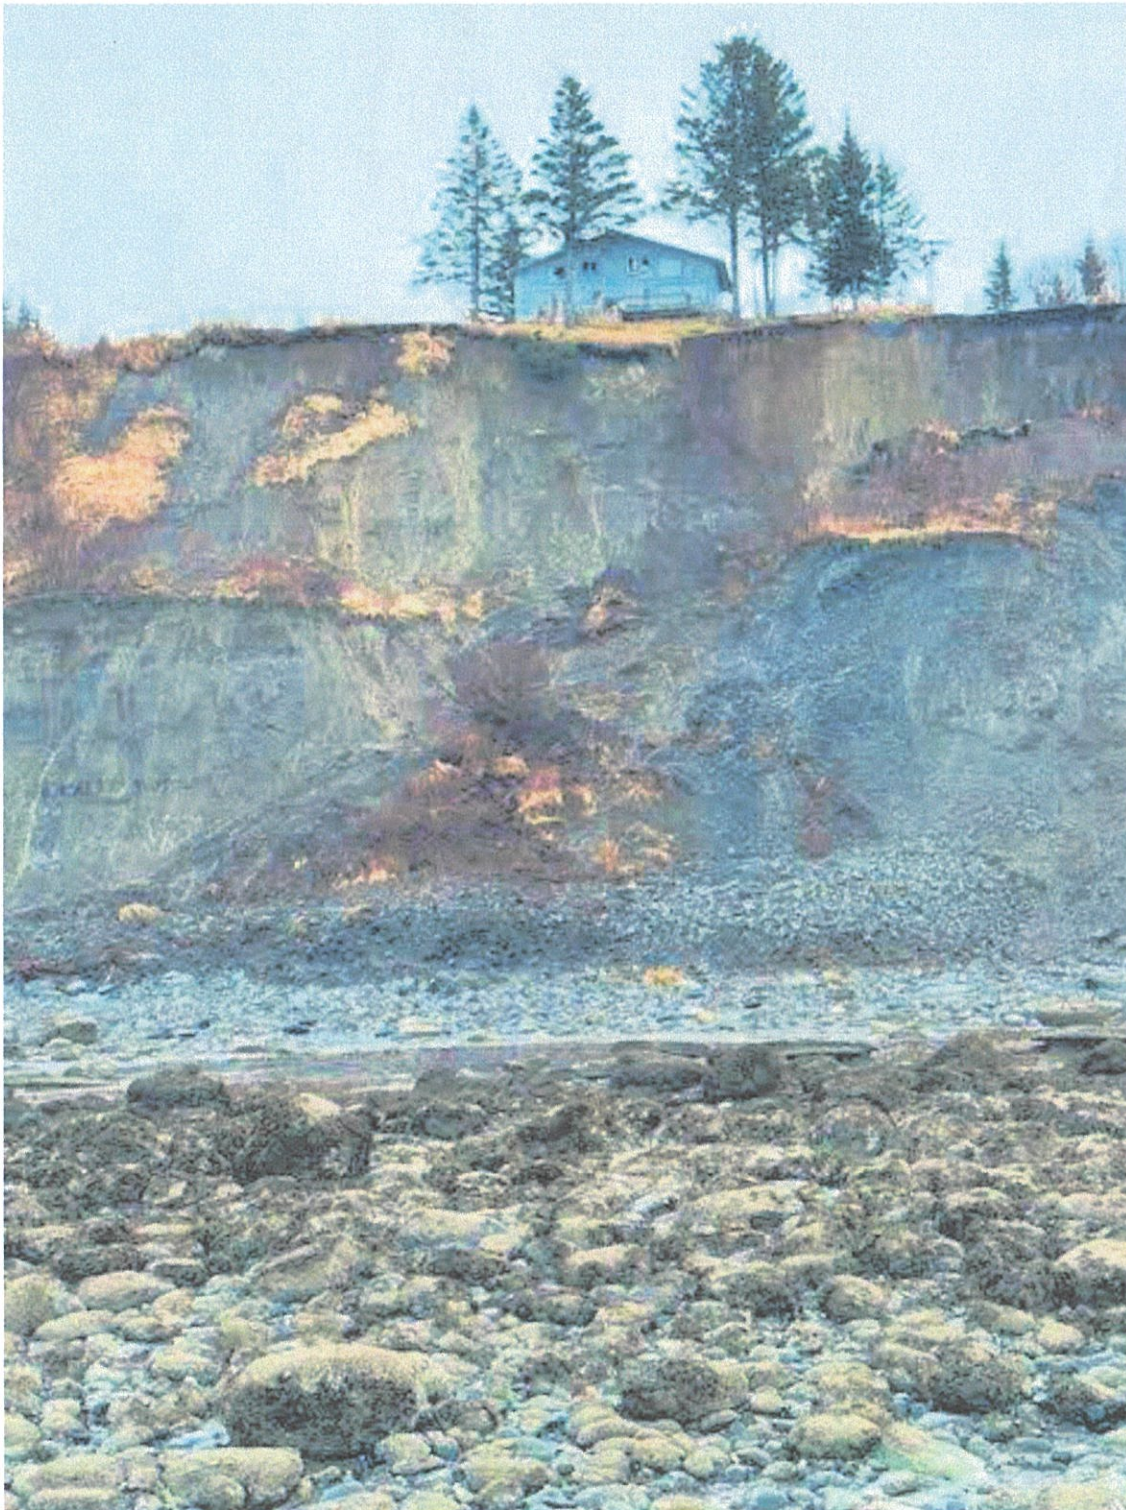
Photo 5. A closer view of the Metz home showing the recent mass movement which blew through the 'bench' directly in front of their home. That part of the bench has thereby become unconsolidated and less stable, and unfortunately this is the material that highway stormwater is now flowing on top of

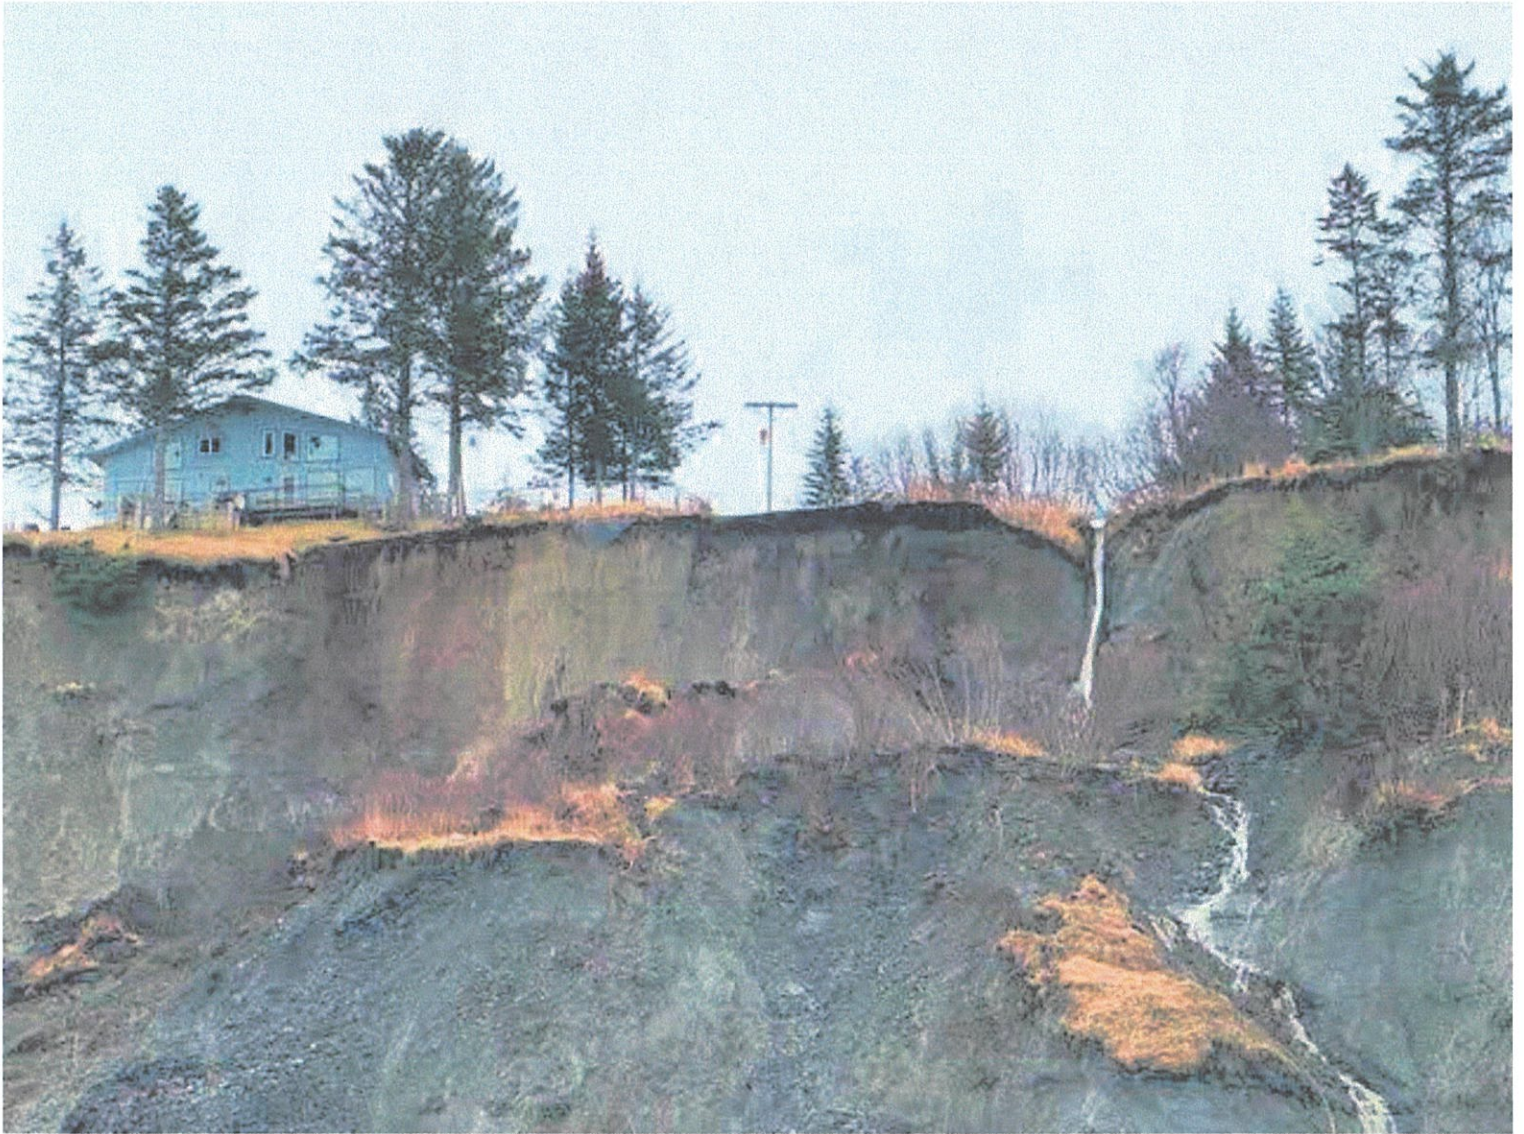
Photo 6. Stormwater discharge shown adjacent to the Metz property. Note that the recent slumping as a result of material saturation has diverted a significant amount of the stormwater to the left along the top of the sloughed material in front of the Metz home, creating an imminent mass wasting situation for the sloughed material – noting that this is all that is left supporting the Metz bluff.

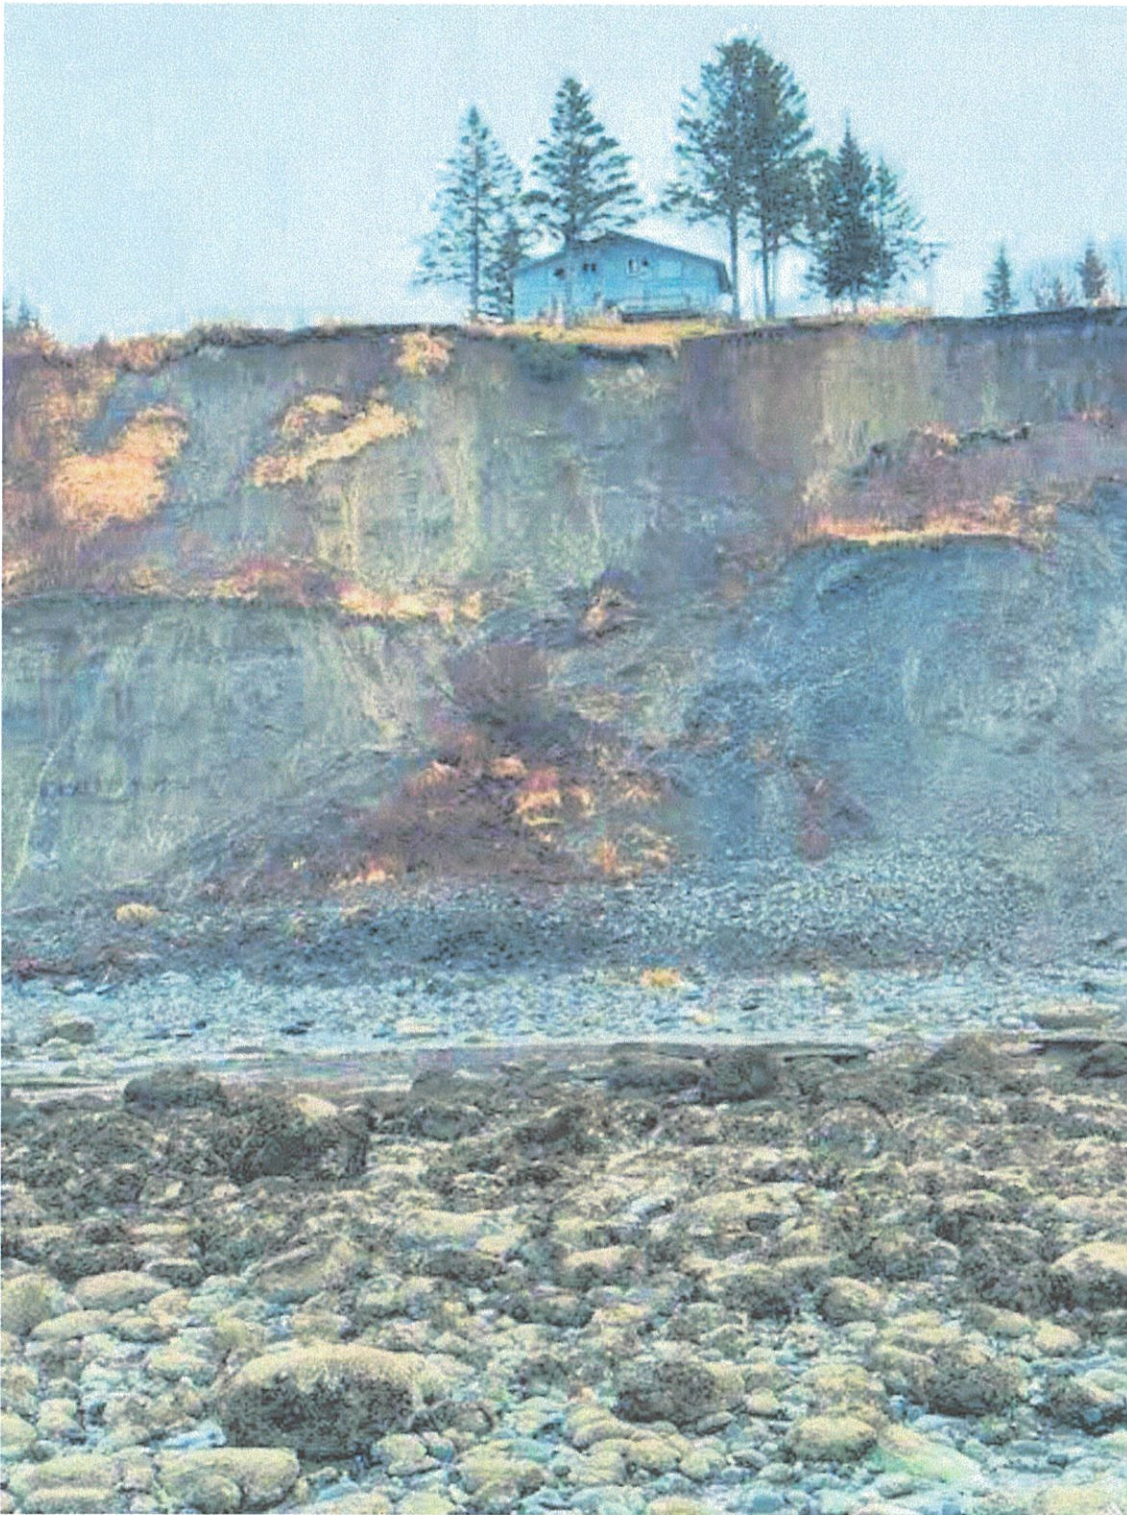
Photo 7. View of the entire sloughed bench and its importance to the stability of the Metz home.
