Archaeological Monitoring for Sewer and Water Improvements Seldovia, Alaska

**Archaeological Monitoring
for Sewer and Water Improvements,
Seldovia, Alaska**

Charles M. Mobley

2008

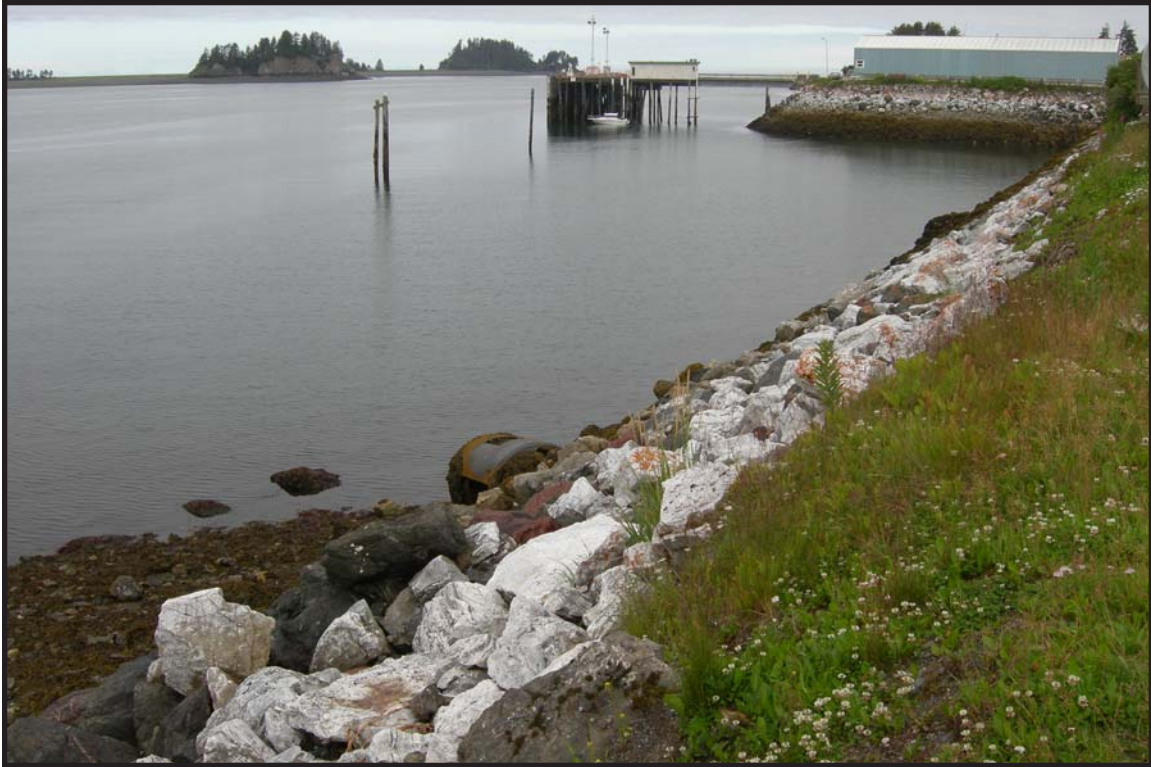
Figure 2. Most of Main Street and the Seldovia shoreline was extensively filled and rip-rapped by the U.S. Army Corps of Engineers after the 1964 earthquake. Note depth of fill and old cannery boiler.

limited historical development or known areas of fill (Figure 2). The remainder of the project was recommended for archaeological monitoring until additional information suggested otherwise. Construction and archaeological monitoring began in August of 2008. The 45% monitoring quota was subsequently reduced, as will be described. Part of the monitoring effort resulted in the discovery and recovery of a significant historic midden deposit under English Street, near the old Russian Orthodox church.

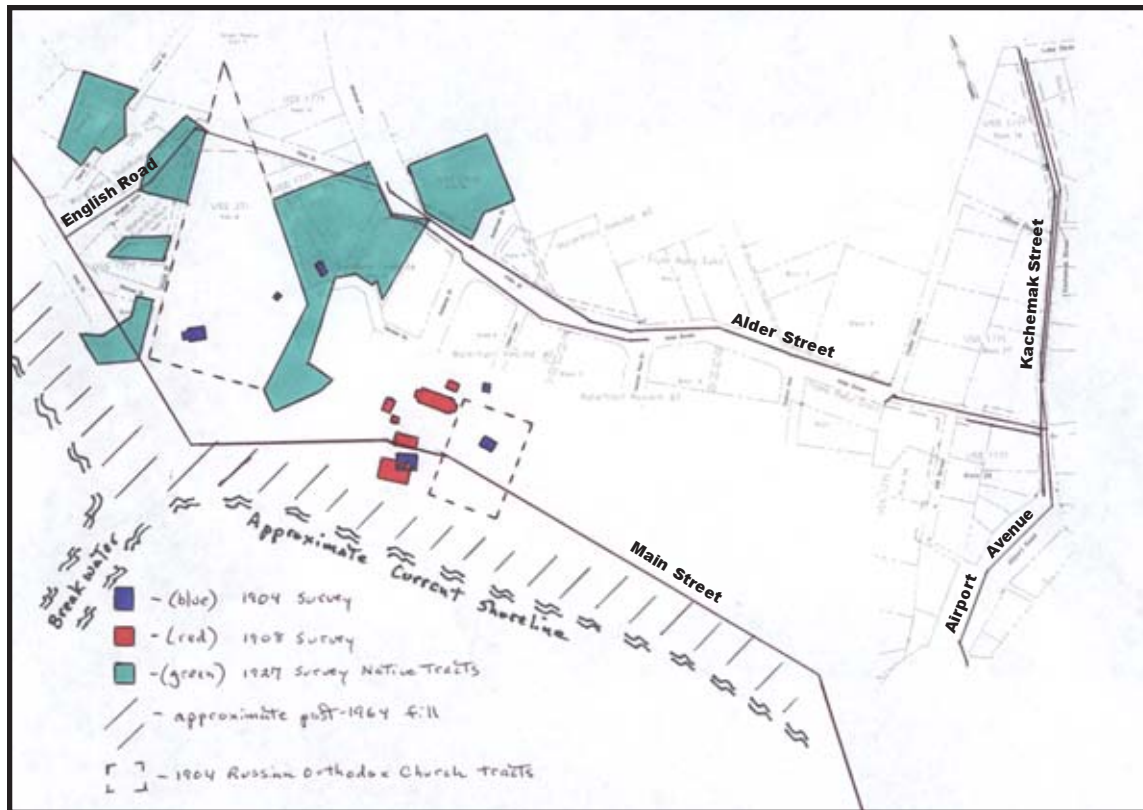
Figure 12. For the Archaeological Monitoring Plan (Mobley 2008) a map was prepared superimposing the 1904 Russian Orthodox Church buildings, 1908 territorial school buildings, and 1927 Native tracts on a current plat with delineations of the proposed sewer and water lines.

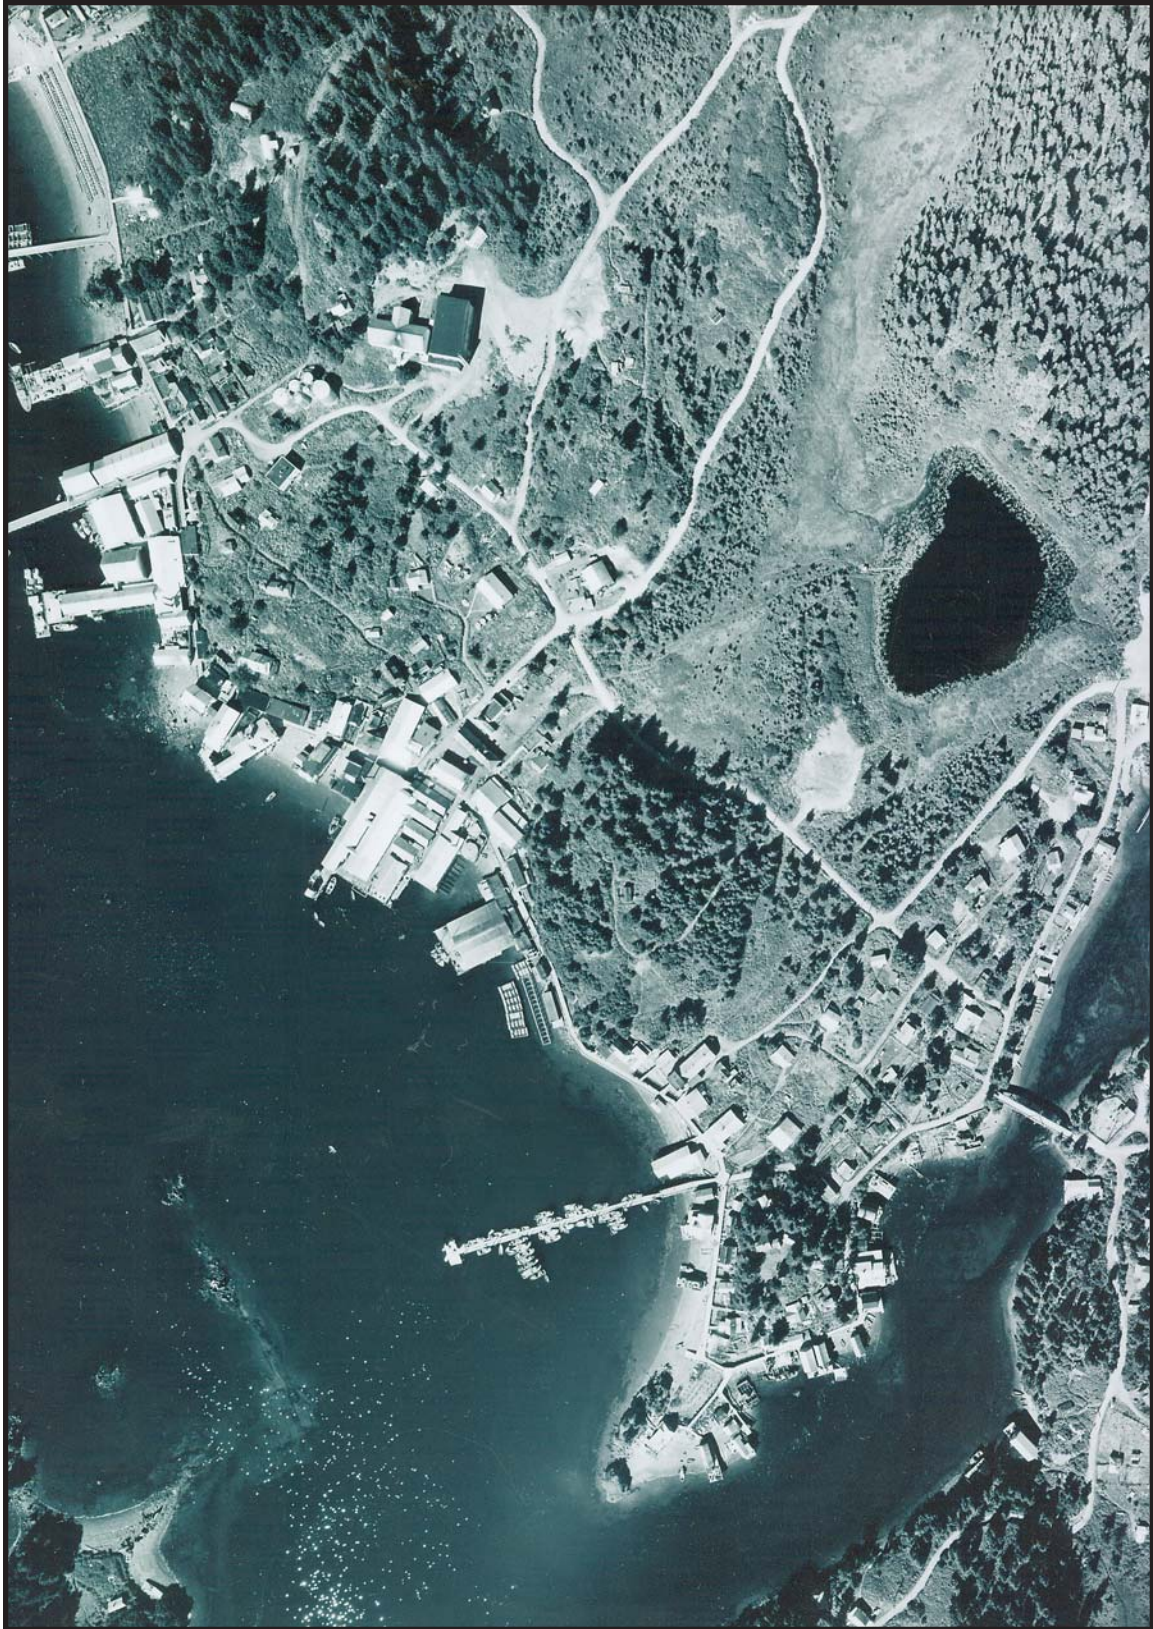
Aero-Metric Inc. 59COE1:3-4

Figure 13. A 1959 aerial photograph shows Seldovia before the 1964 earthquake and subsequent waterfront urban renewal. The large forested parcel at center is the "Cap" Fillmore homestead.

photographs showing the amount of intertidal fill done during urban renewal (Figures 13-14). From that I proposed a set of monitoring needs which eliminated about 45% of the project from archaeological monitoring.

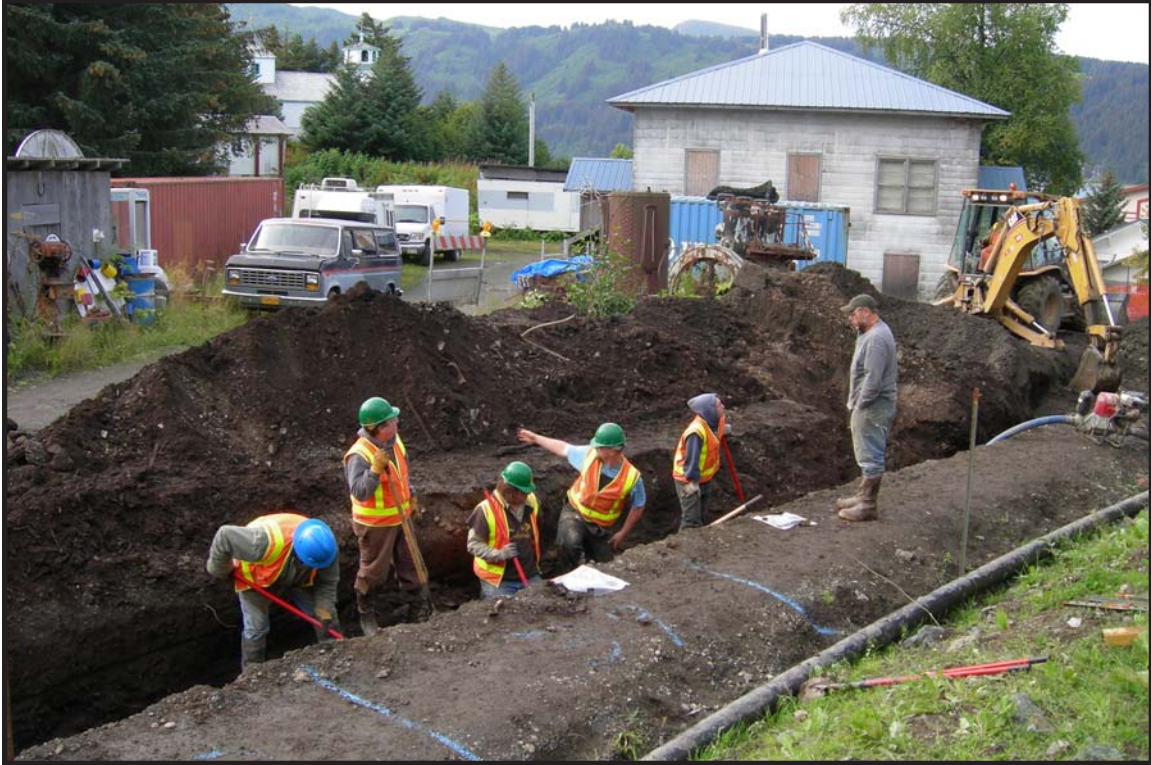
Figure 20. When an 18"-thick historic midden was found beneath English Road, construction crew members helped recover artifacts using hand tools. The old hospital (SEL-335) is at upper right.

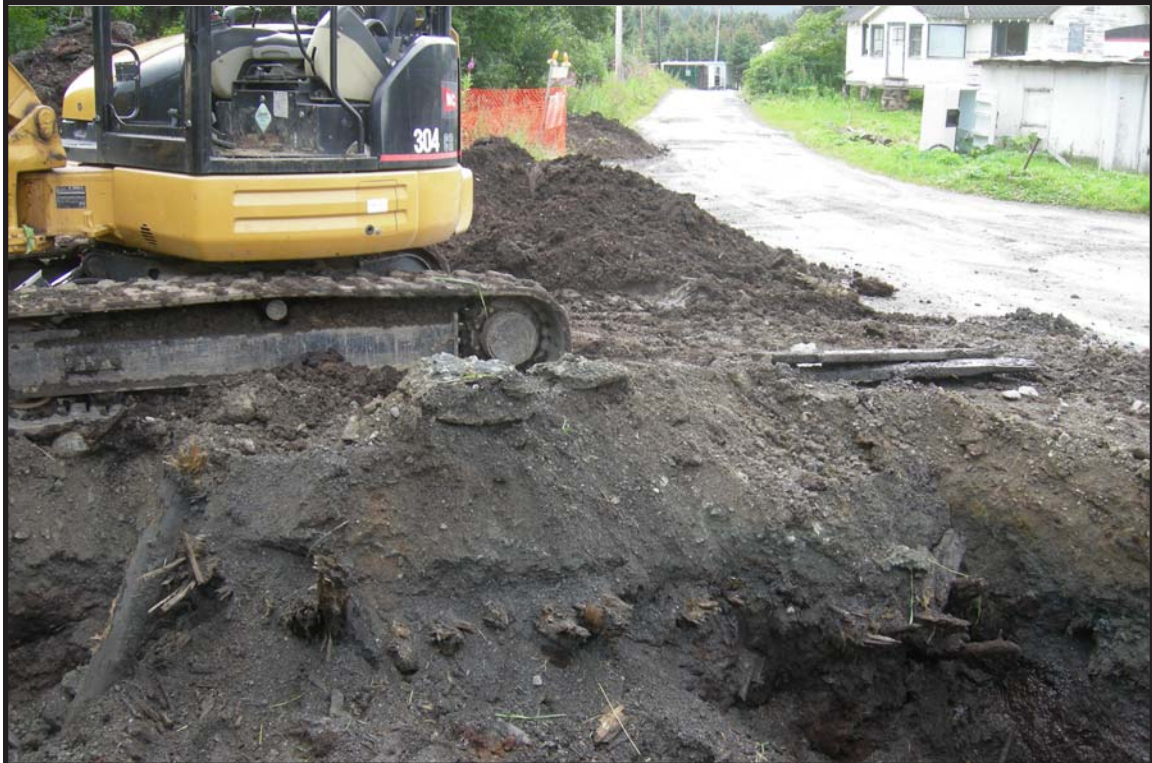
Figure 21. Excavations at the intersection of English Road and Alder Street (here looking southeast down Alder Street) revealed a pavement of parallel logs -- the remains of a corduroy road built to support vehicles traveling over the soft muskeg. The white house at far upper right is SEL-344.

Excavations for water main repair at the intersection of English Road and Alder Street uncovered a pavement of logs representing the buried remains of a corduroy road surface (Figure 21). The logs were oriented more or less perpendicular to English Road and were obviously part of its alignment rather than Alder

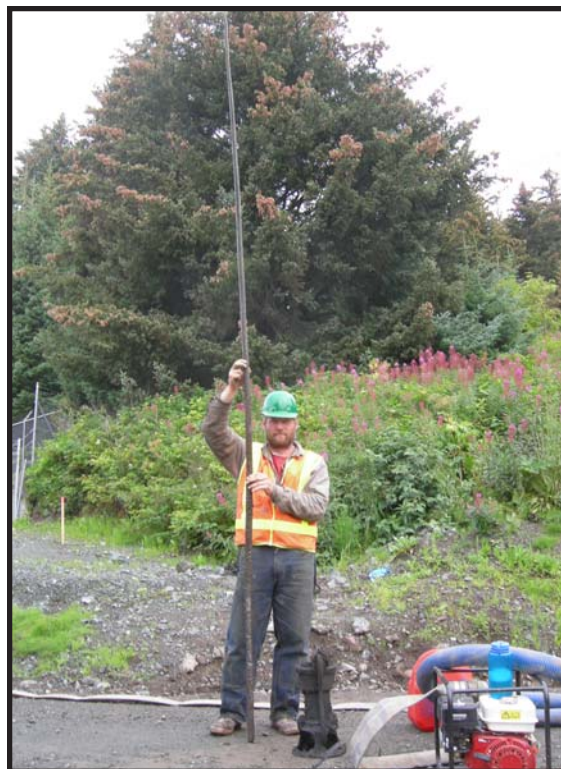
Figure 23. Curtis Dickson holds a 12’6” peeled pole found inside a wooden water catchment conduit near the pump at English and Alder Streets.

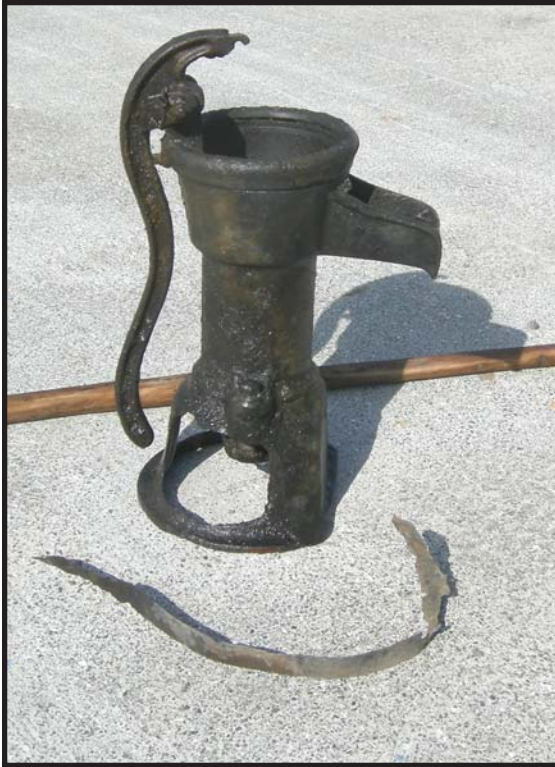
Figure 24. A pump from an early Seldovia water catchment system was found below the corduroy road at the English and Alder intersection.

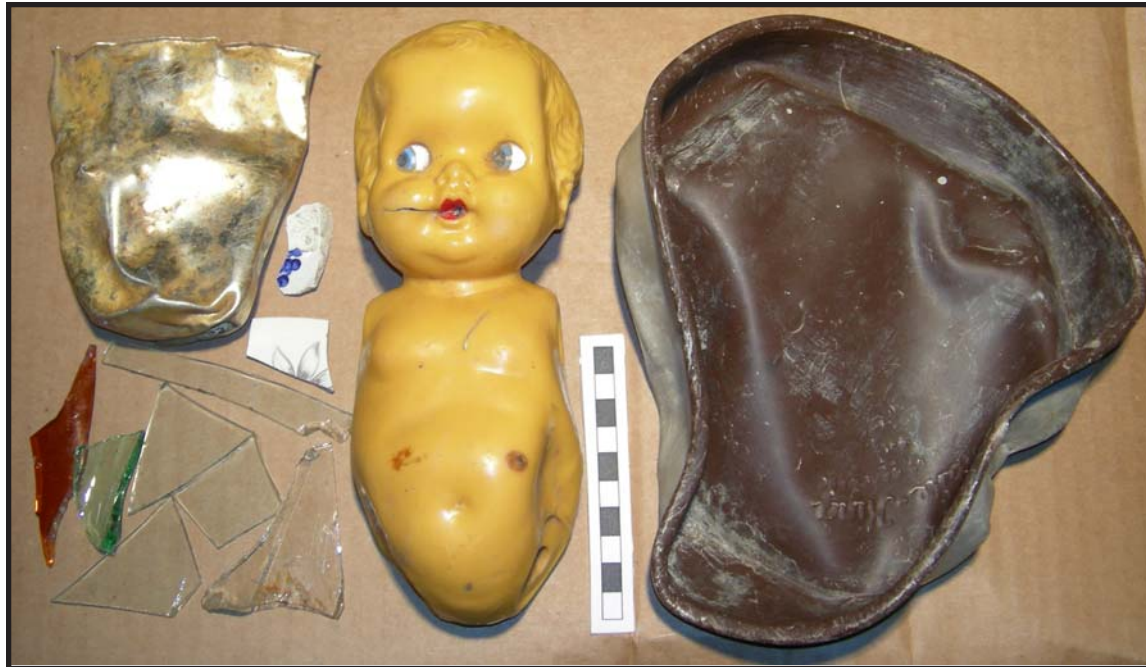
Figure 25. Artifacts found along the edge of Alder Street on the surface or near-surface included a doll, baking pan, window and bottle glass, ceramic shards, and a heavy aluminum drinking cup.

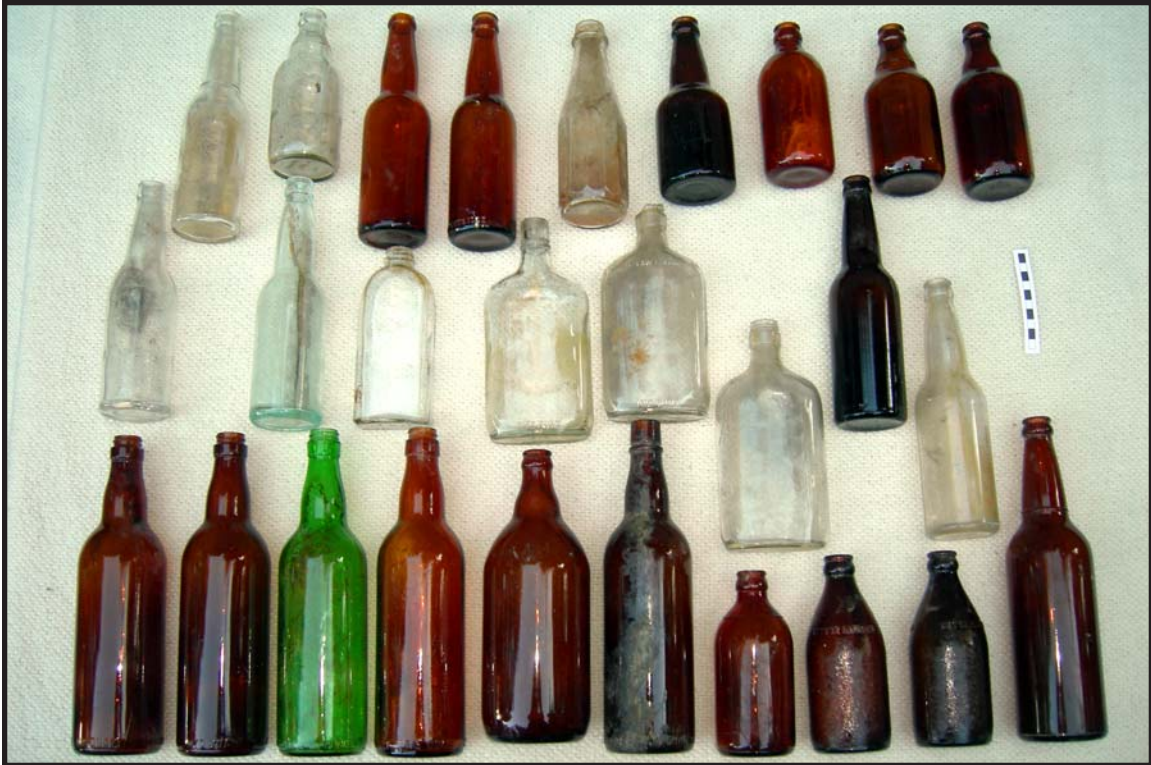
Figure 26. Bottles retrieved by construction workers in the excavations on Alder Street between Station 8+30 and Station 10+00 consisted mostly of amber beer bottles, along with three flask type liquor bottles, several soda bottles, and an uncolored catsup bottle.

Artifacts were found in several disturbed contexts: in the thick fill on Main Street where four water services were worked on early in the project, in the fill covering sewer, water, and fuel lines beneath English Road and the services off of English Road, and in the fill covering sewer and water lines under Alder Street (Figure 25). Surface artifacts were also recovered along both sides of Alder Street and along services off Alder Street. Some of the material was interesting, but most if not all of the artifacts were relatively recent. A collection of 27 bottles retrieved by workers from the excavations done on Alder Street between Stations 8+30 and 10+00, after the need for a monitor was removed from that segment, was dominated by amber beer bottles (Figure 26).

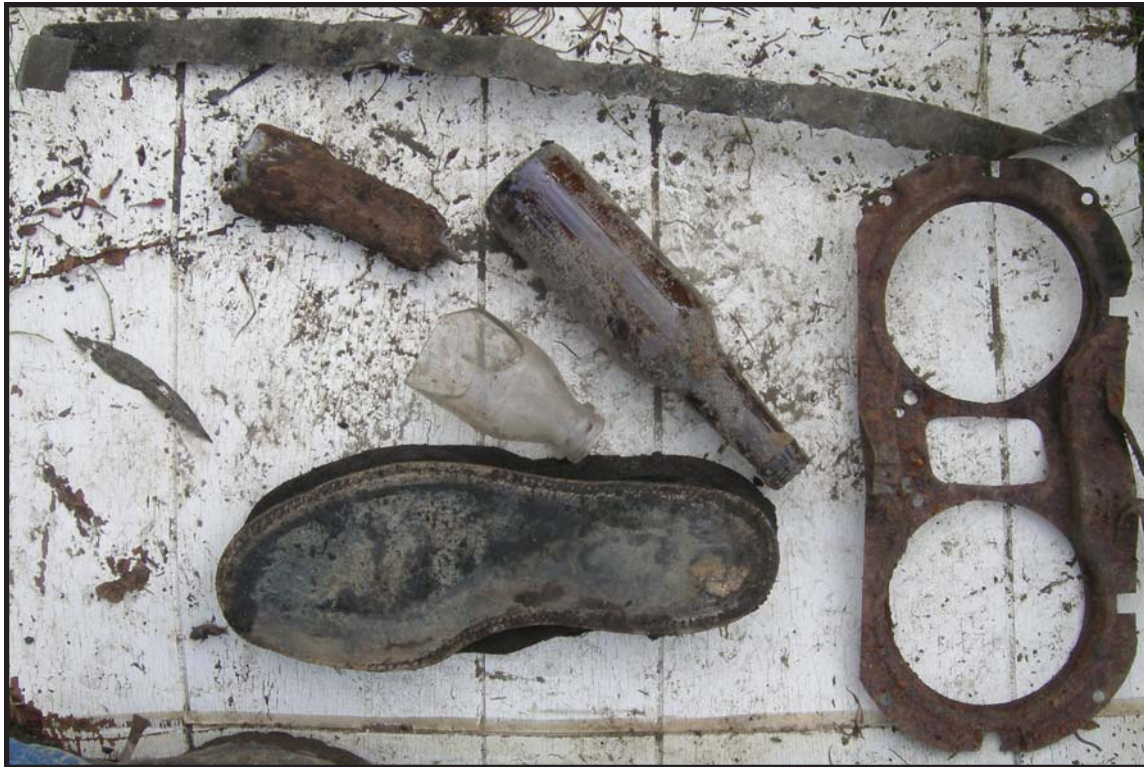
Figure 28. At the corner of Alder Street and English Road recent artifacts were noted in the fill, including what is probably a headlight bracket for a 1964 Ford Galaxy, according to crew members.

Street and English Road, including bottles, metal strapping, shoes, and what is probably a headlight bracket for a 1964 Ford Galaxy, according to crew members (Figure 28). Various other bits of utilitarian and domestic debris were found here and there, including a Crescent wrench lost by workmen the last time they excavated a service on main street, a leather climbing spur of the sort that Homer Electric Association linemen likely wore, and ceramic shards, fragments of enamelware, and bottle and window glass (Figure 29). Wood stave pipe of 6", 8", and 10" diameters was observed under English Road, as well as a composite sewer pipe, small diameter lead pipe, steel pipe in approximately 2" diameter, and copper pipe used for services in 1" diameter (Figure 30). No attempt was made to save removed pipes, though a 1" diameter wooden dowel with three compression scars on it -- a plug for a wood stave pipe -- was retained in the artifact collection. From the fill at approximately Station 0+80 in English

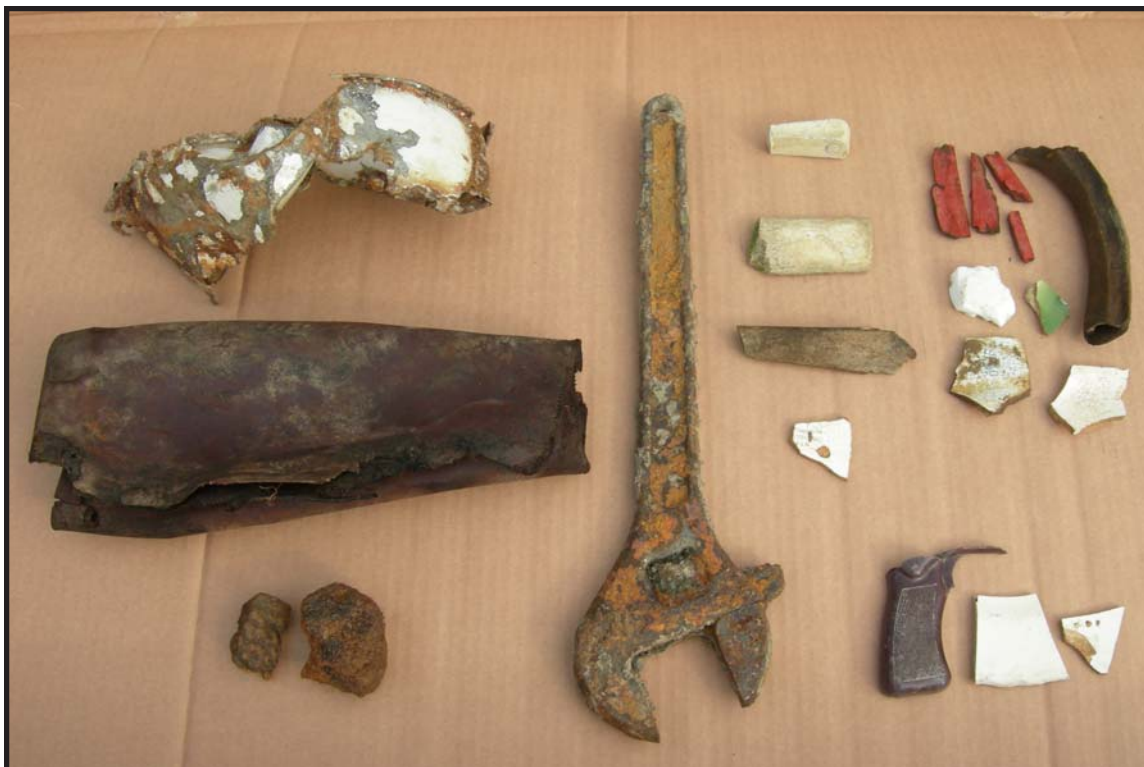
Figure 29. Other artifacts noted in fill included (clockwise from upper left), leather climbing spur, enamelware vessel fragment, paint chips, bone, ceramics, plastic toy pistol grip, and a wrench lost by workmen the last time they excavated a service.

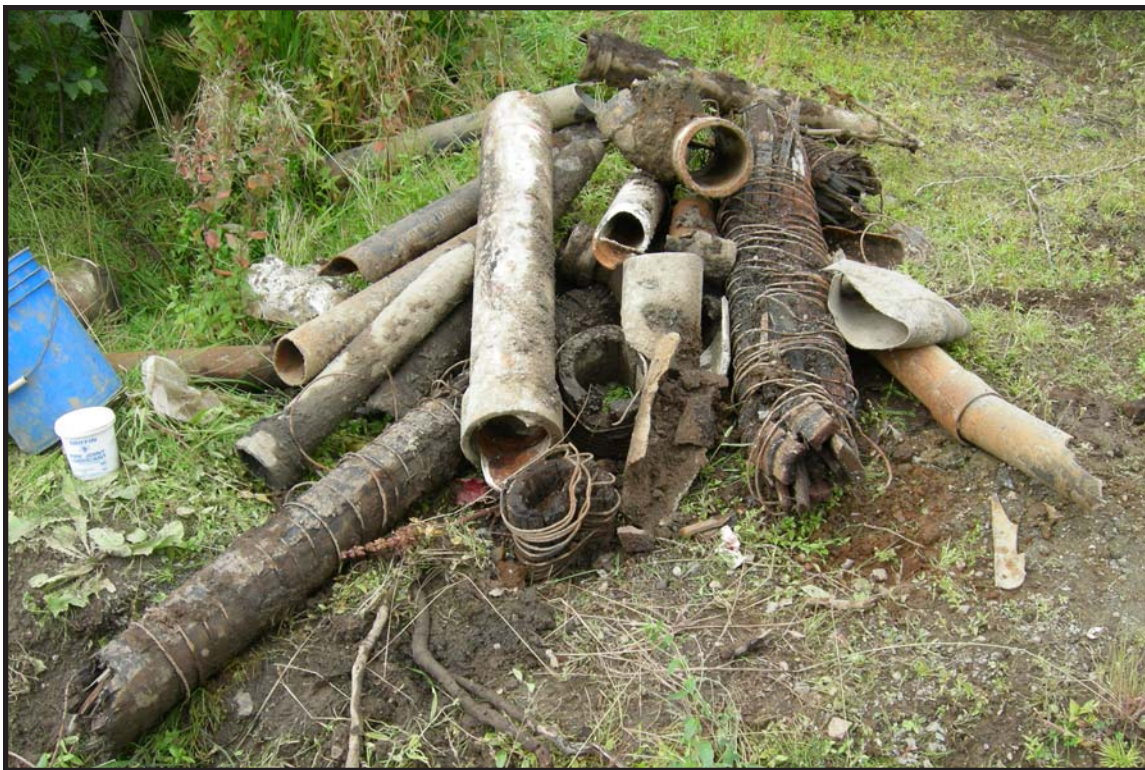
Figure 30. Wood-stave and metal pipe of various diameters was removed from beneath English Road.

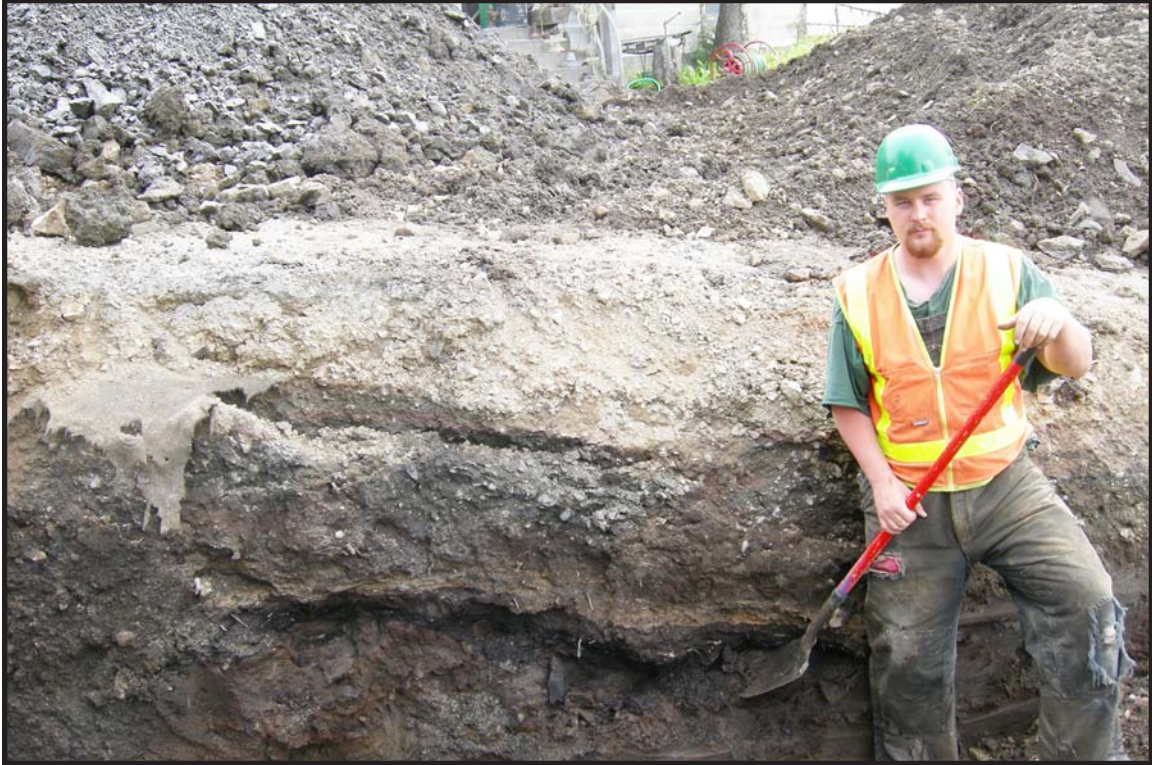
Figure 32. John Geagel points his shovel at the base of Midden Exposure 1, immediately below fill brought in to create English Road, with the old hospital (SEL-335) behind. View is south-southeast.

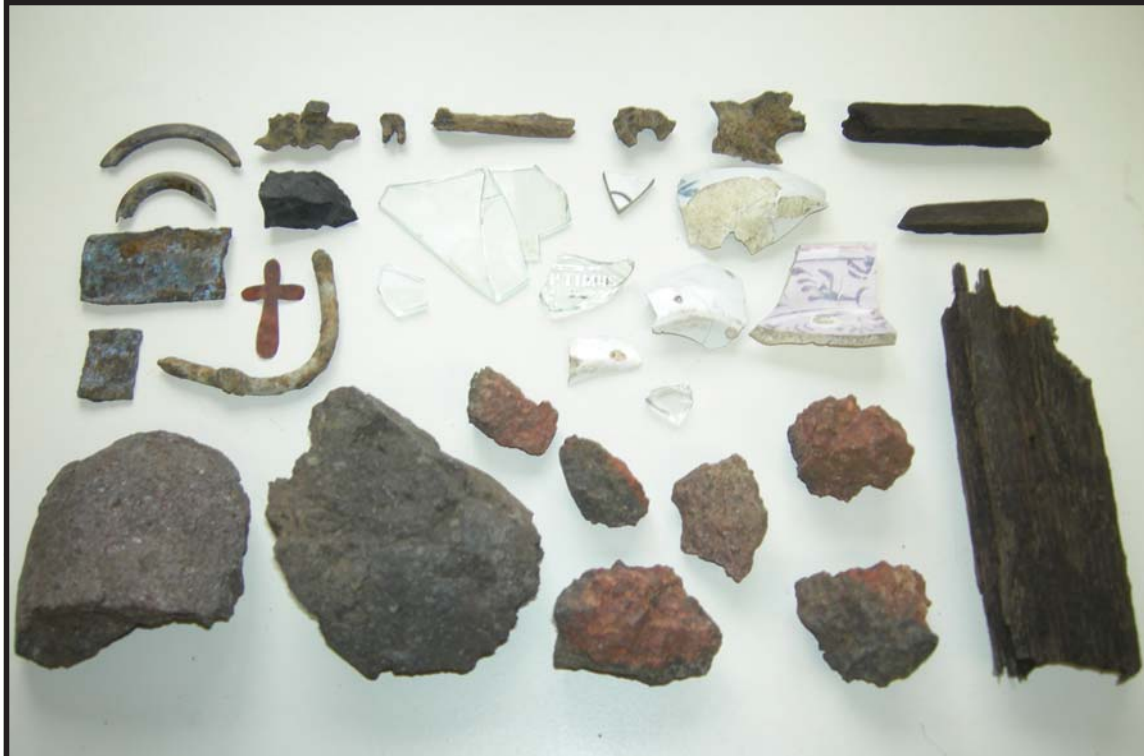
Figure 33. Midden Exposure 1 included (clockwise from upper left): two porcupine incisors, a lump of coal, several other small bones, window and bottle glass, ceramic shards, three pieces of wood, fire-cracked rocks, and four metal objects -- a nail, two small ferrous tablets, and a copper cross.

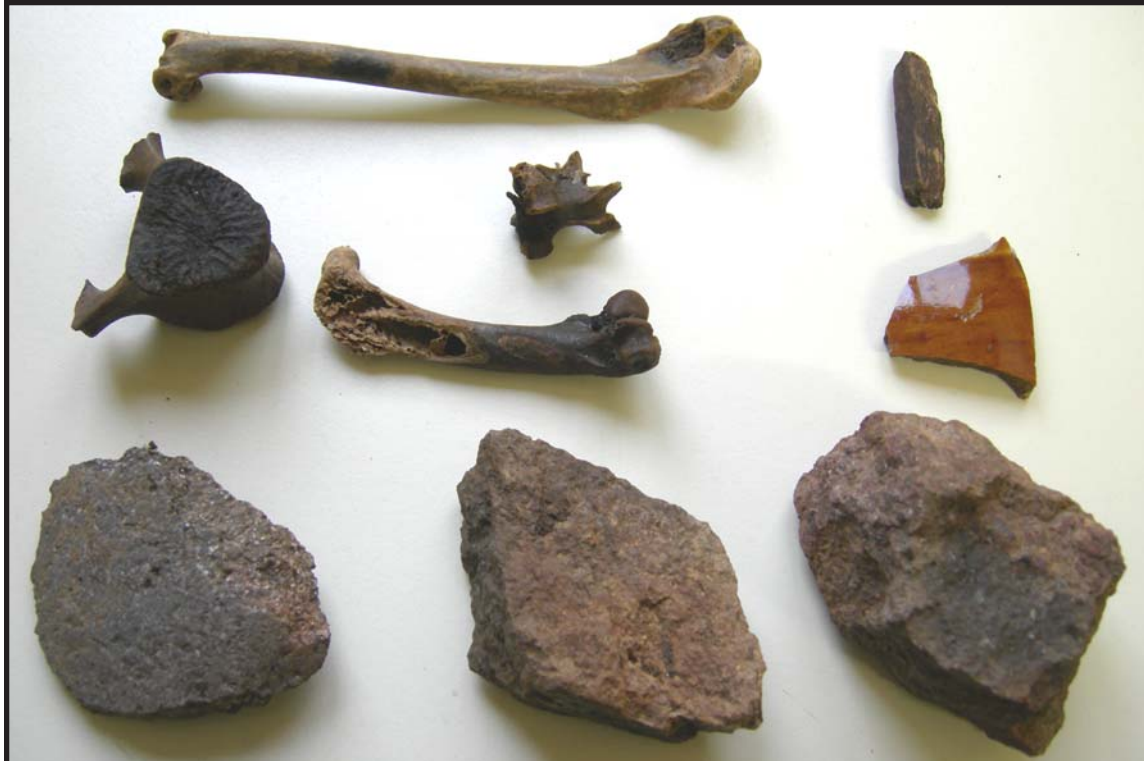
Figure 34. Midden Exposure 2, also in English Road, produced (clockwise from upper left): four bones, a piece of wood, one ceramic shard, and three fire-cracked rocks.

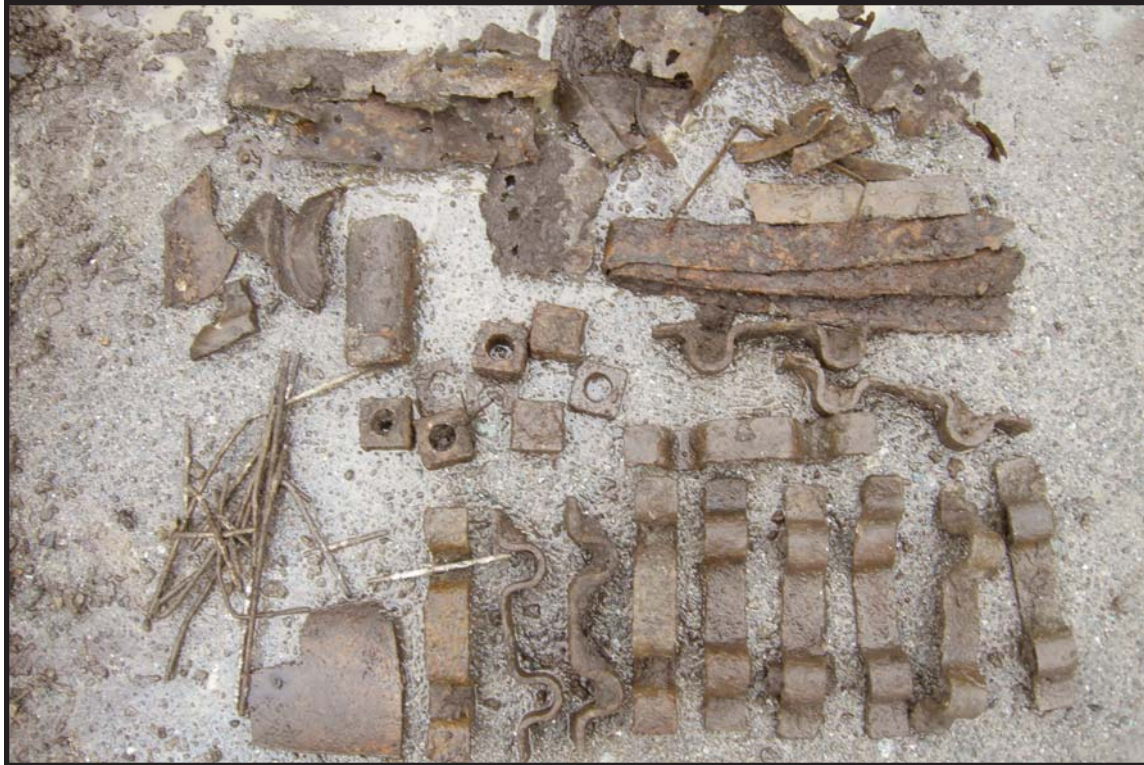
Figure 35. From a 10' section of upper English Road came a group of industrial shop items, including used welding rods, heavy metal conduit hangers, and square nuts.

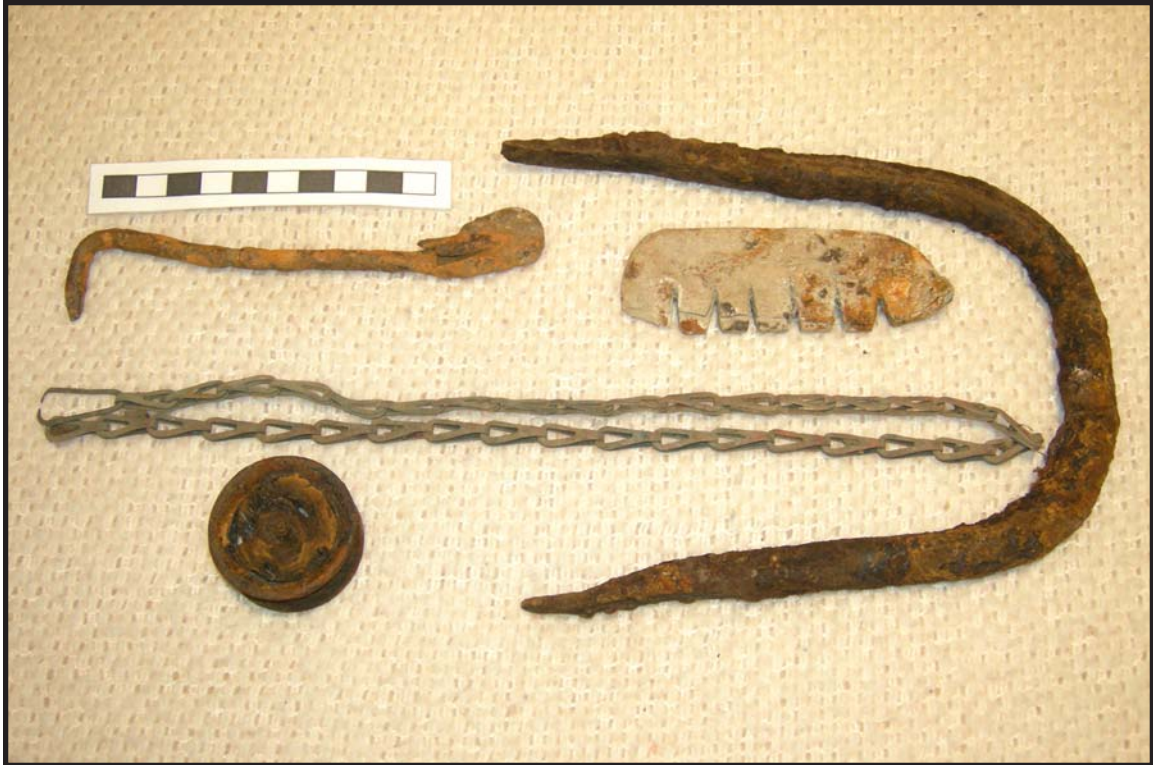
Figure 36. Structural items collected from the English Road midden consisted of a hook-type door latch, a large staple, and a small pulley. Also pictured is a sliced metal object and a short length of ferrous chain.

Aside from the nails and screws, which weren't collected, only a few other artifacts that could be called structural items were saved. These included a hook-type latch for a door, a large staple, and a small pulley (Figure 36).

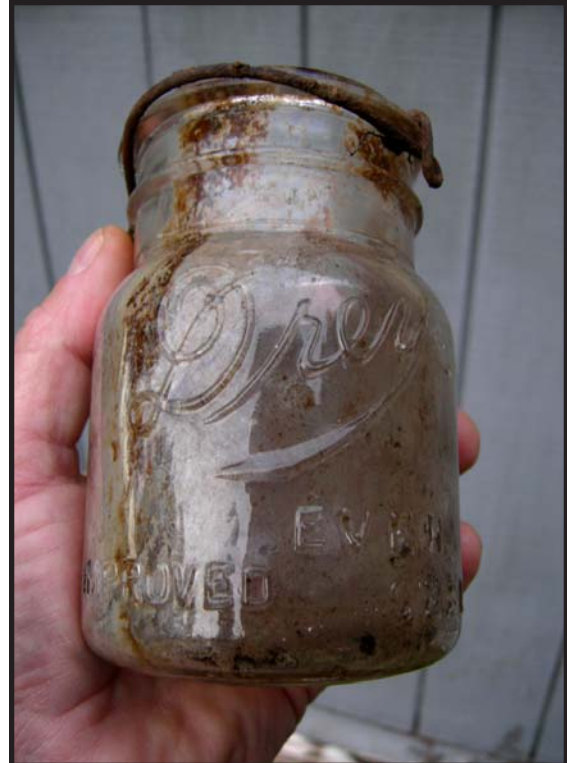
Figure 37. A Drey brand canning jar was recovered from the main midden exposure.

Three food storage items were recovered: two canning jars and a canning jar lid liner. One uncolored pint canning jar is embossed with "Drey" in script and the words "IMPROVED EVER SEAL" (Figure 37). Drey was a well-known canning jar brand manufactured from about 1908 to 1925 by the Schram Automatic Sealer Company and secretly from 1925 to 1938 by the Ball brothers, according to historical research presented on the website www.fruitjar.org. The jar still has the remains of a wire closure.

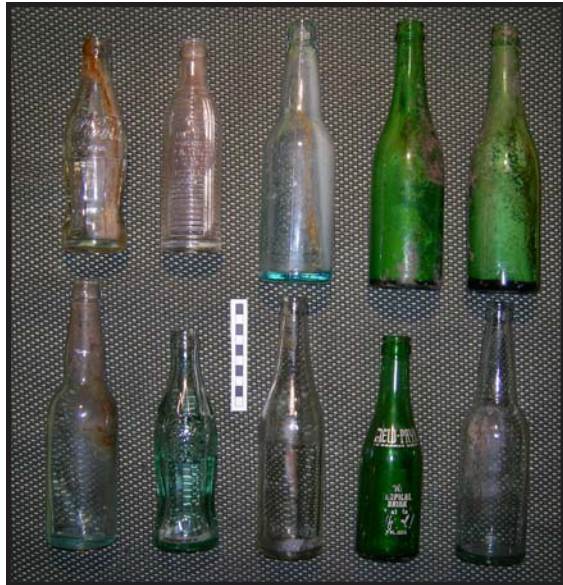
Figure 38. Ten bottles were sufficiently diagnostic or unique to be classified as soda bottles.

Three sorts of beverage containers were identified in the bottle assemblage: soda bottles, beer bottles, and liquor bottles. Ten specimens were classed as soda bottles (Figure 38). One uncolored bottle had embossed horizontal and vertical ribbing and the legend “PAT’D JULY-20-1920, ORANGE CRUSH, BOTTLE, 6 FL

OZS.” This style bottle was in use from the patent date of 1920 until 1955, according to the website www.angelfire.com/tn/traderz/crush. Two 6 oz. Coca-Cola bottles -- an uncolored one and a clear green one -- were found; the green one had “ANCHORAGE ALASKA” embossed on its base. A bright green bottle retained enough of a painted identifying the contents as “MELO-PAYA, A PAPAYA SODA, the TROPICAL DRINK that is different. 7 FL. OZS.” A limited internet search suggests that the Melo-Paya Bottling Company operated in Des Moines, Iowa, with products bottled there and in Orlando, Florida, and St. Joseph (Missouri?), between 1938 and 1948. An uncolored bottle embossed “Welch’s” once contained juice from the Welch’s Grape Juice Company, which has bottled under that name (as opposed to “Dr. Welch’s” since 1893 according to the company website. Other glass containers identified as probably soda or water bottles consisted of two green specimens, an aqua specimen, two uncolored specimens, and a clear green specimen (Figure 38).

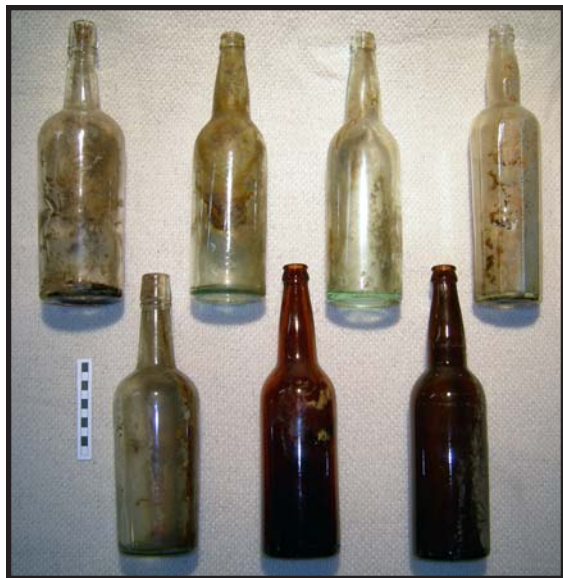
Figure 39. Seven liquor bottles were recovered from the English Road midden.

Seven larger long-neck bottles are classified as liquor bottles (Figure 39). One specimen is ten-sided; the others are round. Three are uncolored, two are amber, one is aqua, and one is clear green. They are taller than the beer bottles, ranging from 28 to 30 cm.

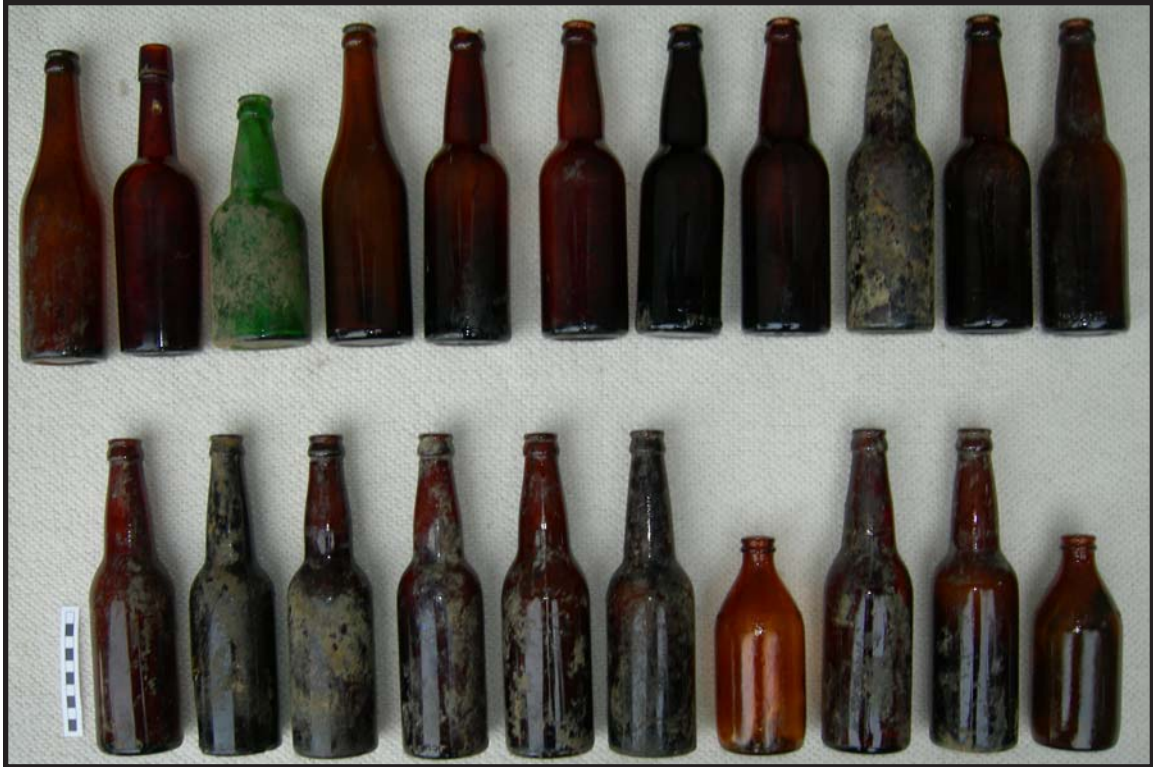
Figure 40. One green bottle and 20 amber bottles from the English Road midden are classified as beer bottles.

Beer bottles from the English Road midden consist of 21 specimens including two short clear amber examples that are not that old (Figure 40). The remainder are mostly shouldered amber long-necks, about 24 cm tall.

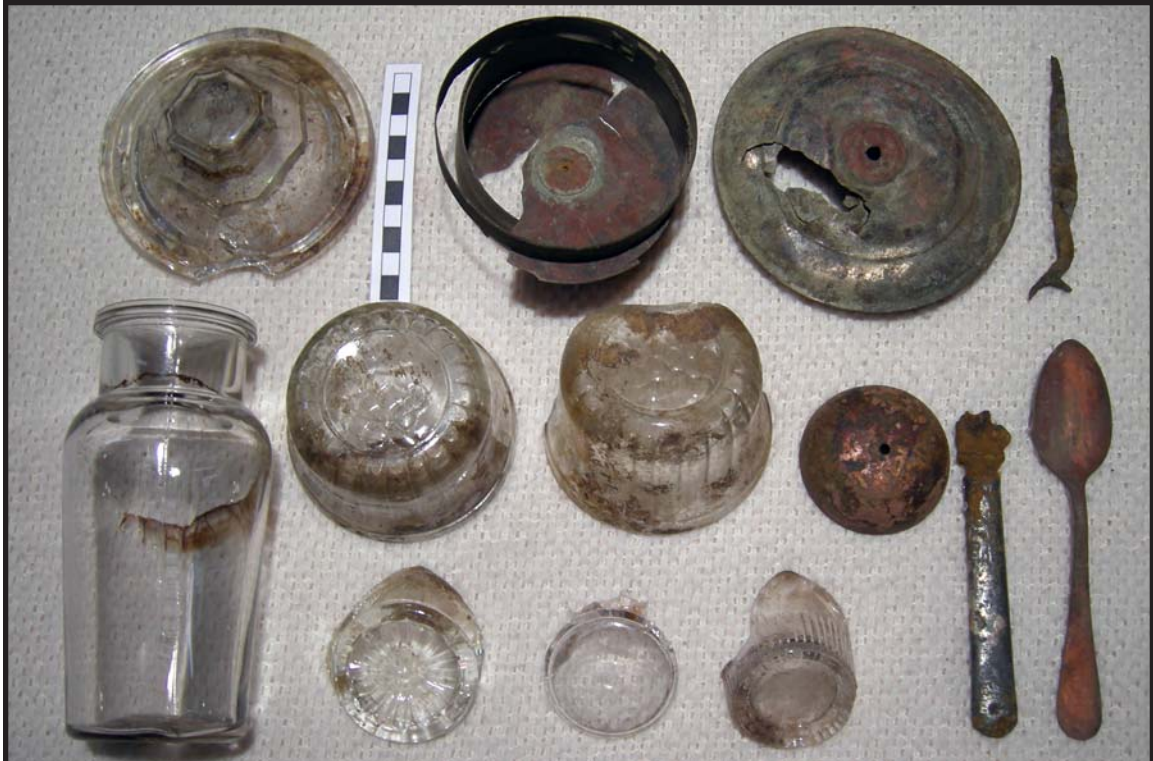
Figure 41. Domestic food preparation or serving items included glass beverage and food serving containers, metal tins, a silver-plated dinner knife and cuprous spoon. The scissor fragment belongs to the Personal grooming category, and the round cuprous bell belongs to Personal miscellaneous.

Artifacts associated with food preparation or serving consisted of some table items of glassware and cutlery (Figure 41), and a number of ceramic shards. The glass and metal table specimens consist of three beverage serving glass bases, two identically patterned small glass desert bowls, a glass carafe and the glass lid to

a largemouth jar, a silver-plated dinner knife, a cuprous spoon, a metal lid to a cannister, and a cylindrical cannister made of soldered copper.

The wrench lost in the fill of a water service off Main Street has already been mentioned and illustrated (Figure 29), as have scissors fragments (Figure 41). A large 1" diameter cold chisel was also found in the midden (Figure 50).

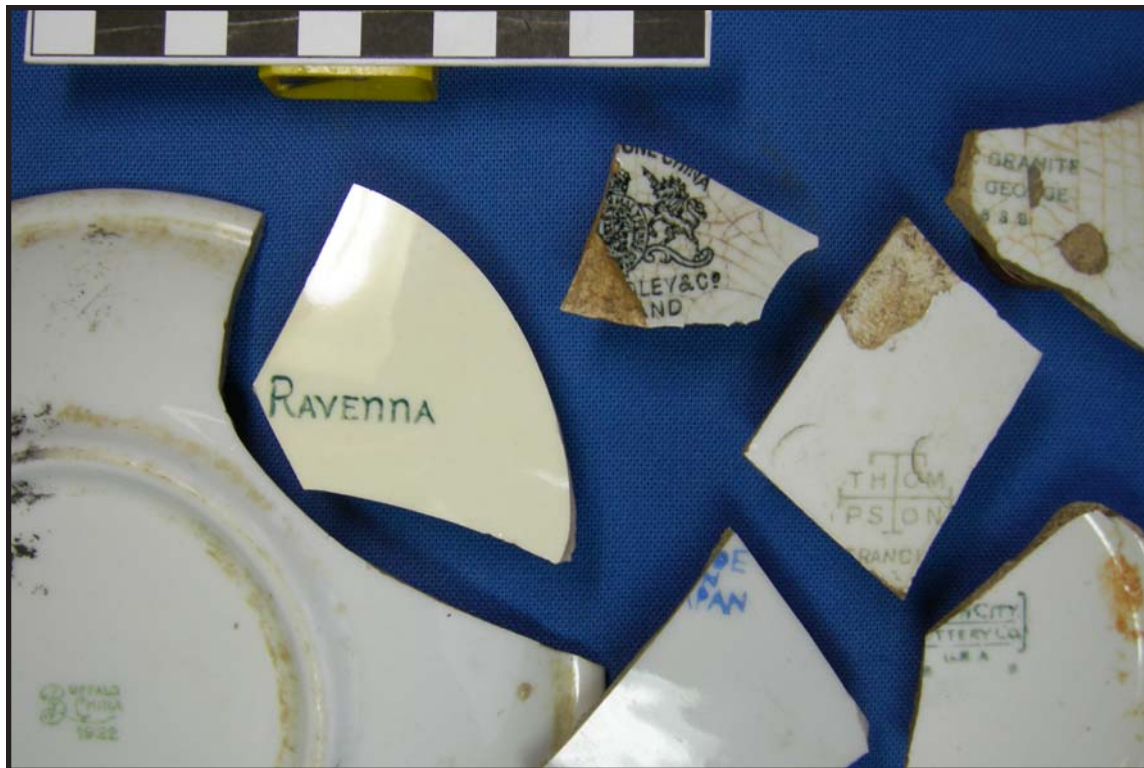
Figure 42. Seven ceramic shards displayed maker's marks. Clockwise from lower left are marks of the following companies: Buffalo Pottery, Homer Laughlin China, unidentified, C.C. Thompson Pottery, W.S. George Pottery, possibly Garden City Pottery, and an unidentified Japanese company

Maker's marks were present on seven ceramic specimens (Figure 42), all of which were white paste. One mark of the C.C. Thompson

Pottery Co. of East Liverpool, Ohio, is dated to about 1916-1938 (Kovel 1986:214); the "FRANCE" on the mark likely indicates the pattern name. The mark of the Buffalo Pottery Company of Buffalo, New York, conveniently includes the date of 1922 (Kovel (1986:164) suggests a date of about 1930 for the mark). The mark "RAVENNA" refers to a design (not the pattern) manufactured by Homer Laughlin China Company of East Liverpool, Ohio, beginning in 1930-33, according to the website www.missing-piece.com. The website www.twisteddisher.com says "Homer Laughlin dishes have not only been sold to the public, but also were used as supermarket promotions, free items inside products like oats and detergent, and also have a strong history as restaurant ware." The specimen marked "GRANITE" and "GEORGE" was manufactured by the W.S. George Pottery Company of East Palestine, Ohio (and Canonsburg and Kittanning, Pennsylvania), which was in business from 1904 to

1960, according to the website www.wsgeorge.jdfiles.org. The “83B” refers to the shape, and the aforementioned website has a useful index of shapes and patterns, but it is far from complete and the shape number is not listed. I found, photographed, and left in place another W.S. George specimen marked 55B in the intertidal zone of Seldovia Slough where the old sawmill (no AHRS site number) used to be, but that shape number isn’t listed either. In regard to the “MADE IN JAPAN” mark, the Kovels (1986:229) say the earliest they’ve seen that country identified on an imported ware (as required by the 1891 McKinley Tariff Act) is 1921. One partial maker’s mark says “_N CITY POTTERY Co./U.S.A.” and is possibly the product of the Garden City Pottery Company of San Jose, California -- in business from 1902 to 1979 (Pasquali 1999). Finally, one shard with a partial British Royal Arms symbol showing an oval shield, crown, and unicorn was found with the letters “_LEY & Co./_ND”

and “_ONE CHINA”; but the maker’s mark doesn’t appear in Kovel’s (1986) inventory because -- as they say -- “the Royal Arms mark was so popular it was used by dozens of factories and it is impossible to give an all-inclusive listing here.”
