Archaeological Monitoring for Sewer and Water Improvements Seldovia, Alaska

**Archaeological Monitoring
for Sewer and Water Improvements,
Seldovia, Alaska**

Charles M. Mobley

2008

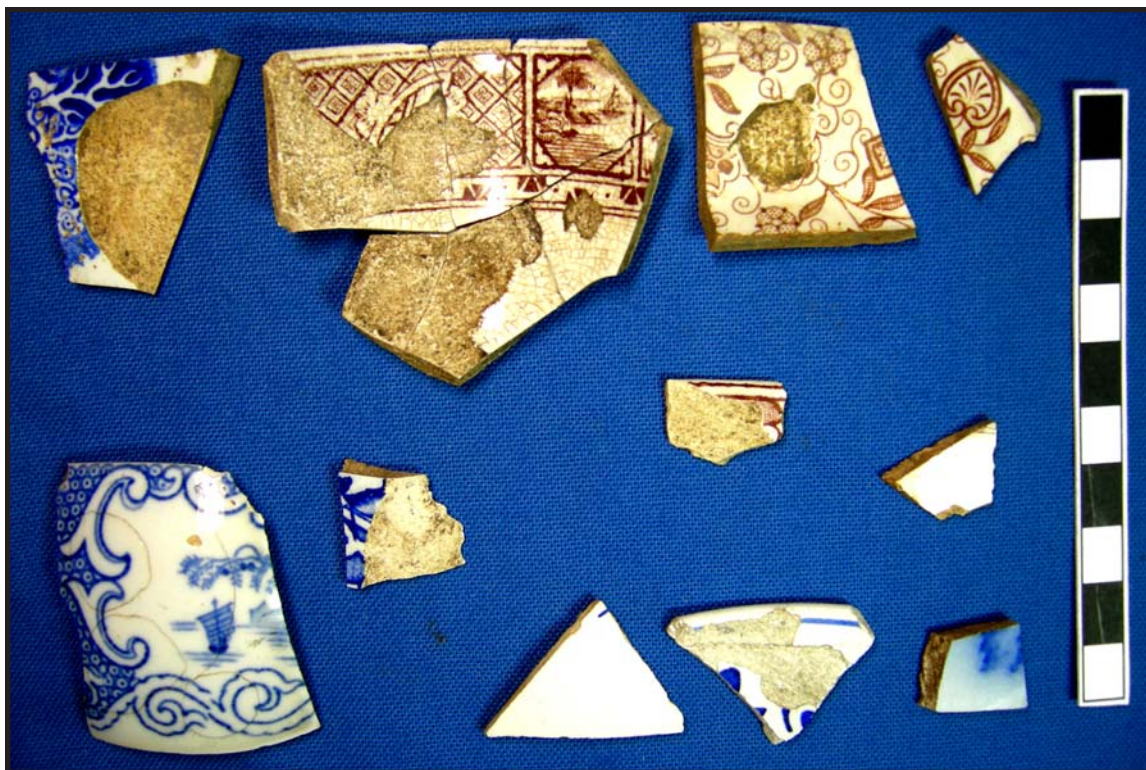
Figure 43. Several transfer printed shards were recovered. The brown-on-white is the “Sitka” pattern produced in England; the blue-on-white in the lower left is also of English manufacture. At bottom right is a shard of flow blue.

Several transfer-printed shards were noted in the collection (Appendix B), including blue-on-white, but none were of the “blue willow” patterns often found in archaeological sites (Gaston 1994). The transfer print patterns were in green, blue, and brown (Figure 43). One small shard was identified by Daniel Thompson as flow blue, a blurry transfer print “introduced about 1835 and...popular in various forms throughout the nineteenth century (Majewski and O’Brien 1987:145). Another shard was identified by Thompson as the “SITKA” pattern (1885-?) manufactured by T. Hughes Pottery of Burslem, Staffordshire, England; the pattern was also recognized on shards from the historic Dena’ina village of Kijik (VanStone and Townsend 1970).

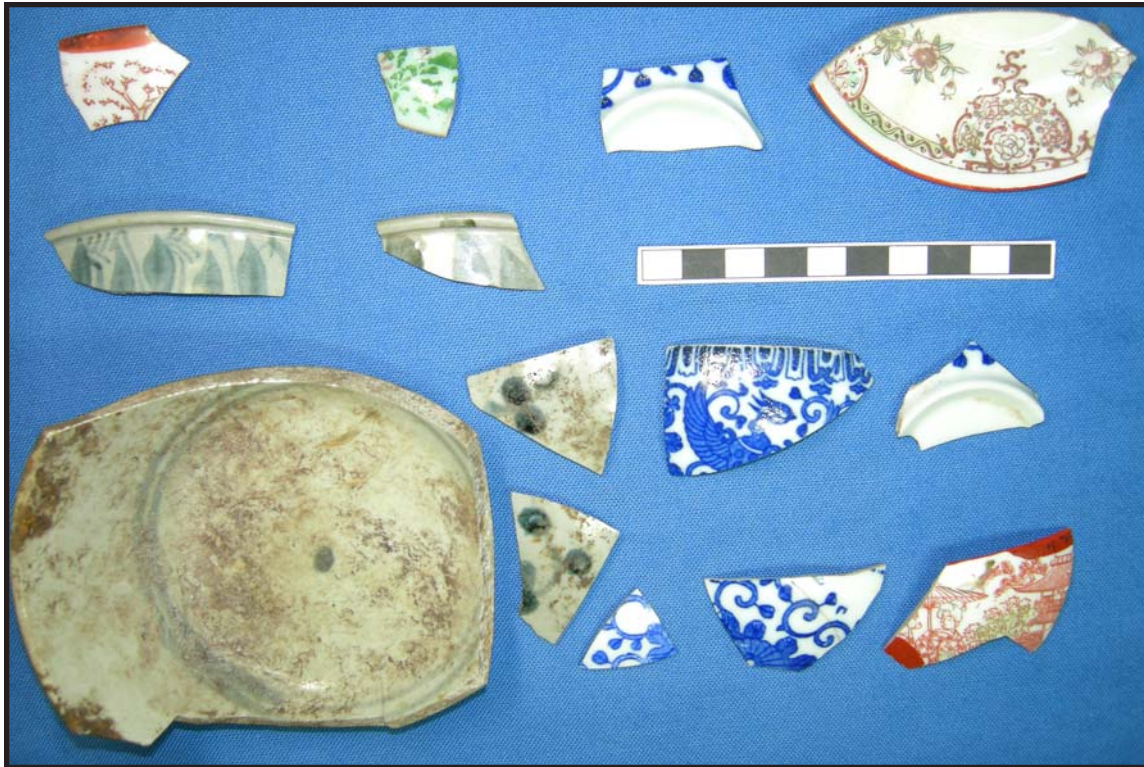
Figure 44. The porcelain sample included two of Japanese manufacture (upper left, lower right), one of Japanese or Chinese manufacture (upper right), and 11 of Chinese manufacture (all others shown).

Notable is the relatively high frequency of Japanese and Chinese shards in the porcelain collection: 14 of 34 specimens (Figure 44). Chinese vessels are represented by five handpainted gray-on-gray shards (probably from tea or rice bowls), five blue-on-white shards, and a red and green polychrome shard. Specimens identified by Thompson as Japanese consisted of a red overprint cup fragment with a pattern of a woman in a kimono and traditional architecture, and a red/green/gold overprint fragment. One shard was of Oriental origin but couldn't be attributed specifically to Chinese or Japanese manufacture.

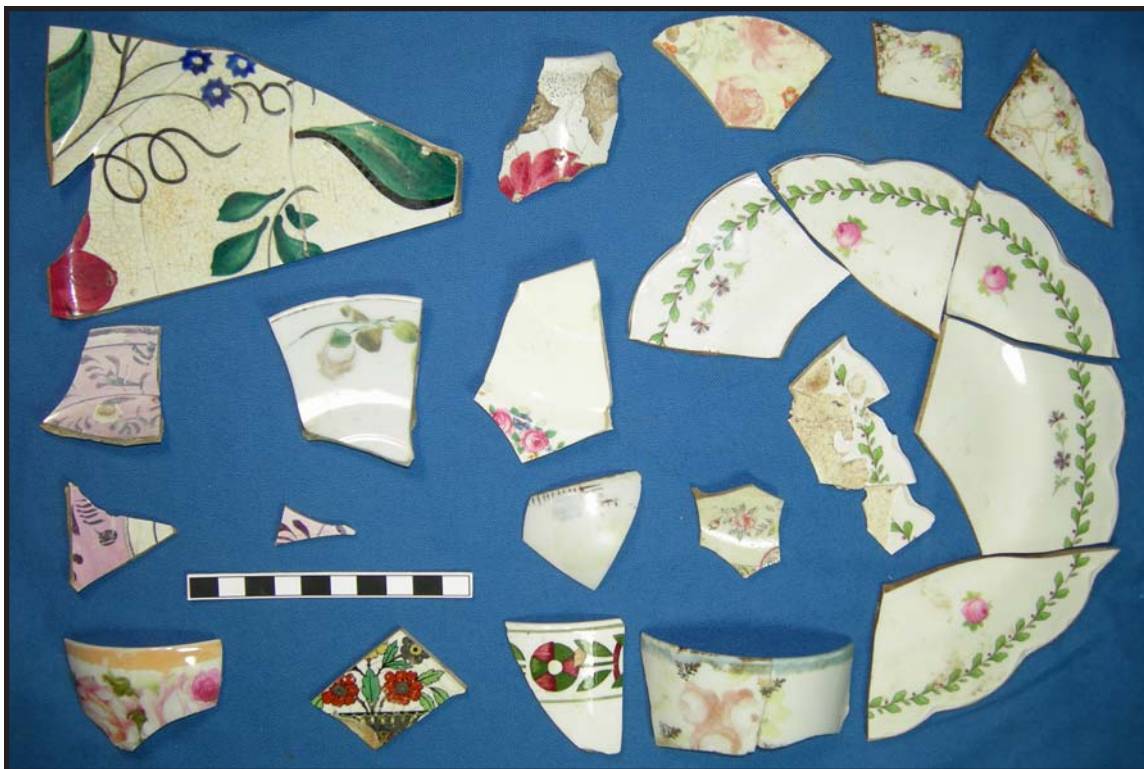
Figure 45. The total sample of handpainted and decal shards consisted of these samples, except for the 1922 Buffalo Pottery Company saucer (not shown), which has a single gray encircling line.

Handpainted vessels and those with decal designs -- including some identified by archaeologist Daniel Thompson as "Decalcomania" -- were also present (Figure 45). Almost all had a floral theme.

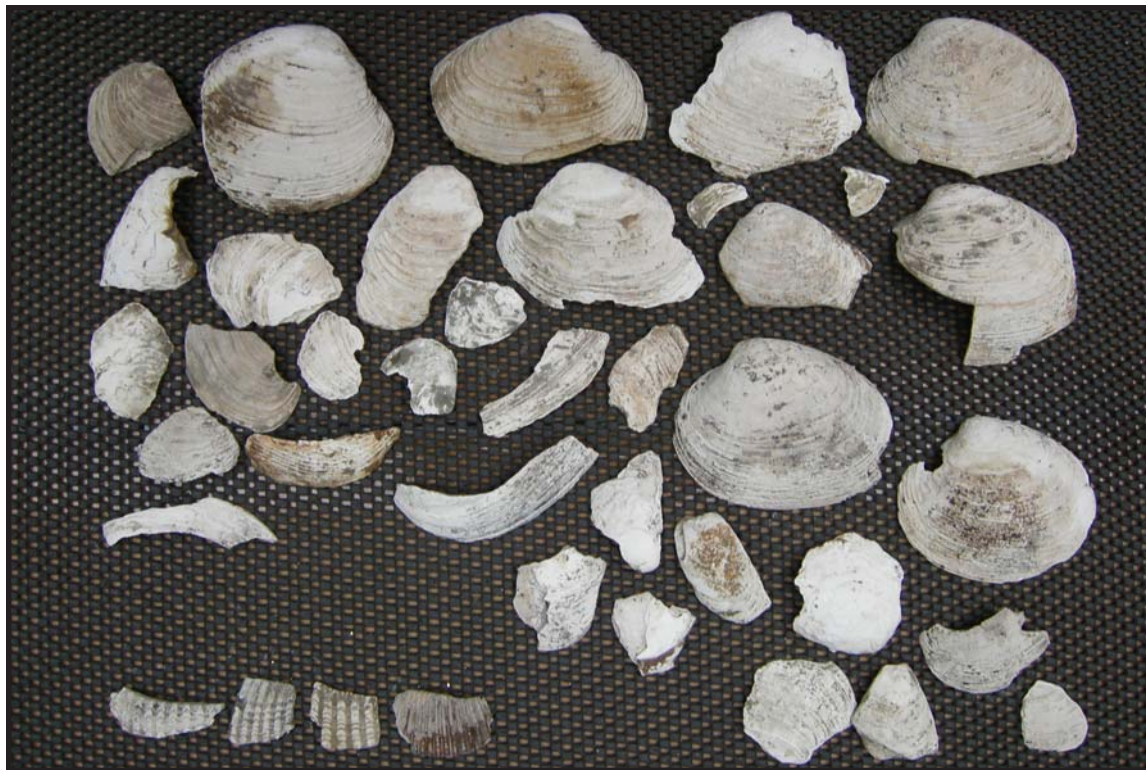
Figure 46. The midden deposit produced a few, mostly fragmentary, cockles (lower left) and Saxidomus (remainder). These specimens were collected, photographed, and discarded.

Food remains found in the midden exposures consisted of marine shells and animal bones. The marine shells were all single halves or smaller fragments of bivalves, primarily *Saxidomus* sp., with a few cockles (Figure 46). The specimens were dispersed rather than concentrated in the midden, and they weren't quan-

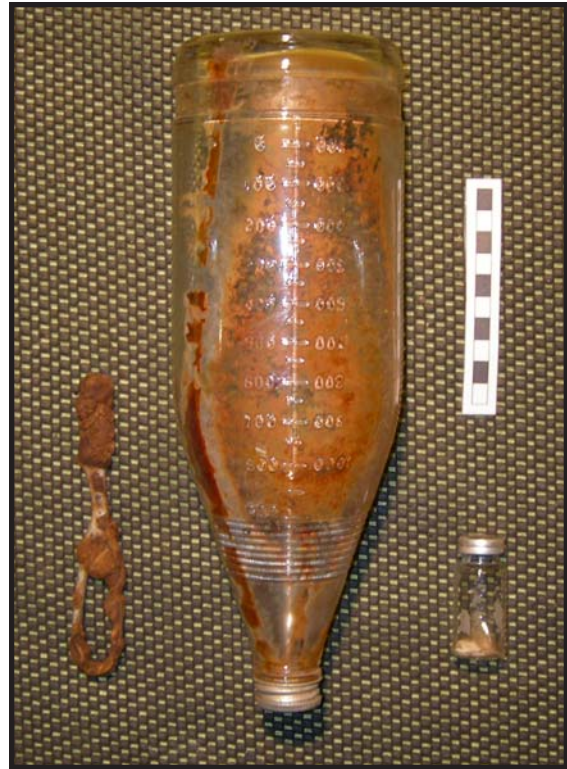
Figure 47. Possibly discards from the old Seldovia hospital (SEL-335) are these artifacts: a vial, bottle, and stainless steel shears or tool fragment.

date a syringe needle, the broken handle to a stainless steel scissors or forceps-like tool, and a glass bottle with a milliliter scale running in both directions -- up and down -- so it could be turned

upside down and used for an intravenous feed (Figure 47). The bottle still has its metal cap, which reads "DEX 5% IN SALT," and the bottle base (made by Duroglas) is embossed

“ABBOTTLABORATORIES.” These items may have been discarded from SEL-335, the old Seldovia hospital, when it was in operation during the 1940s and 1950s.

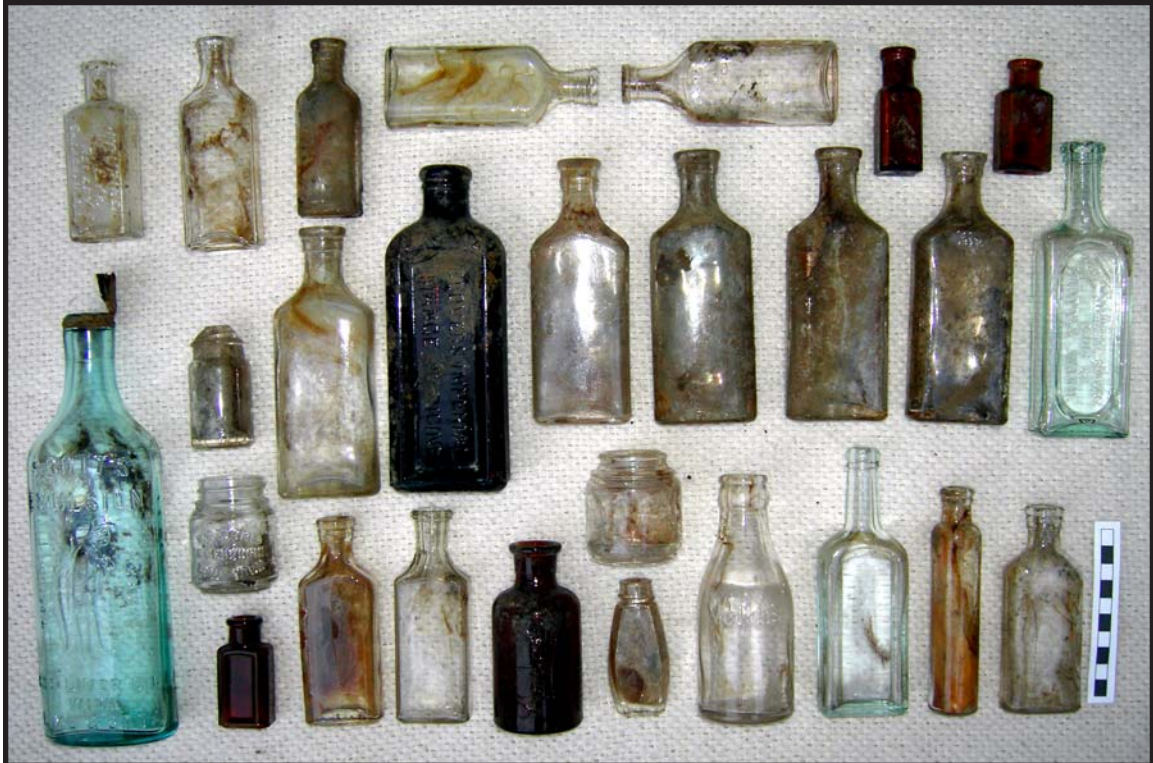
Figure 48. A number of medicine bottles were found in the midden, including the large aqua cod liver oil bottle on the left embossed with a man holding a huge cod over his shoulder.

Also classed as medicine-related items are 27 bottles -- many in a small flask shape -- that likely once held medicinal products (Figure 48). Embossing reveals the contents of several specimens (Appendix E). One lovely large aqua bottle is embossed with a man carrying a huge fish over his shoulder, and the words “SCOTT’S EMULSION, COD LIVER OIL WITH LIME & SODA.” A crimped metal cap still sealed the bottle, and it was about one-fifth full of product when found (I peeled the top back and emptied the contents for permanent storage). An uncolored squat screw-top cylinder bottle was embossed with “TRADE MARK VASELINE CHESEBROUGH NEW YORK.” An aqua rectangular bottle was embossed on the narrow sides “Chas.HFletcher’s” and “CASTORIA.” An uncolored rectangular bottle with beveled

corners was embossed “MURINE EYE REMEDY Co. CHICAGO, U.S.A.” An amber rectangular bottle with beveled corners was embossed “H. CLAY GLOVER CO.” on one narrow side, “NEW YORK” on the other, and on a wide side was embossed “GLOVER’S IMPERIAL MANGE MEDICINE, 6 FL OZ.” A clear green rectangular bottle has embossed on one wide side “OPTIMUS, STEWART & HOLMES DRUG CO, SEATTLE, WASH,” indicating a remedy advertised for dyspepsia by a Seattle firm in business at least between 1899 and the late 1910s, according to internet references.

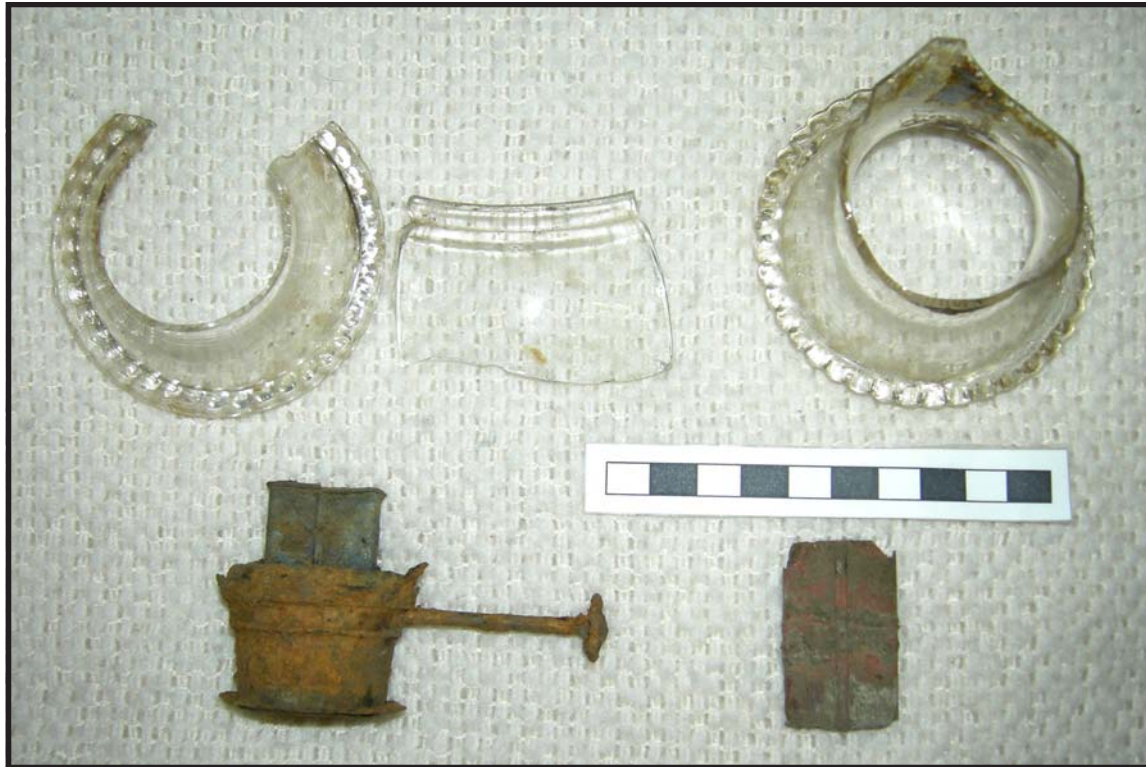
Figure 49. Domestic furnishings included two base fragments of uncolored oil lamp globes, a wick assembly and another wick holder, and an uncolored glass fragment for an overhead globe.

assembly from an oil lamp was found, and a wick holder was found elsewhere in the midden (Figure 49). Two almost identical base fragments of uncolored oil lamp globes were found, along with a fragment of an uncolored thin glass globe that is likely for a stationary overhead gas light.

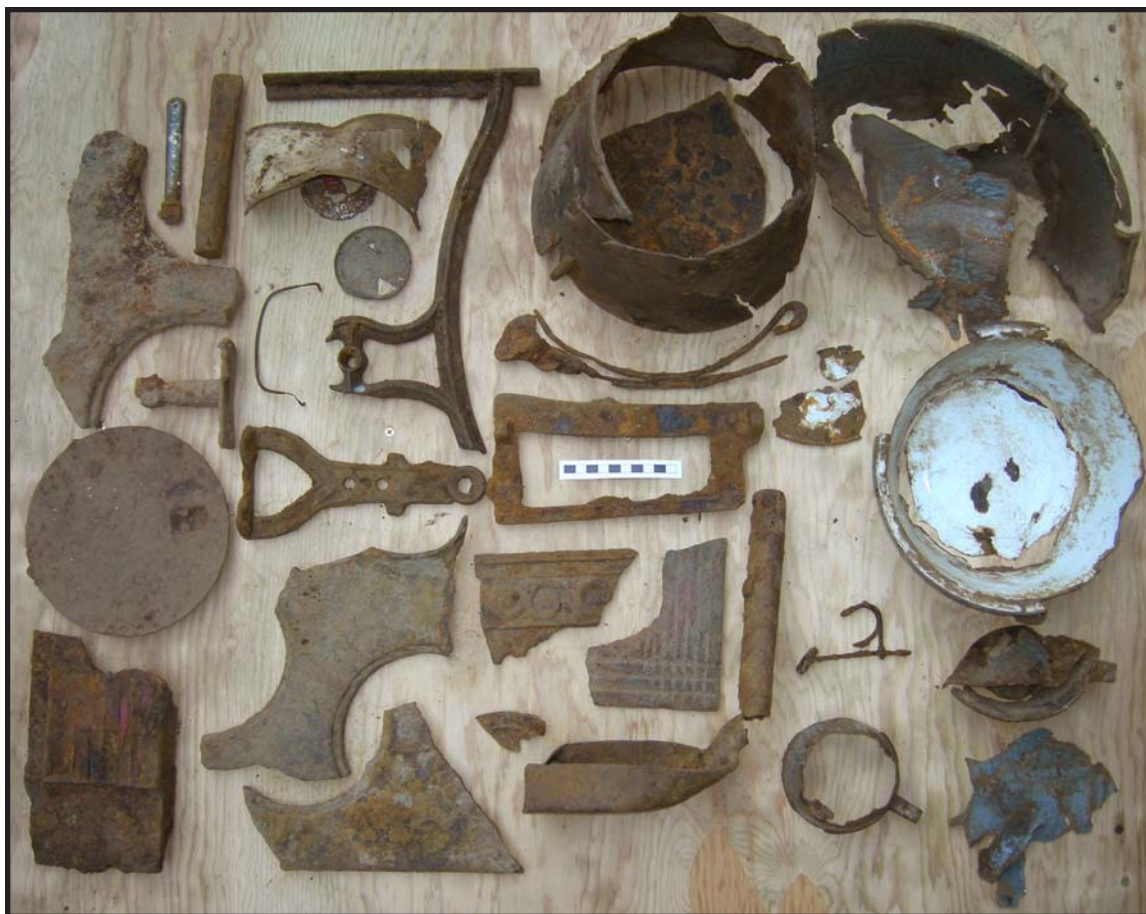
Figure 50. Metal artifacts collected from the midden include cast iron stove parts, part of a sewing machine frame, a cast iron kettle and enamelware containers.

Stove parts found in the midden exposures consisted of relatively small cast iron chunks about 10" x 10" size (Figure 50). Judging from the decorative embossing at least two stoves are represented in the collection (Appendix G). None of the pieces fit another. Also assigned to the domestic furnishing category is a simple twisted wire coathanger.

The wrench lost in the fill of a water service off Main Street has already been mentioned and illustrated (Figure 29), as have scissors fragments (Figure 41). A large 1" diameter cold chisel was also found in the midden (Figure 50).

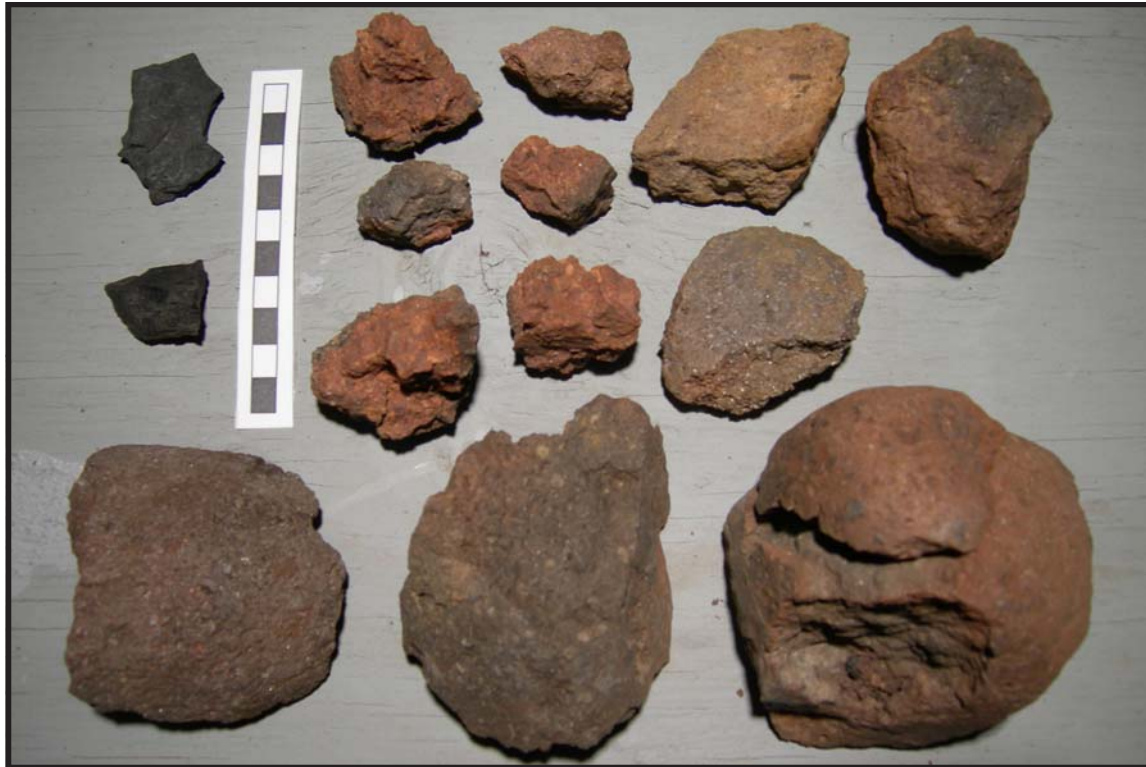
Figure 51. Stone artifacts recovered from the midden include two pieces of coal and 13 fire-cracked rocks.

domestic items, as are bottles of indeterminate function. The coal consists of two small pieces (Figure 51). Archival and oral history accounts both repeatedly mention Seldovia's reliance for domestic heating on coal acquired locally north of Kachemak Bay, as well as wood. Surprisingly little coal was found, but a lot of coal ash was uncovered -- that's what formed much of the midden matrix. The few coal specimens compared to the amount of coal ash would suggest that coal was handled frugally, and not typically lost or wasted.

Thirteen reddened fire-cracked rocks were found in the midden deposit (Figure 51, Table 2). Each has coarse uneven surfaces indicative of thermal fracture, and most also have some cortex. The fire-cracked rock is typical of prehistoric Kenai Peninsula sites, resulting from either the Dena'ina pattern of hot-rock

cooking or the Eskimo tradition of banya, or steam bath. The historic Seldovia Native community had a banya tradition that lasted until about World War II, according to Fred Elvsaa. I would suggest the fire-cracked rocks found in the midden exposures along English Road reflect use of banyas by the local Native community.

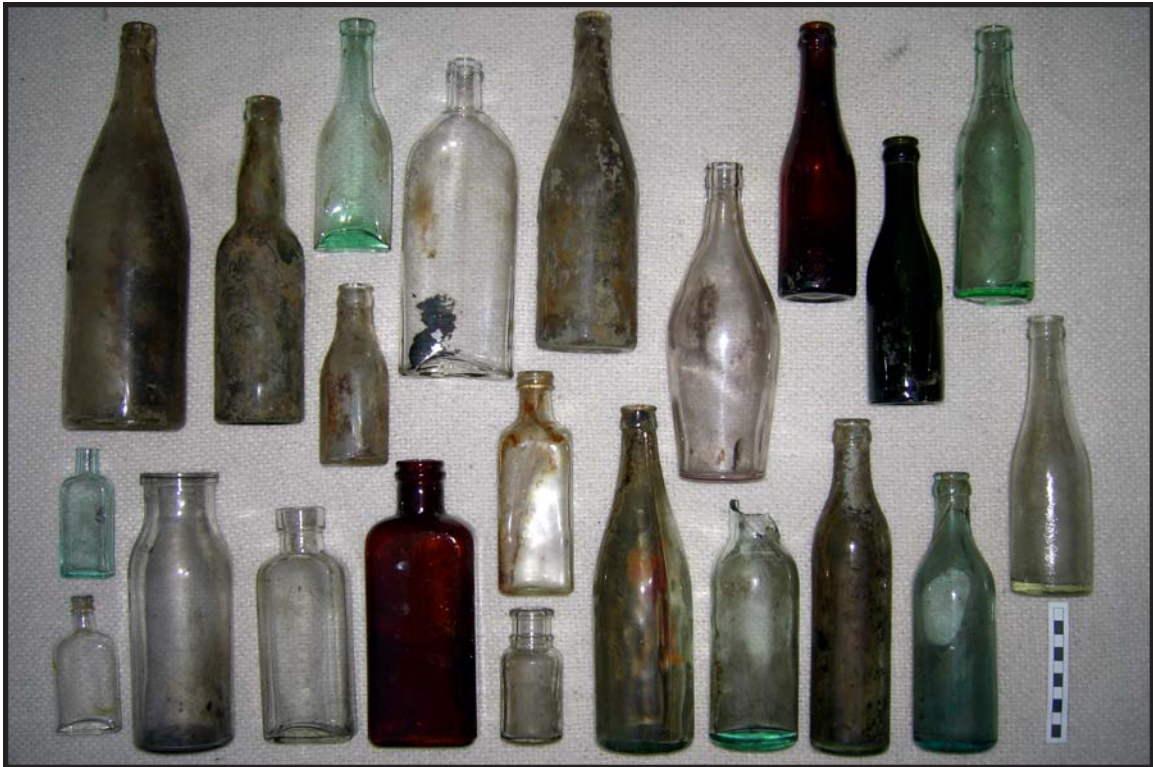
Figure 52. Assigned to the miscellaneous domestic category were these bottles that weren't assuredly identifiable to other categories, though some are likely soda, beer, liquor, and condiment containers.

bottle categories (Figure 52). Some are likely soda, beer, or liquor containers that might be identifiable to function by specialists more familiar with bottles than I. One small rectangular aqua bottle is embossed on its narrow sides with “THREE IN ONE” AND 3-IN-ONE OIL CO,” a product invented in 1894 and still produced today; the Seldovia specimen was made for a cork stopper and thus predates the 1910 shift to screw-top caps (as determined from the

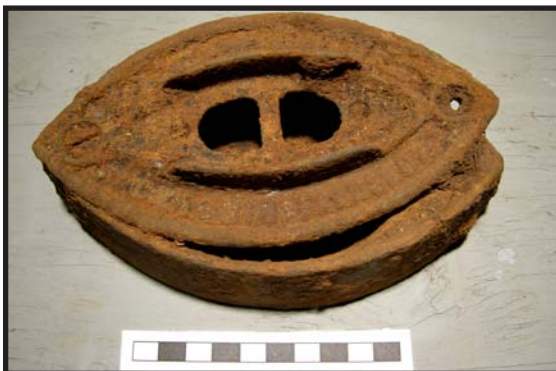
Figure 53. A clothing iron manufactured in Ohio was recovered from the midden.

An iron for ironing clothes (Figure 53) was collected from the main midden area. It has no handle, but the top plate remains and is embossed "A.D. WILLIAMS/CHAGRIN FALLS O."

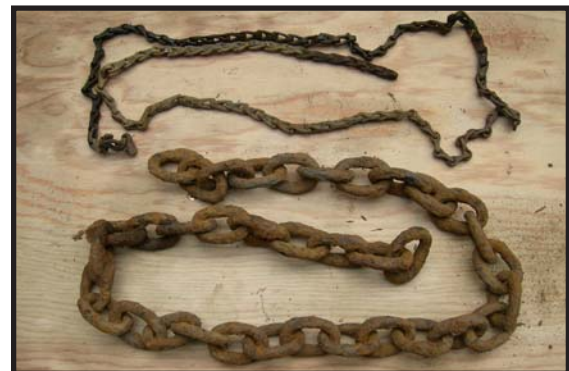
Figure 54. Three lengths of chain (the two pictured and another like the one at top) were recovered from the excavation backdirt

The other is a 60" length of smaller ferrous chain of bent "8" links of a design (Figure 54) that Sears Roebuck and Company sold as "Safety Chain to be used on plugs, stoppers, closet pulls, etc." (Schroeder 1970:921). The two chains and a third short chunk of the Safety Chain type (Figure 36) were found in the backdirt of excavations at the east end of English Street.

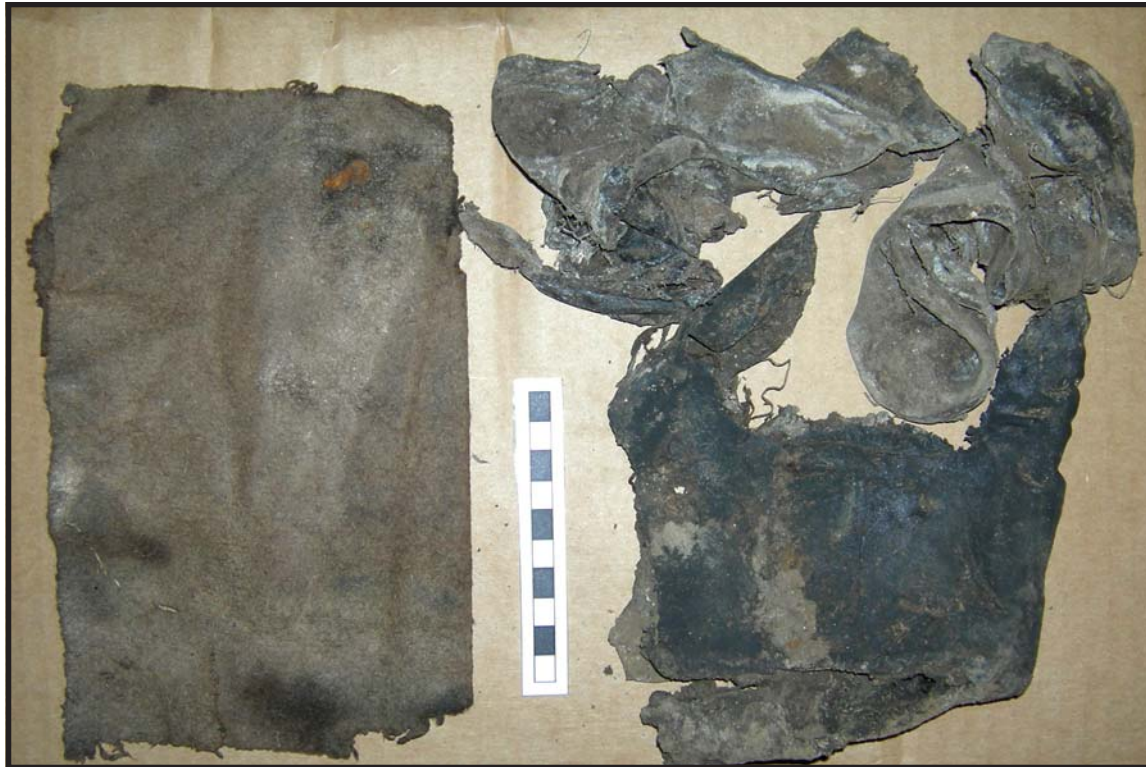
Figure 55. Most of the fabric noted in the midden under English Road was soaked in fuel oil and consequently discarded; saved were these three items.

Most of the few fabric items found in the exposed midden were rags soaked in fuel oil -- toxic and not subjected to collection or analysis. Three exceptions were made (Figure 55). Collected were: a length of soft coarse-woven fabric like saddle-blanket material, twice folded into a 21 cm x 14 cm rectangle; an ob-

ject like an oval “boot” or cup of multiple sewn canvas layers, measuring 4 cm x 8 cm around and at least 11 cm long to a torn edge; and two sewn rags that weren’t oil-soaked. The preacher/cobbler who had a shoe repair shop in the hospital during the 1960s also worked on saddles, according to Jerry Willard, and perhaps the coarse fabric derives from his discards. The sewn canvas item is probably a commercially made recoil pad to fit the butt of a rifle or shotgun.

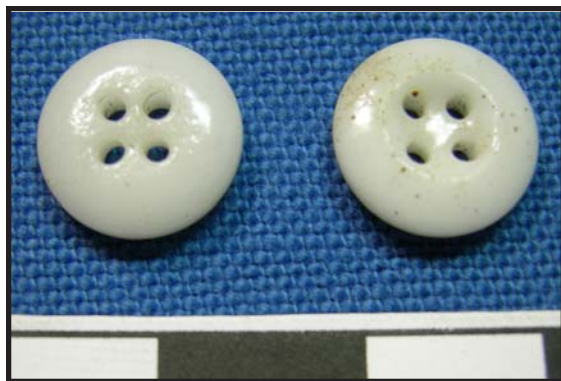
Figure 56. Two identical porcelain buttons were found in the midden.

Recovered from the main midden area were two identical white four-hole porcelain Prosser buttons (Figure 56), patented in 1849 and eventually manufactured in England, France, and the United States primarily for underwear, work shirts, and plain garments (Sutton and Arkush 2001:211). Also collected was one cuprous metal fastener of the sort that might be used for bib overalls was found, on which was stamped “STA’ ON” (see Figure 62).

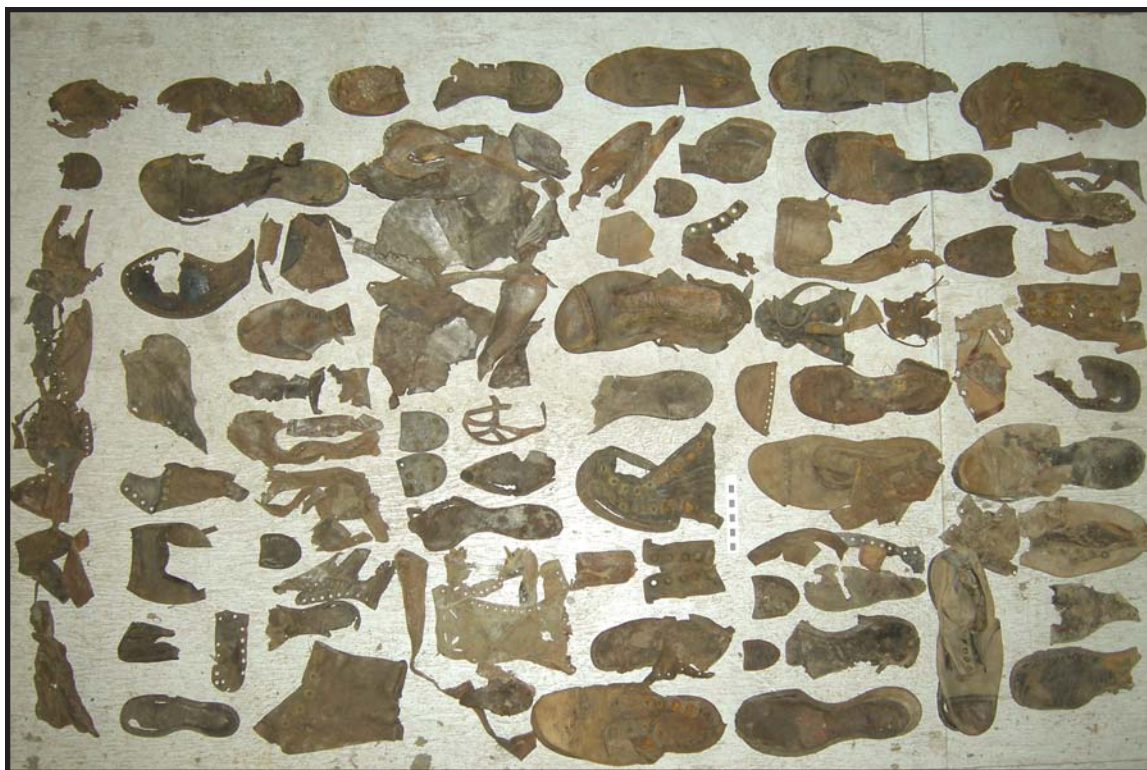
Figure 57. Many pieces of shoe leather were recovered from the midden exposures on English Road.

The volume of leather artifacts wasn't anticipated. The specimens were washed in water and dried, resulting in brittle leather and considerable delamination of the heels and soles. Counts of relatively whole soles were used as a rough quantification by recovery unit (Appendix H), and a sense of the volume of material is provided in Figure 57. The footwear assemblage holds more information than that realized in the following generalizations.

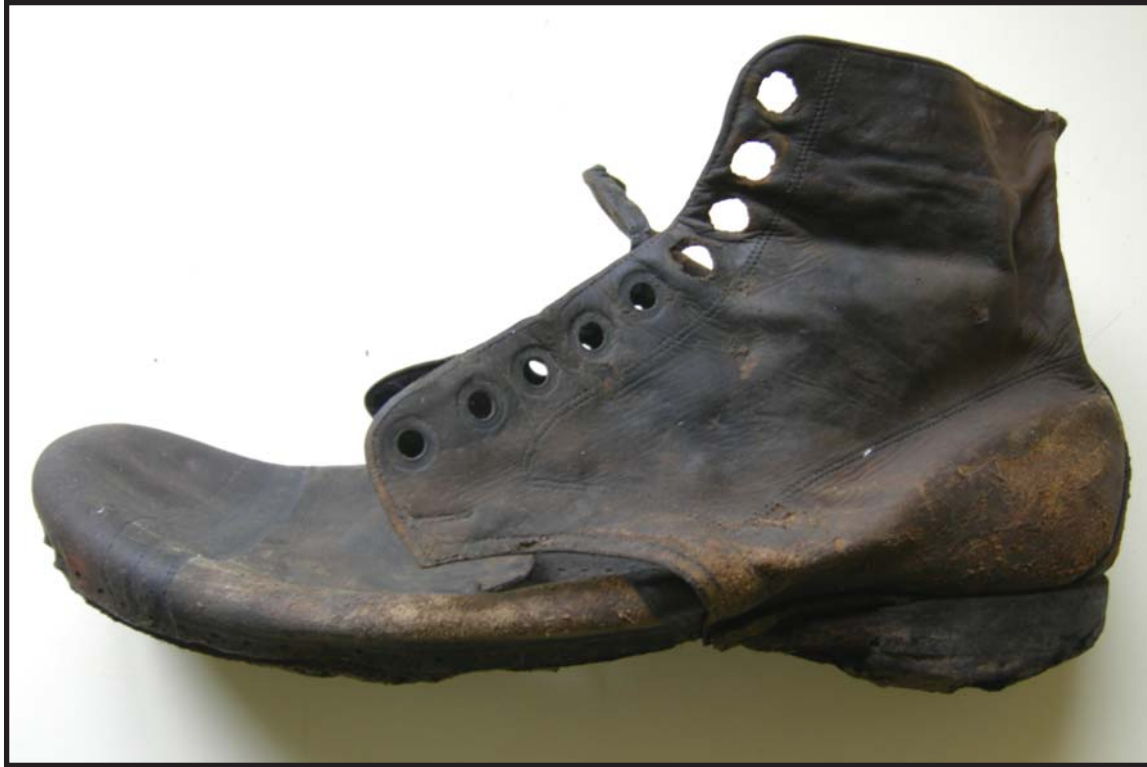
Figure 58. When reconstructed from the pieces found in the midden exposure, this boot style is little different from work boots worn today.

example, though there were a few exceptions and those specimens were tabulated along with the rest (Appendix H). Most of the shoes were broad and long and probably worn by men (Figure 58), though female footwear was suggested by a couple small heels, one small pointed-toe sole, and a latticed toe as if from a fancy sandal. One small heel was notable for having a thick copper plate affixed to it. Several soles were small enough to indicate a child's size.

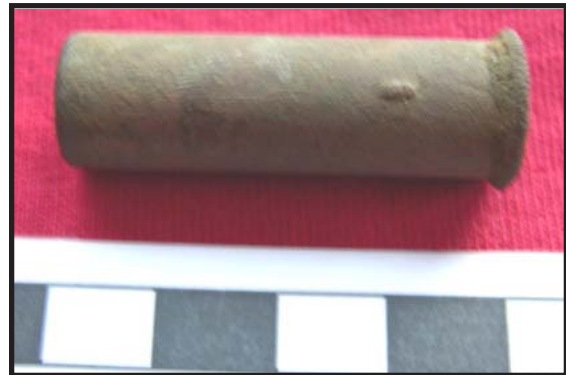
Figure 60. A lipstick (red) cartridge from the midden was initially mistaken for a firearm cartridge.

The lipstick applicator is of a cuprous metal, cylindrical, with an expanded base (Figure 60). At first it was mistaken for a firearm cartridge, but the bright red pigment inside and a small raised boss on the barrel of the item indicates it's true function.

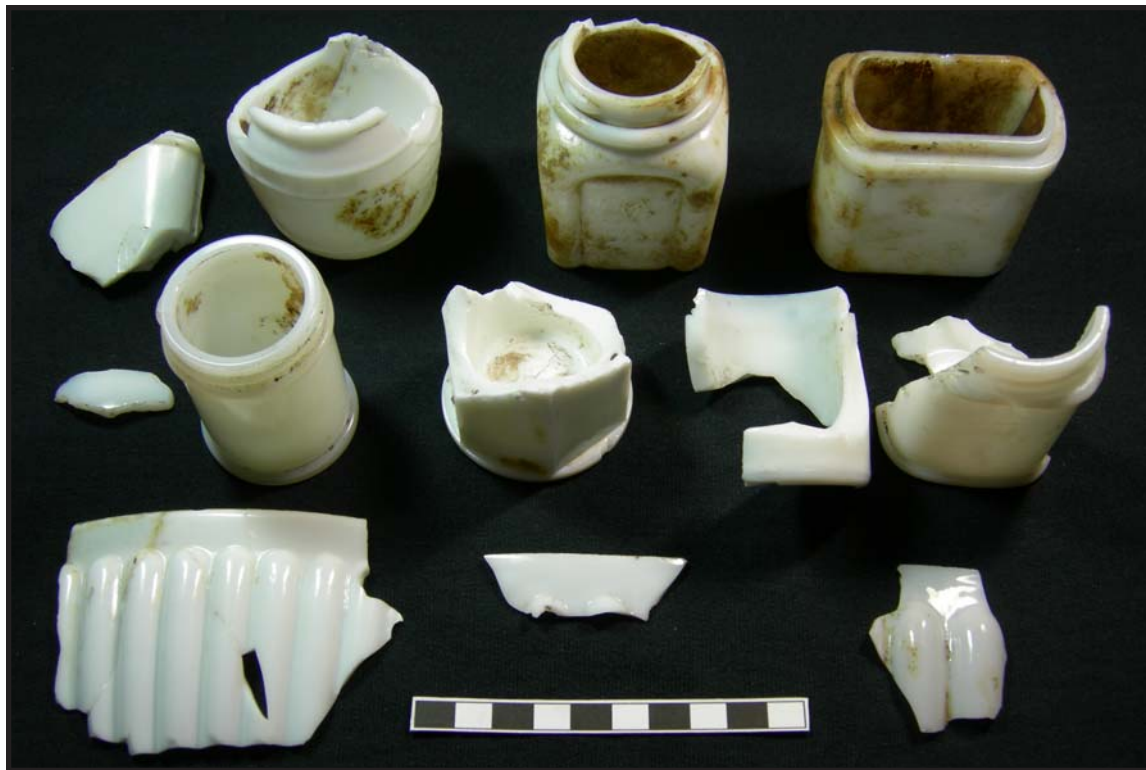
Figure 61. "Milk glass," or white glass, consisted of cold creme jars (top), and what may be parts of two ribbed light fixture globes (bottom).

The white glass collection is primarily from small jars, although one piece of white glass tile was recovered from disturbed contexts at the far west end of English Road, and several pieces of what may be a white glass light fixture were recovered from the main midden area. White glass is often called "milk glass" and is usually attributed to jars containing "cold cream" -- a skin softener. Because the jars are small and thick they are not so fragile, and seven specimens recovered at Seldovia are relatively complete (Figure 61). The jars are about six cm high and variously cylindrical, rectangular, square, barrel-shaped, and hexagonal with a round base. One square specimen with an indented panel on each side has embossed on one panel an elabo-

rate curvilinear symbol inside a double circle and the words "CREME Luxor" below it -- a product of Armour and Company of Chicago. A contemporary product review by Wiley and Pierce (1914:177-178) described the product as "the usual type of 'vanishing' cream containing glycerin and soap...a good product still handicapped with extravagant claims such as 'rejuvenates,' 'healing,' though former labels implying skin nourishment have been withdrawn." The barrel-shaped specimen is embossed with the words "Luxor COLD CREAM" -- another Armour and Company product, described by Wiley and Pierce (1914:178) as "a white petrolatum and wax product, of good quality, perfumed..." The complete cylindrical specimen has embossed on its base a "H" straddling an "A".

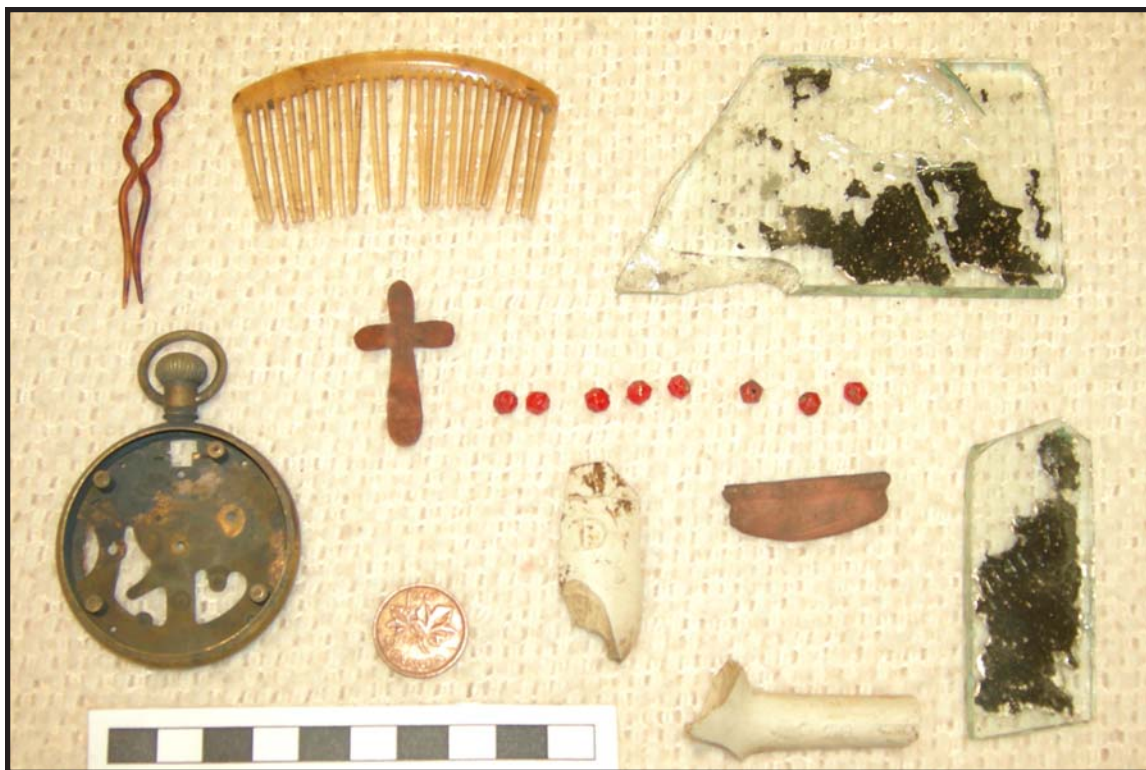
Figure 62. Personal grooming and hygiene articles from the midden included two mirror fragments, two hair barettes, and eight red glass beads; also found in the midden were two clay pipe fragments, a copper cross, a suspender clip, a 1968 Canadian penny, and (from Alder Street) a pocket watch.

commercially made items (Figure 62). The mirror fragments are from a thick silvered glass; several other fragments were also noted but only these two were collected (Figure 62).

Included in the miscellaneous personal category is the copper cross found in Midden Exposure 1, two fragments of a clay pipe, a Canadian penny, and eight glass beads. The brass side and back to a pocket watch is illustrated (Figure 62), but it was actually recovered by a construction worker from the water trench at about Station 5+00 on Alder Street, and is thus not from the midden as spatially defined here and may even be from fill. The small cross is cut from thin copper sheet less than 1 mm thick; a small strip of the same material was found in the Bag 35 area along with the two-pronged hair barrette. The copper cross is of note in that -- though the find spot under English Road is in

Eight faceted opaque red glass beads were recovered from the main midden exposure: one from the Bag 35 area and seven from the Bag 39 area (Figure 31). All were tarred with coagulated fuel oil (Figure 62). Each had a 0.7 mm diameter hole and a distance of 4.2 mm from hole to hole. When viewed through the hole the beads had a pentagonal form, for a total of 22 facets counting the opposing two with holes. A quick perusal of some bead references (Bundy 1998; Ross 1990; Kidd and Kidd 1970) didn't turn up comparable specimens.

The two clay pipe pieces consist of a stem fragment and a bowl fragment; though they don't co-join, they are likely from the same pipe (Figure 62). The pipe's heel, commonly the place where pipe makers imprinted their mark in the clay, is missing from either fragment. In-

stead there are four impressions on the bowl and stem. On one side of the stem fragment, transected by the break, is the impression “_AND” in thick block letters, while on the opposite side is the truncated “W.W H_” (perhaps the second W is actually N) in an even blockier font. That opposite side also has been separately stamped “C 78.” The bowl has a fancy “D” impressed on it (Figure 62). The D more or less matches the D of what are known as “T.D.” pipes, made by McDougall of Glasgow, Scotland, according to Dixon (2005:114), so the “_AND” may be the end of the word “Scotland.”

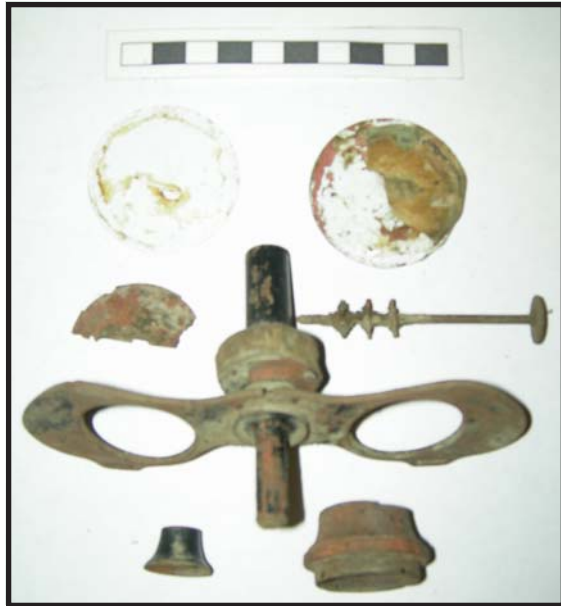
Figure 63. Parts of what are thought to be binoculars were found in the main midden area.

At first the binoculars were thought perhaps to be the remains of a stereo-optican -- a late Victorian parlor luxury consisting of two lenses in a holder in which a stereo postcard could be inserted for stereo viewing. However, Robert King, an Alaskan archaeologist for the Bureau of Land Management and author of the recent book “Postcards from Alaska: Souvenir Pictures of the Last Frontier, 1890s-1940s,” inspected a picture of the artifact and was able to say that the specimen is definitely not a stereo postcard viewer. Given its heavy duty brass frame and gear assembly, it is probably a pair of binoculars (Figure 63). The two clear glass round disks were actually found about six feet away from the metal parts, but I think they are from the same article.

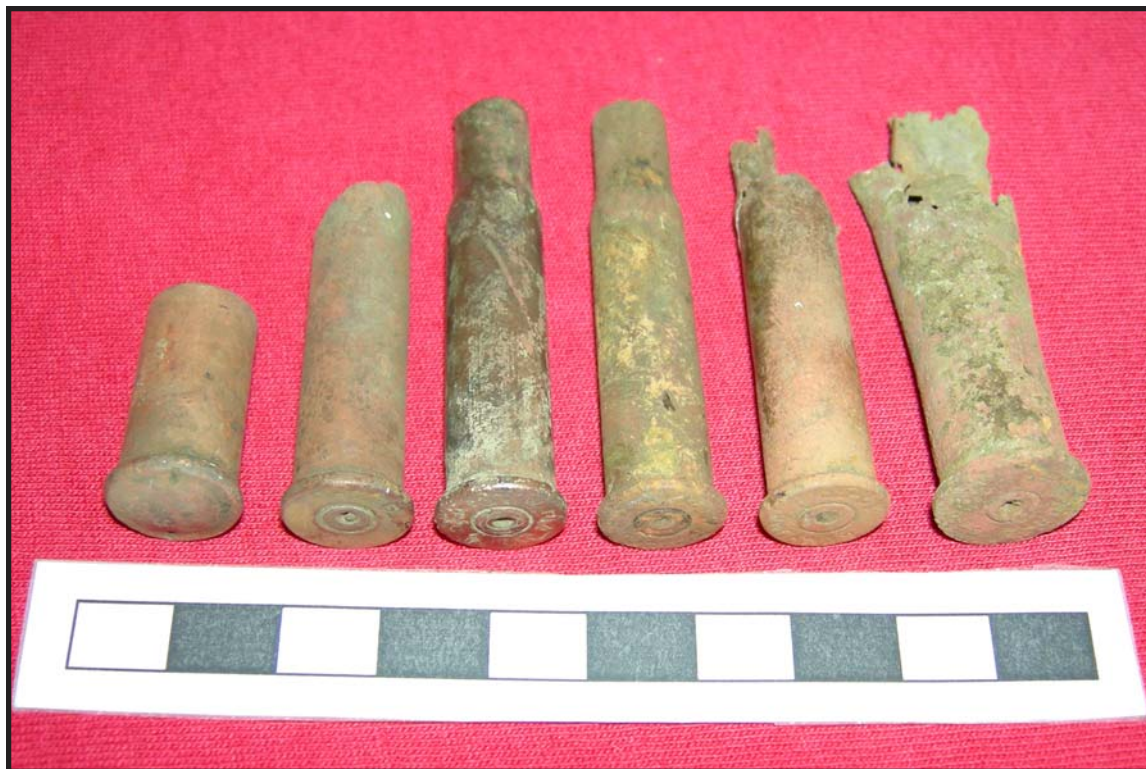
Figure 64. Cartridges recovered were from left to right: double-rimfire, .32 Special, two Winchester 30-30, unidentified, and a .50 caliber specimen.

processing. Three cartridges were recovered from the main midden area, and three came from Midden Exposure 1. Maker's marks and calibers are not legible on some specimens. Midden Exposure 1 produced the case from a .32 centerfire marked "32 SPL" and a rimfire showing two opposed firing pin marks without case markings but having an outside diameter of 1.08 cm -- equal to a .44 caliber. In a historic site on the Kenai Peninsula McMahan and Reger (1997:25-26) found two such cartridges, matching in length (2.34 cm), material (copper rather than brass), and in one case a bulge resulting from expansion of the metal against the gun's receiver during firing, leading them to suggest that they could have been fired from a Winchester Model 66 between 1866 and 1880. Midden Exposure 1 also contained a Winchester Repeating Arms Company 30-30 marked "WRA CC 30 WCF." Another identical Winchester 30-30 case was found in the main midden, along with a Remington ("REM-UMC") case of un-

determined caliber and a large case of approximately .50 caliber (Figure 64).

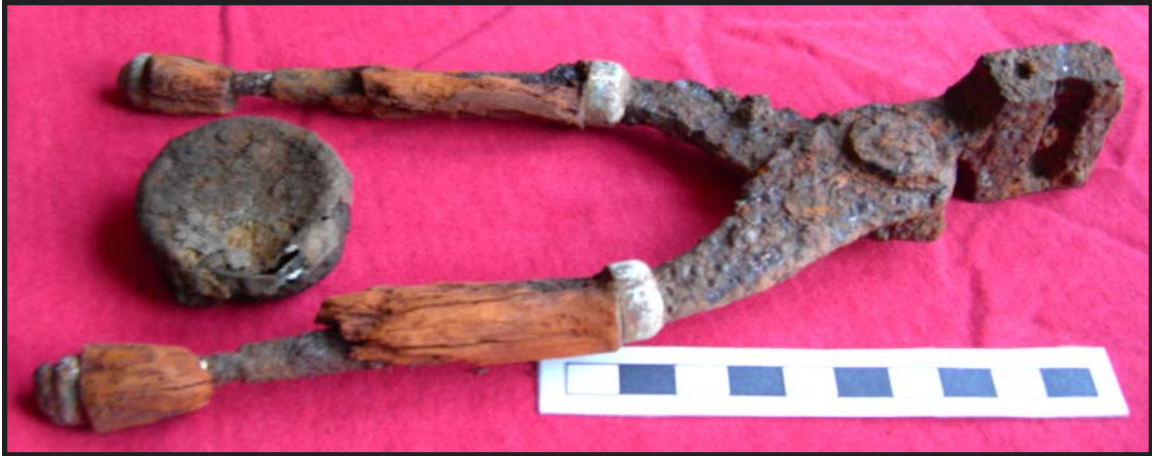
Figure 65. A rusty bullet mold for a 9 mm bullet was found , along with a small round metal friction-fit tin of the sort often used for centerfire primers and percussion caps.

A small cylindrical ferrous metal box measuring 4.0 cm in diameter and 1.4 cm deep, was found in an artifact concentration in the Bag 37 stretch of English Road (Figure 31). The container was empty and rusted through on one side, and too fragile to consider twisting open the two friction-fit halves. I suspect it was manufactured and sold as a container holding centerfire primers or percussion caps for a muzzle-loading firearm. Despite the availability of breach-loading firearms, muzzle-loading firearms and equipment were sold by Sears, Roebuck and Company and Montgomery Ward and Company at least to the very end of the 1800s

The bullet mold is a hand-held contraption like a pliers with the bullet cavity formed where the bite of the pliers would be (Figure 67). The artifact is of ferrous material except for the two handles -- which had wood grips and pommels of a nonferrous metal. The artifact is rusted into an open position, and the bullet mold cavity is also rusted. The sprue-cutter that would have sliced off the the unwanted lead casting protruding from the pour hole is gone, but the hole with which it was attached is evident. It would appear that the mold would have produced a round-nosed 9 mm projectile, 2.6 cm long, with five bands cast around its base.

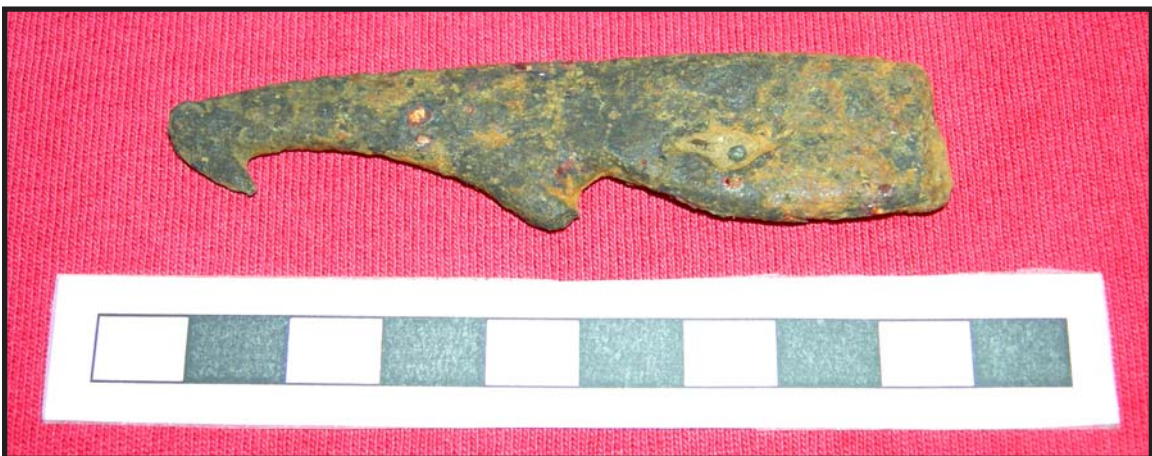
Figure 66. A ferrous metal object with a double barbed side profile may be part of a harpoon used in sea mammal hunting, or it could be part of a sliding latch system, or possibly a spanner wrench.

The last item to be classed as hunting-related is a ferrous metal object with a double barbed profile, like a harpoon (Figure 66). If it is a harpoon, it's base must be broken, since there is no line hole or other necessary means of attachment. It's possible to imagine the object as the catch mechanism to a sliding latch system, but again it must be a fragment because there is no hole or other means of attachment. Thirdly, it could be the end of a spanner wrench.

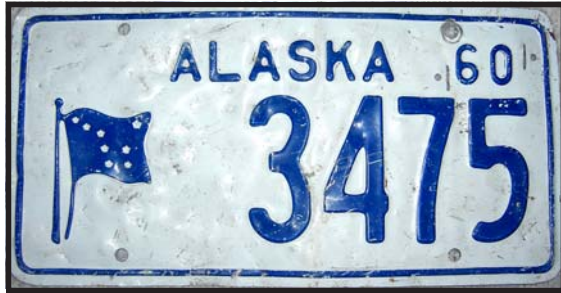
Figure 67. A 1960 Alaska license plate was found in the sod at the edge of Alder Street.

A 1960 Alaska license plate (Figure 67) was recovered from the near-surface along Alder Road, outside of the historic midden area.

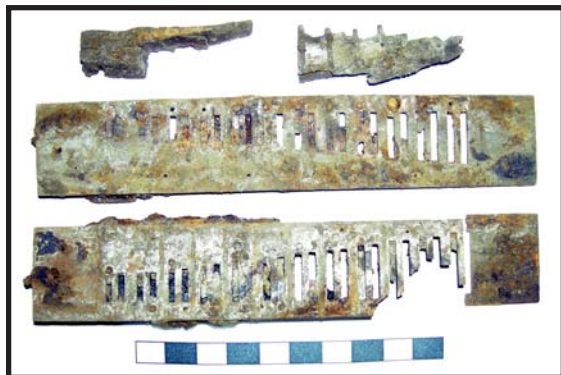
Figure 68. The midden beneath English Road also produced this harmonica.

the midden consisted of the two brass reed elements and part of the wood between, but the ferrous metal parts were gone (Figure 68). One brass reed element was in two pieces, and most of the individual reeds on both elements were corroded away. There are 24 reed elements and the specimen's length is 2.8 cm x 15.3 cm -- indicating a long harmonica that would have had a two-octave range.

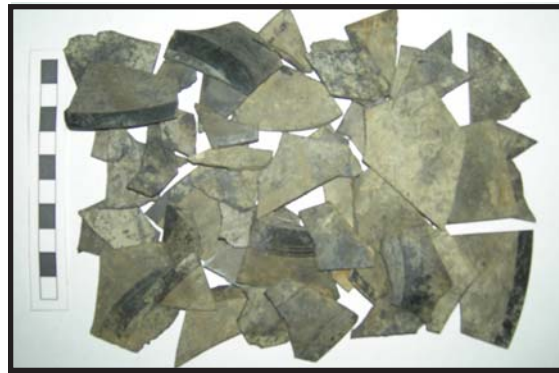
Figure 69. One small area of the main midden produced 55 pieces of a 33 1/3 vinyl record.

The second music-related artifact is a collection of 55 friable vinyl fragments from a 33 1/3 record (judging from the rim curvature). The largest piece was 4cm x 6cm (Figure 69).
