Archaeological Monitoring for Sewer and Water Improvements Seldovia, Alaska

**Archaeological Monitoring
for Sewer and Water Improvements,
Seldovia, Alaska**

Charles M. Mobley

2008

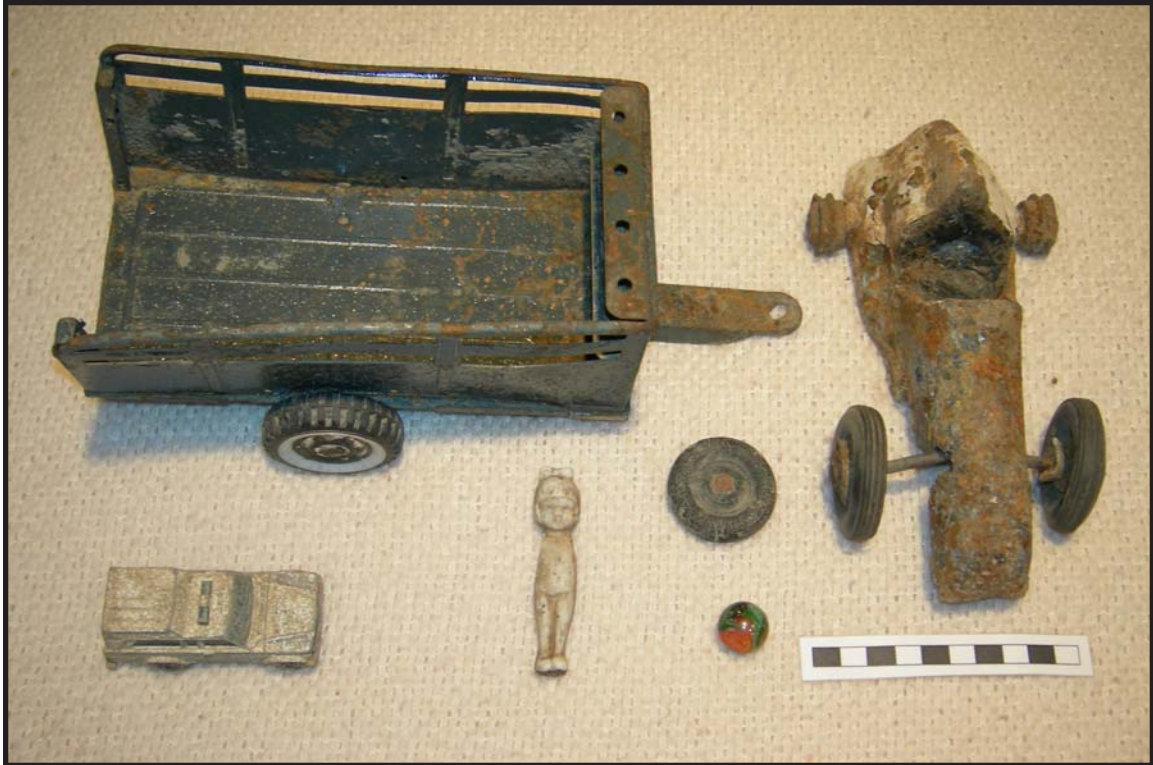
Figure 70. Several toys were found in the midden excavation and in surface and near surface contexts at the corner of English Road and Alder Street.

in the excavations at the intersection of English Road and Alder Street was a multicolored opaque glass marble 1.7 cm in diameter; it is accompanied in the illustration (Figure 70) by a metal toy trailer found on the surface nearby.

The English Road midden excavations also produced children's toys. These included a small (7.4 cm x 1.6 cm) ceramic doll with a hole through the body where movable arms would have been inserted (Figure 70). The doll is female and has a bow centered on her head. On the back in block letters is stamped "JAPAN." A flesh-painted porcelain shard that looks like an egg fragment is probably part of a doll's head, while another porcelain shard represents the torso of a human figurine (Figure 71). A corroding ferrous toy race car, painted white and with a wire front axle featuring rubber tires, was recovered minus its back axle (Figure 15). A rubber tire to a slightly smaller toy vehicle was also found in the midden (Figure 70). A small (7.4 cm long) but complete toy ambulance of

pot metal (Figure 70) was recovered, embossed on the bottom "AMBULANCE," "ECH 1/64," "No 269," and a word or name in unfamiliar characters probably relating to the manufacturer.

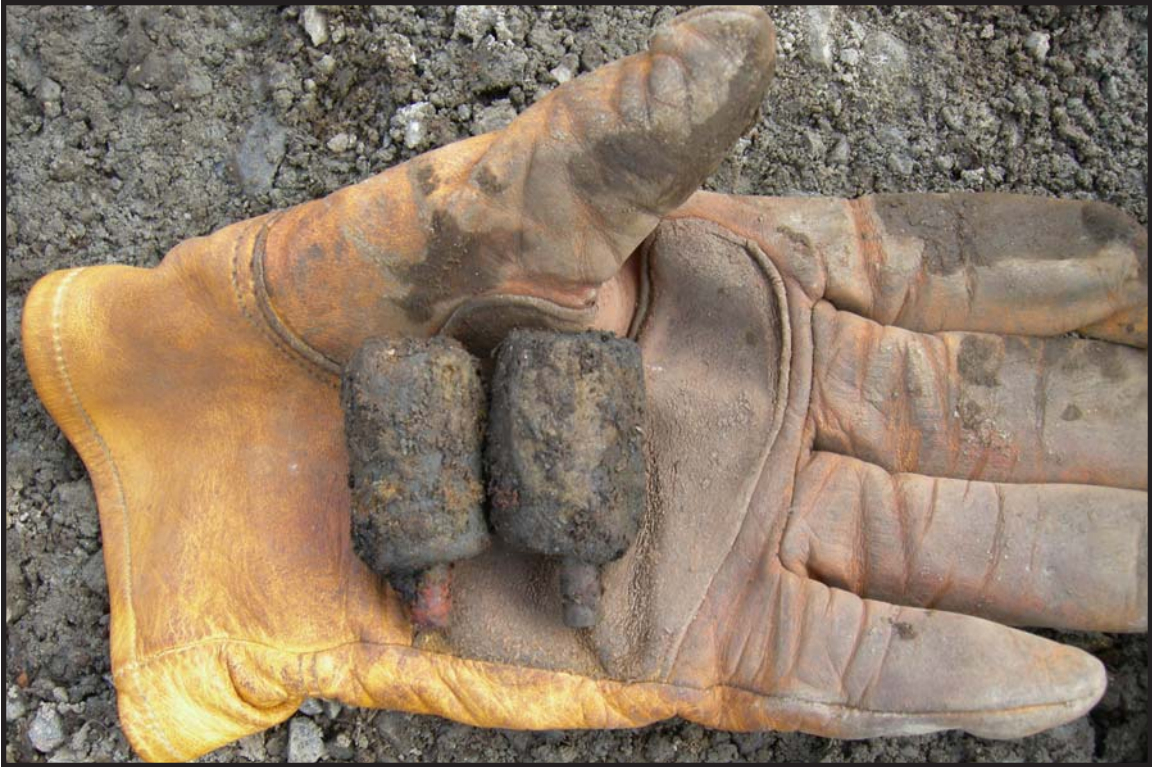
Figure 72. Several corroded batteries like these D cells were noted in the excavation backdirt, photographed, and discarded.

batteries and metal scrap. The remains of batteries included several rotting D cells were recovered from the main midden (Figure 72), and the carbon cores (15 cm x 2.2 cm) from two larger batteries were found in archaeological testing at the northwest corner of Seldovia and Alder Streets.

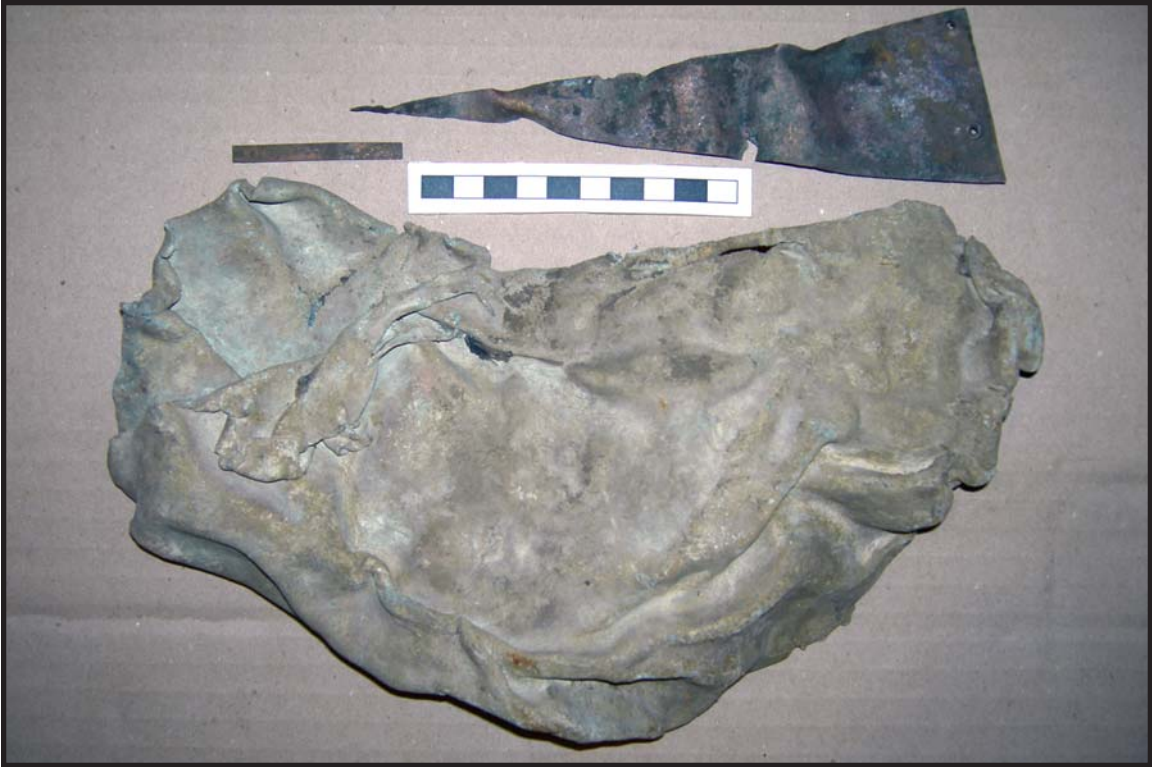
Figure 73. Pieces of scrap metal recovered from the excavations include a large chunk of lead sheet, a triangular scrap of sheet copper, and a thin strip of copper.

Three pieces of scrap metal came to light (Figure 73), besides the metal pipes that

were scavenged by the construction crew, and all three were saved. A large chunk of folded lead sheet was recovered from the utility excavation to SEL-335 -- the old hospital. A triangular piece of sheet copper, perhaps a scrap of roof flashing, was recovered from the midden. And a small strip of copper of the same gauge as the copper cross (Figure 62) was also found in the midden.

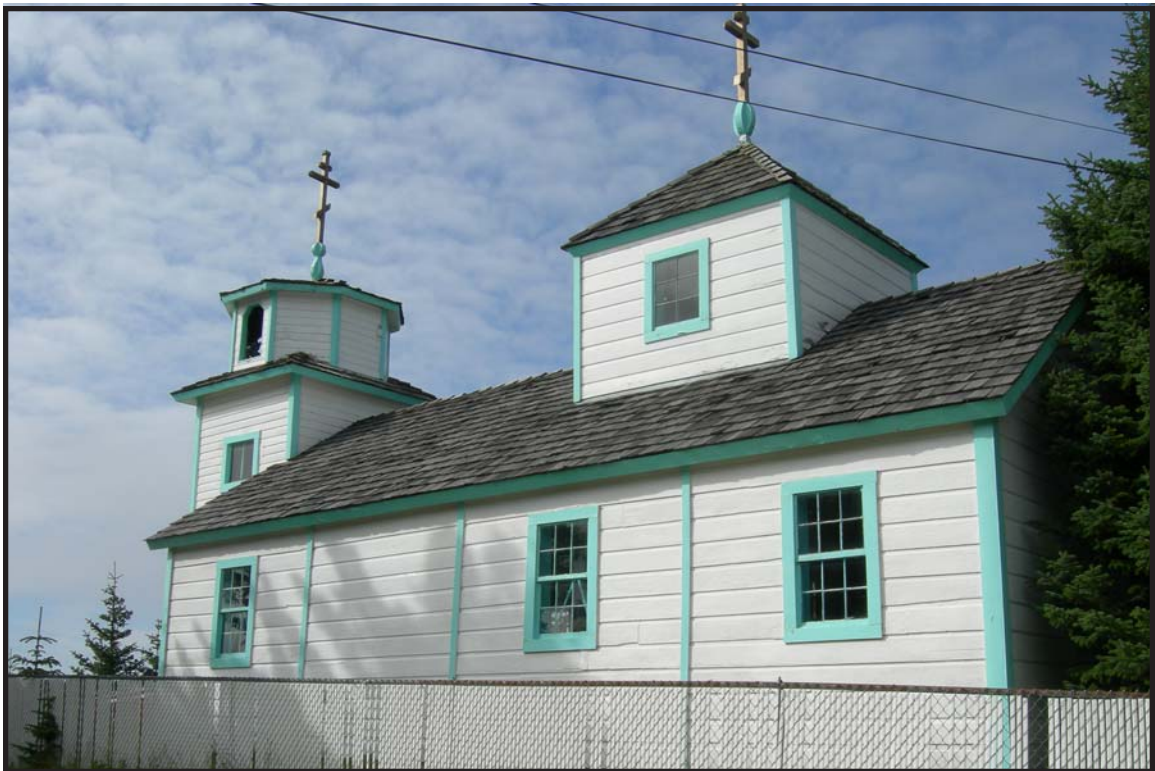
SEL-023. Most of the Russian Orthodox church was built by 1891; the front tower was added by 1906.

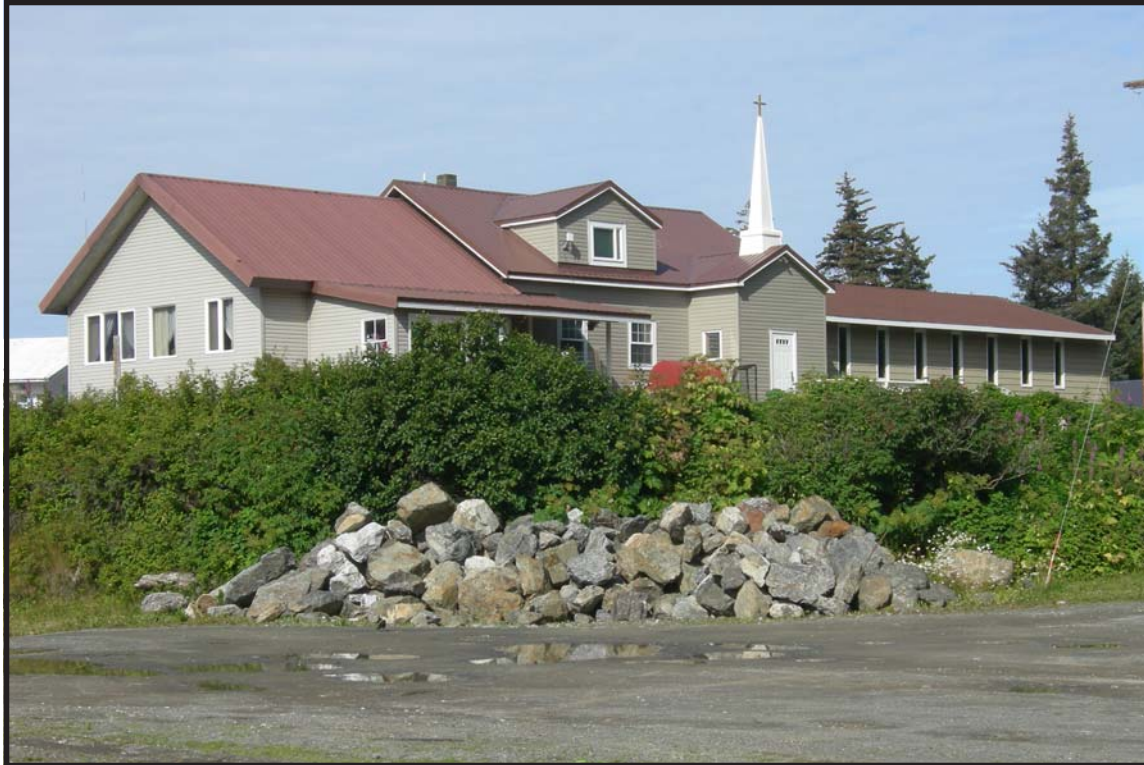
SEL-331 (Springer's #1). The narrow central block of the Seldovia Bible Chapel "was built in 1944 by Rev. George Tobleman and reputed to have the strongest concrete in town." The north (right) wing was built in the 1970s, the south (left wing) was added later.

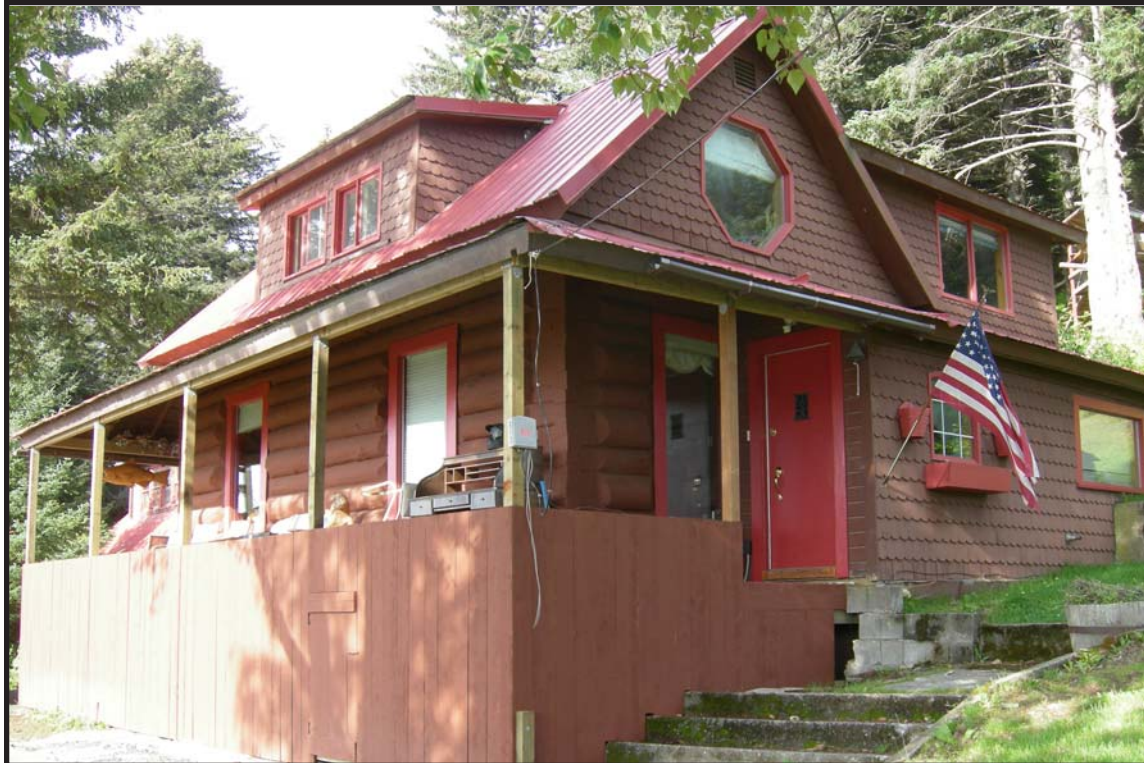
SEL-332 (Springer's #4). "The log portion was built about 1915 by one of the Balishoff brothers from Kenai....Recent remodeling has revealed that the rest of the house was built over a two-year period from 1920 to 1921, for and first occupied by Ralph and Juanita Anderson."

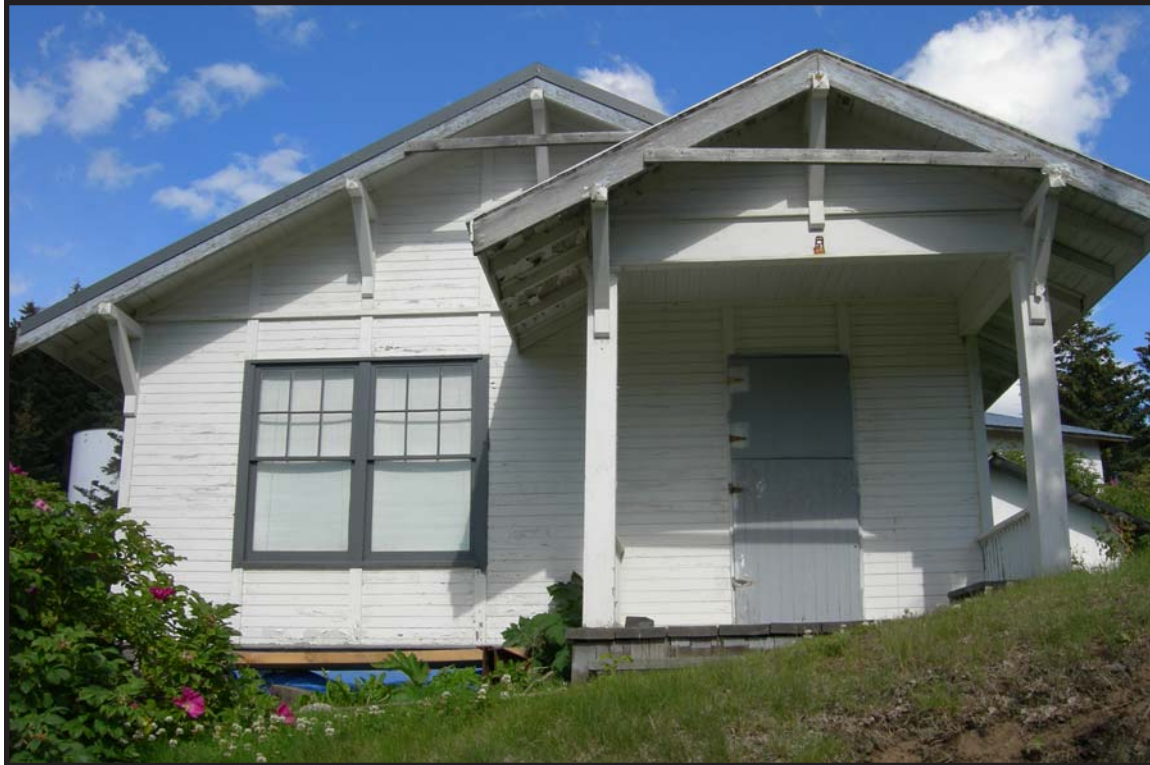
SEL-336 (Springer's #8). The Winfree home was "a 1928 Sears mail order house...with the assembly instructions in Danish. However, with the numbers of Scandinavian fishermen living in Seldovia, translation was readily available. It was built for the late Winnie Zawistowski and her first husband."
