# **Hazardous Materials Assessment**

City of Homer, Public Works Department,
Homer Education and Recreation Complex (HERC) 1 Screening,
Homer Education and Recreation Complex 1 (HERC1),
450 Sterling Highway,
Homer, Alaska 99603

Assessment Date: May 05-06, 2023

Report Date: July 25, 2023

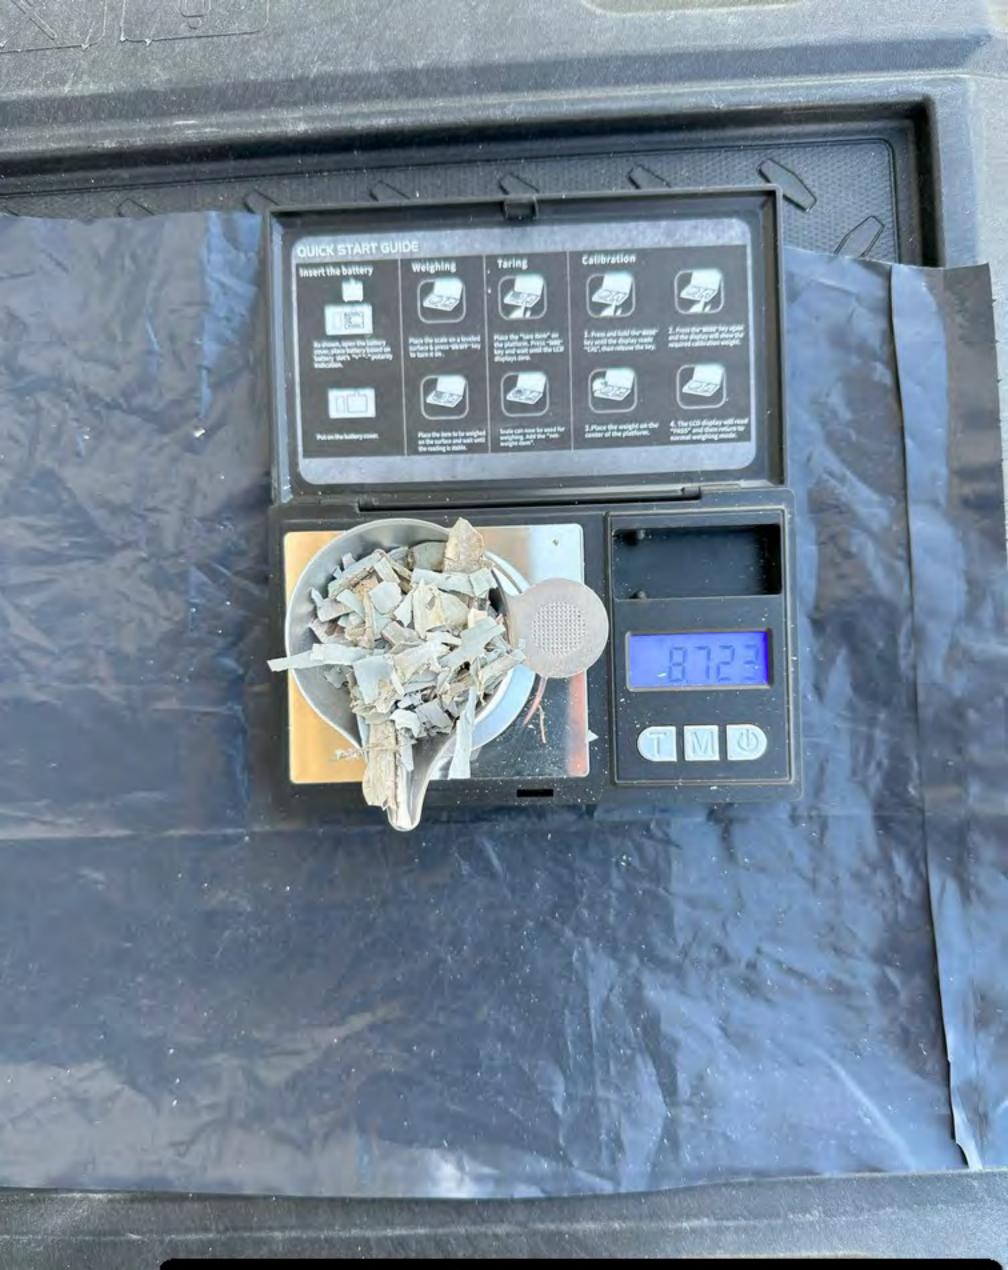
260; 2023-05-05 11:10

HERC1-0523-P22	Grey paint on exterior window trim, sills, and casings	Some wood splinters from the substrate and dirt are in the sample	West exterior of Room 105 from wood window casing	8.7	Paint	259, 260	05/05/2023	11:10	
HERC1-0523-P23	Beige paint in janitor closet outside of Men 119	Some wood shavings and splinters from the substrate are in the sample	From the wood column near the middle of the janitor closet outside of Men 119	8.1	Paint	302, 303	05/05/2023	16:58	
HERC1-0523-P24	White paint on interior "Marlite" wall panels	None noted	In corridor at entry to Room 105, duplicate sample P34 collected from same location	8.2	Paint	324, 325	05/06/2023	12:41	
HERC1-0523-P25	White paint on exterior foundation walls	Some dirt is present in sample	East exterior of Room 110 on foundation wall	8.0	Paint	253, 254	05/05/2023	10:29	
HERC1-0523-P26	White paint on corrugated metal siding	None noted	West exterior of Room 105	9.4	Paint	257, 258	05/05/2023	11:01
