# AGENDA ITEM REPORT

**Ordinance 23-12, An Ordinance of the City Council of Homer, Alaska Amending the FY23 Capital Budget by Appropriating \$63,070 from the Port Reserves Fund for Professional and Technical Assistance to Support Submission of a Port Infrastructure Development Program Grant Application for the Purpose of Float Replacement in the Small Boat Harbor. City Manager/Port Director.**

## System 1 Condition Report

*City of Homer*  
**Homer Small Boat Harbor  
Float Condition Assessment**

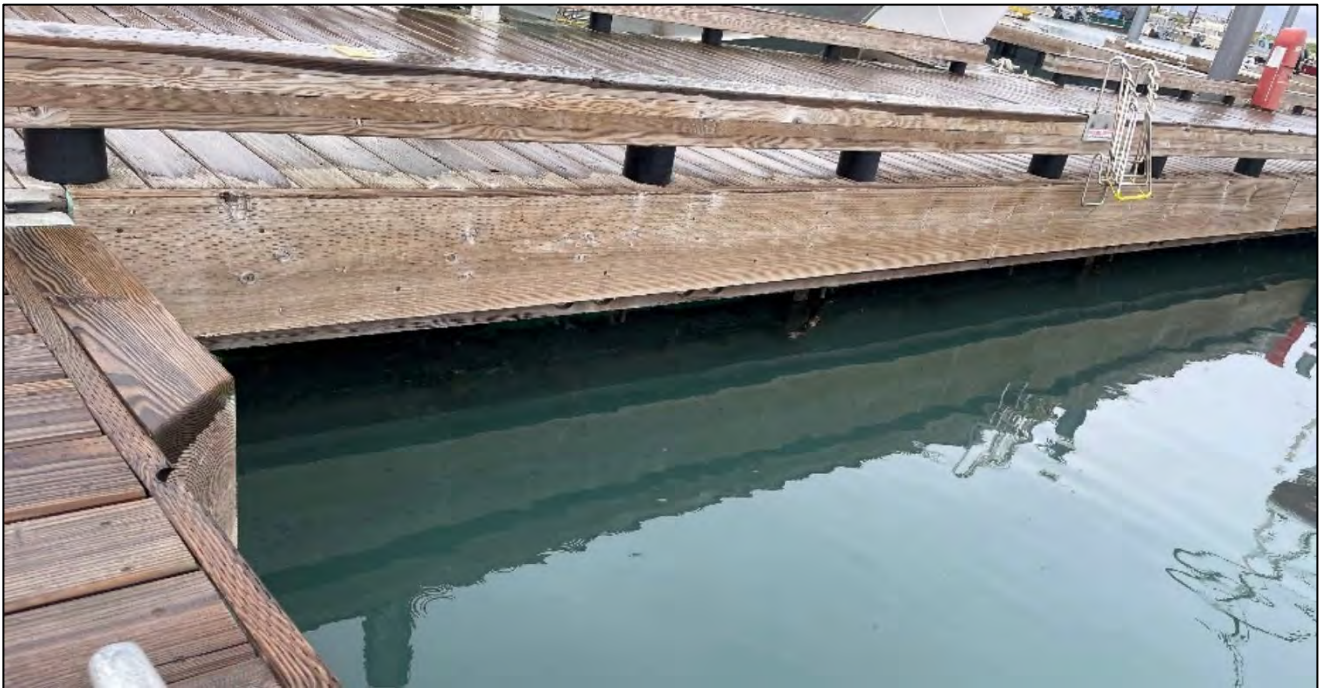
Figure 2.9: Timber floats have sufficient freeboard and reserve flotation.

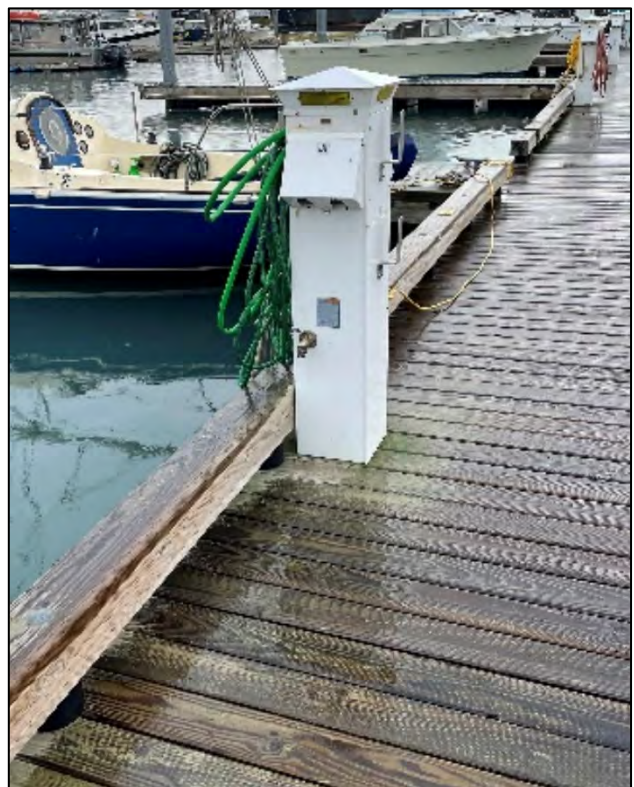
Potable water is piped within or under the floats and hose bibs are located periodically on the edge of the floats (Figure 2.10). J Float is equipped with power (combined water/power pedestals) at each stall as shown in Figure 2.11. There is no power service available on R Float or S Float.

Figure 2.11: Typical combined power and water pedestal (J Float).

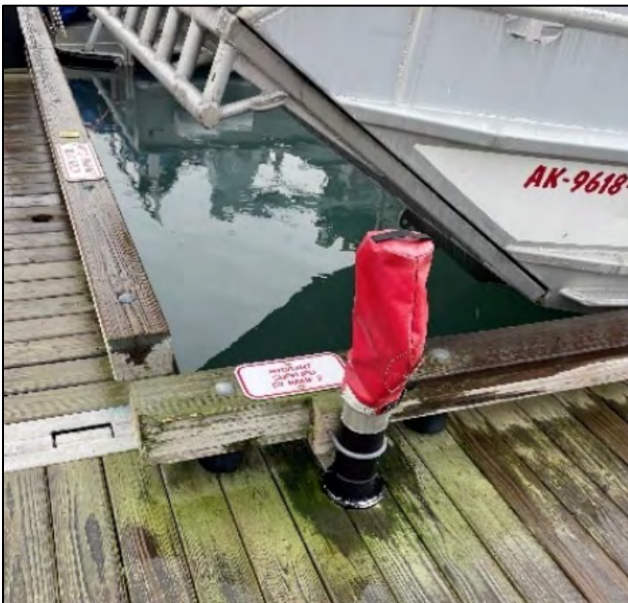
Fire suppression systems include fire extinguishers placed on the floats as well as a dry standpipe fire suppression system with an upland charging station for Fire Department use. According to the National Fire Protection Association (NFPA) 303 “*Fire Protection for Marinas and Boatyards*”, the fire suppression system appears to be inadequate because the above-water piping is HDPE which is not fire-resistant (Figures 2.12 and 2.13). A failure in part of the piping system due to melting during a fire could render the system useless or worse cause delay in fighting a fire. The above-water HDPE pipe should be replaced with metal pipe or it may be possible to install a suitable fireproof cover sleeve.

Figure 2.12: Fire suppression system standpipe/hydrant near J Float

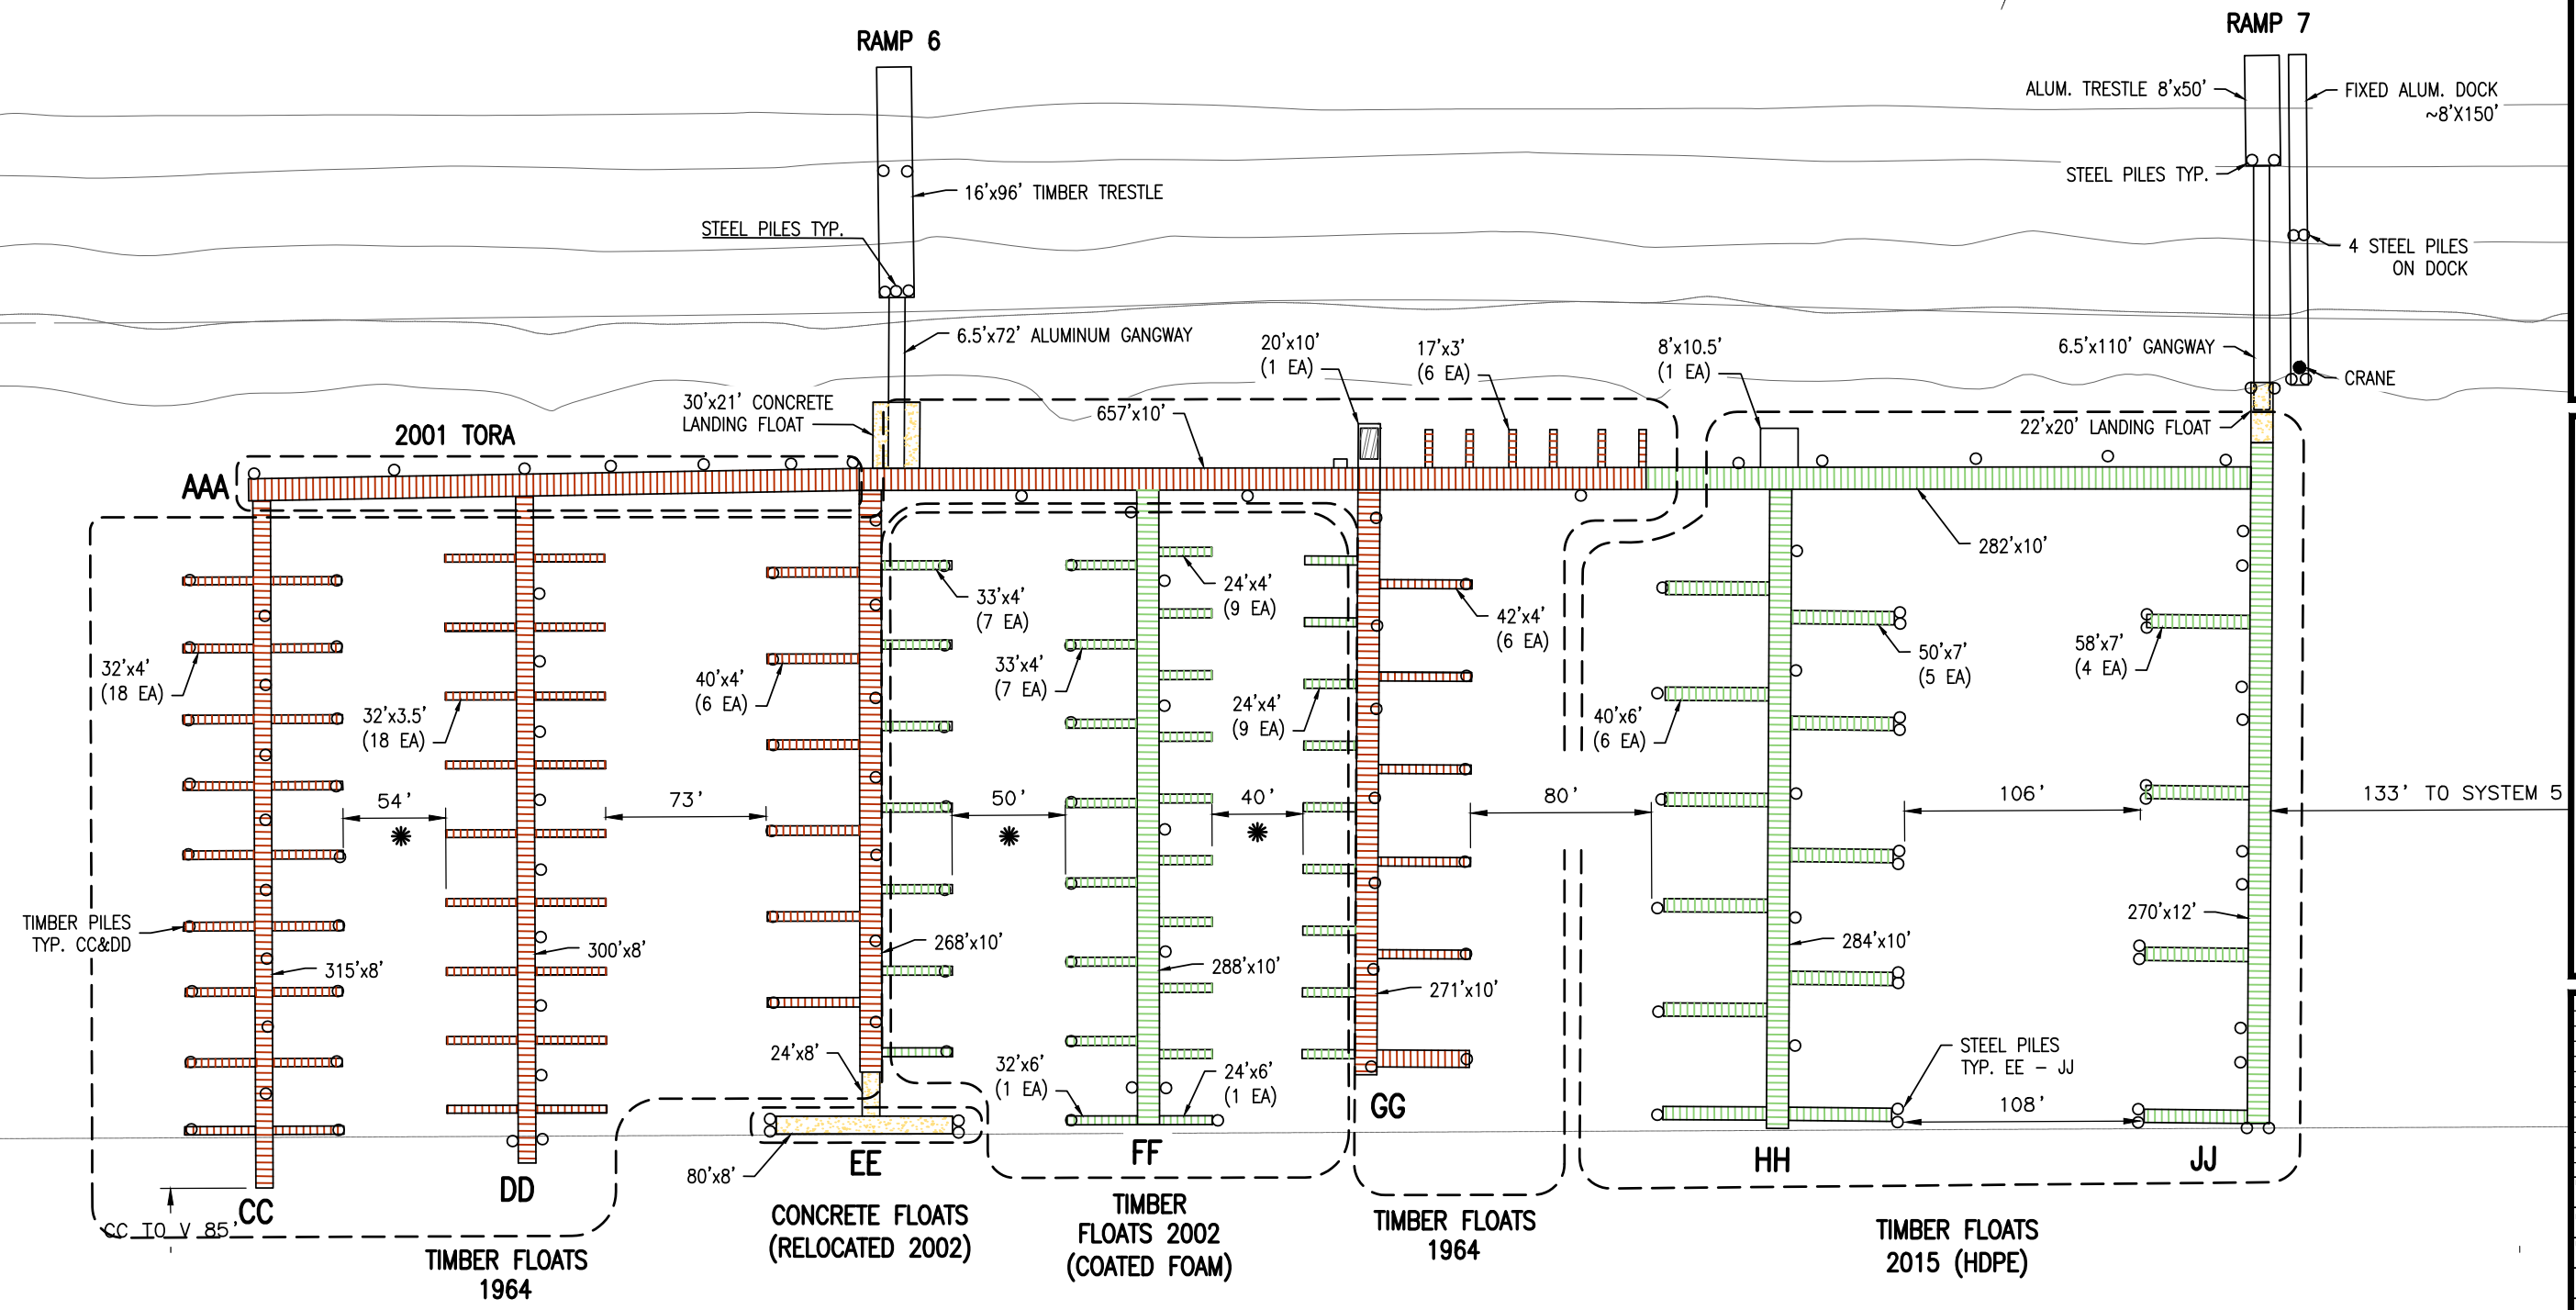
**1 SYSTEM 4 SITE PLAN**  
 Scale: NTS

- NOTES:**
- \* DENOTES FAIRWAY WIDTH IS LESS THAN THE MINIMUM REQUIRED PER STANDARD (1.5 X LONGEST SLIP LENGTH).
  - \* DENOTES FAIRWAY WIDTH IS LESS THAN IDEAL PER STANDARD (1.75 X LONGEST SLIP LENGTH).
