Report of Investigation 2022-5

COASTAL BLUFF STABILITY ASSESSMENT FOR HOMER, ALASKA

Richard M. Buzard and Jacquelyn R. Overbeck

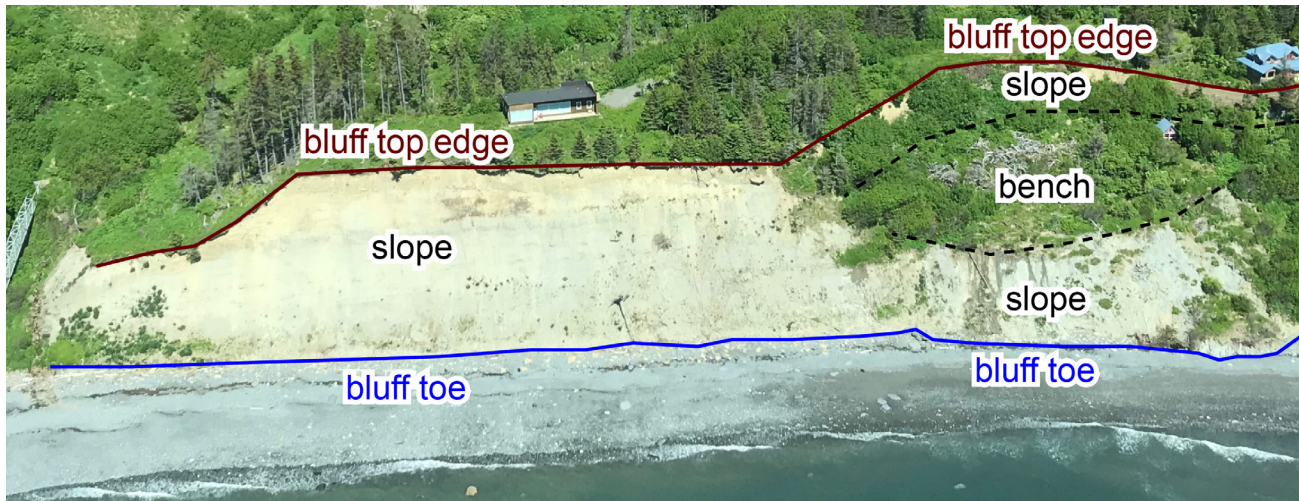
Figure 3. Oblique image of a coastal bluff with delineated toe (blue) and top edge (maroon). The right side shows how delineations are made for a complex section. The bluff has a bench (black dashed lines), so the delineated top edge is landward of this bench. In this example, there is a building on the bench that is seaward of the bluff top edge (far right side).

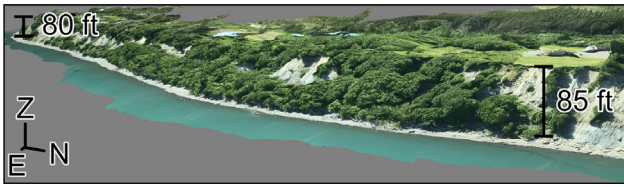
The coastal bluffs along Kachemak Drive have low combined instability. There is relatively slow erosion to stable shorelines, and the area with the greatest erosion is now protected by gabion seawalls. The bluffs average 55 ft (17 m) tall with slopes around 35 degrees (73 percent). Some sections of the bluffs are densely vegetated, others exposed (fig. 14). No major streams run through this area. There are still some areas with medium to high instability due mainly to steepness, height, and lack of vegetation. Overall, this region has the second lowest instability score (table 13). Although erosion rates are slow, some structures are very close to the bluff edge.

Figure 14. Looking west toward the partially vegetated bluffs near Kachemak Drive in the oblique image-derived 3D model.
