Homer Small Boat Harbor

System 4 Condition Report

Prepared by:
Kimberly Nielsen, PE
R&M Consultants Inc.
9101 Vanguard Drive
Anchorage, AK 99507

System 1 Condition Report

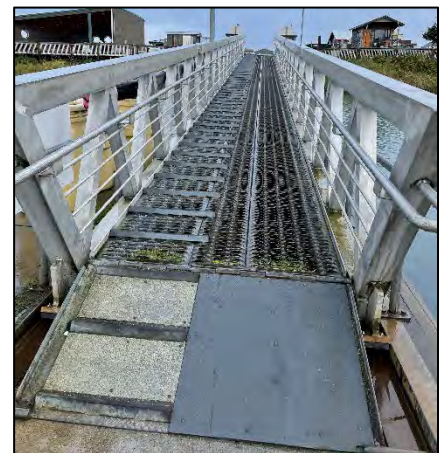
Ramp 1 and Ramp 2 trestles are constructed of creosote-treated timber, with timber support piles and timber cross bracing. Steel piles have been installed at the end of the trestle to support a 74-ft long aluminum gangway ramp. The steel piles and steel floor grating and landing tracks on the gangway have evidence of corrosion but otherwise only minor damage was found (Figure 2.1). In general, the steel grating on the gangways does not meet ADA-accessibility guidelines. Gangways must be at least 80-ft long to meet current ADA requirements and there must be at least one ADA-accessible route for each size slip in a public harbor (the quantity of ADA-accessible slips required varies depending on the size of the harbor). Ramp 3 was rebuilt in 2013 and includes steel pile and treated timber trestle and a covered gangway that is 100-ft long and provides access to all the various slip sizes available throughout Homer Harbor. Because of this, an

Figure 2.1: aluminum gangway with steel floor grating and landing tracks

ADA gangway is not required at some of the other locations. However, we recommend that any new project that replaces a trestle, should consider providing a new 80-ft or longer covered gangway with flooring that meets ADA.

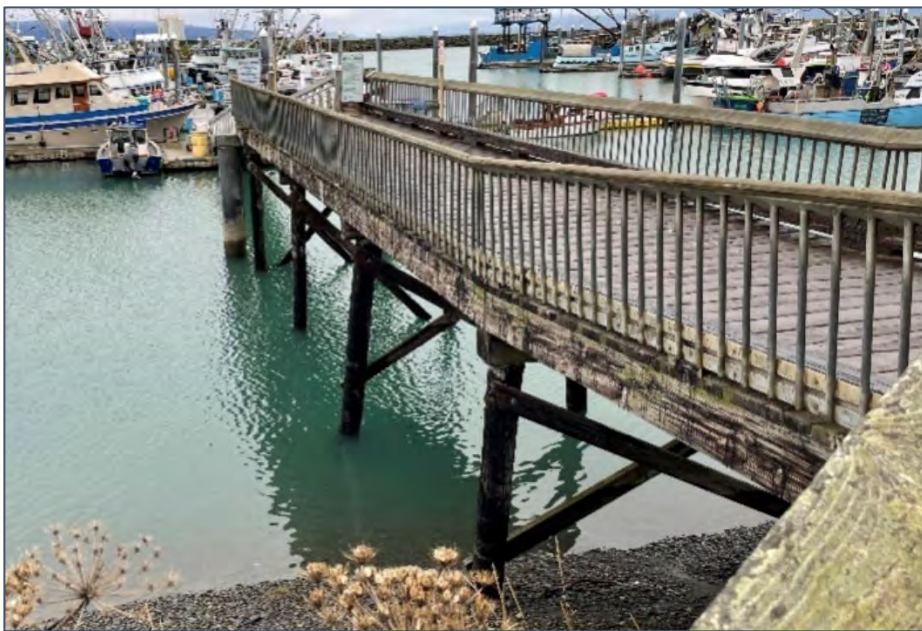
The decking and bullrails on the two trestles have evidence of deterioration due to wear. The timber support piles have moderate section loss and minor splits and gouges. Timber support piles have timber cross bracing (Figures 2.2 and 2.3. Some of the cross bracing has major deterioration, some boards are missing, and hardware located in the tidal zone is partially corroded (Figures 2.2 through 2.5). Note that the trestle decks on both Ramp 1 at Ramp 2 appear to have a dip—where it changes from a sloped deck to a level deck. Handrails appear to be a later addition to these trestles. Embedment depths on the timber piles is not evident, but timber harbor piles of this time period in Alaska were not typically driven to depths sufficient to withstand heavy axial or seismic/lateral loads, especially without relying on the cross bracing. If not already, vehicle access to these trestles should be restricted.

Figure 2.2: Ramp 1 timber pile supported trestle.

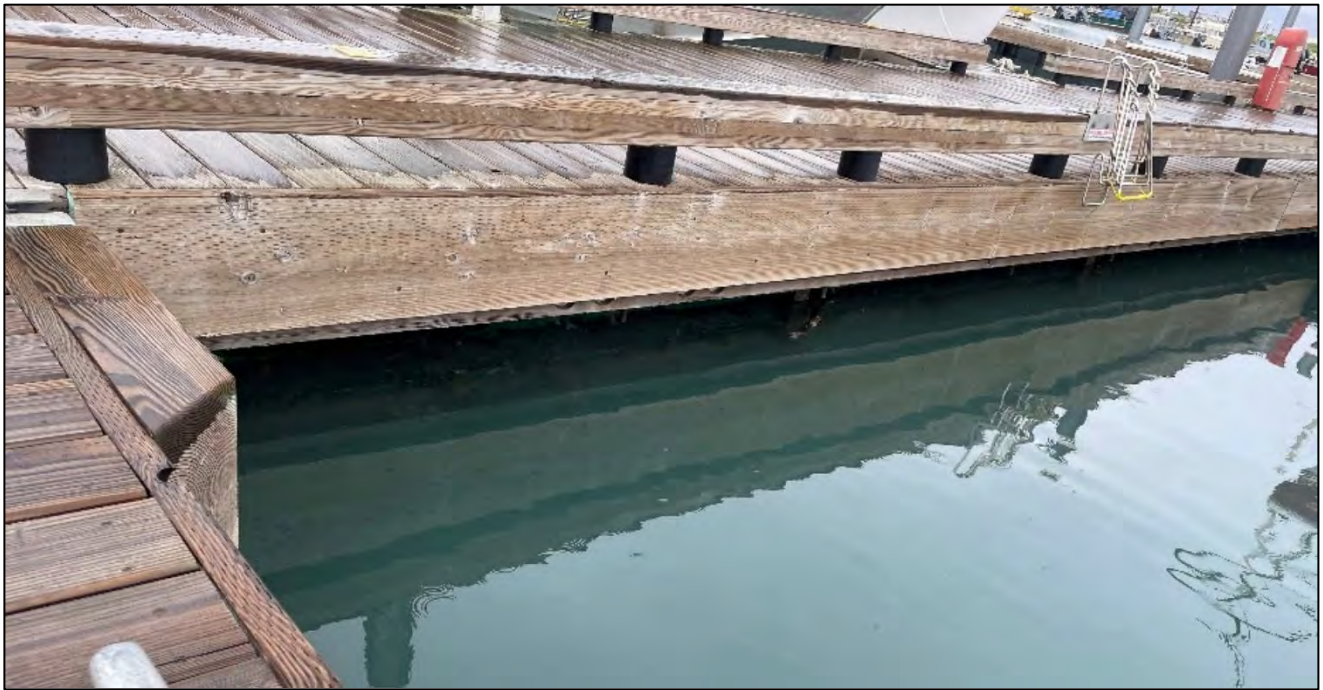
Figure 2.9: Timber floats have sufficient freeboard and reserve flotation.

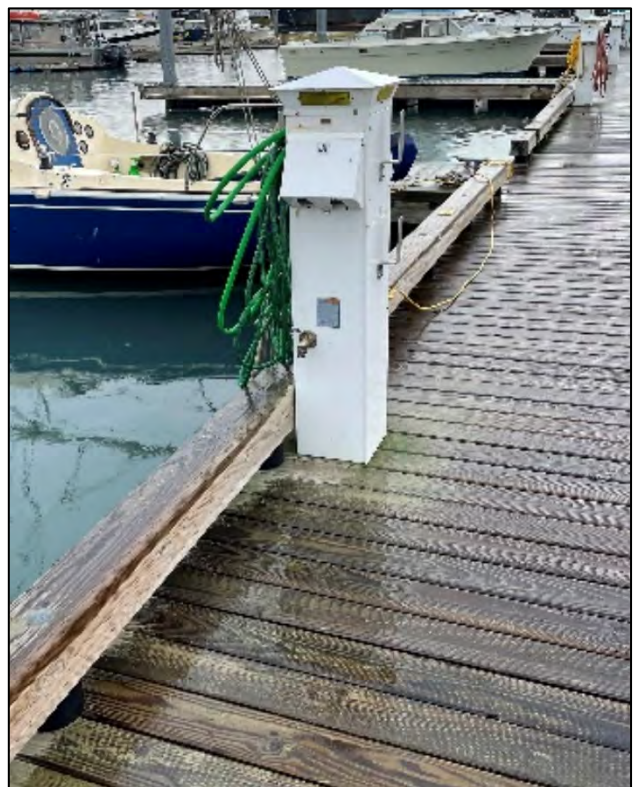
Potable water is piped within or under the floats and hose bibs are located periodically on the edge of the floats (Figure 2.10). J Float is equipped with power (combined water/power pedestals) at each stall as shown in Figure 2.11. There is no power service available on R Float or S Float.

Figure 2.11: Typical combined power and water pedestal (J Float).

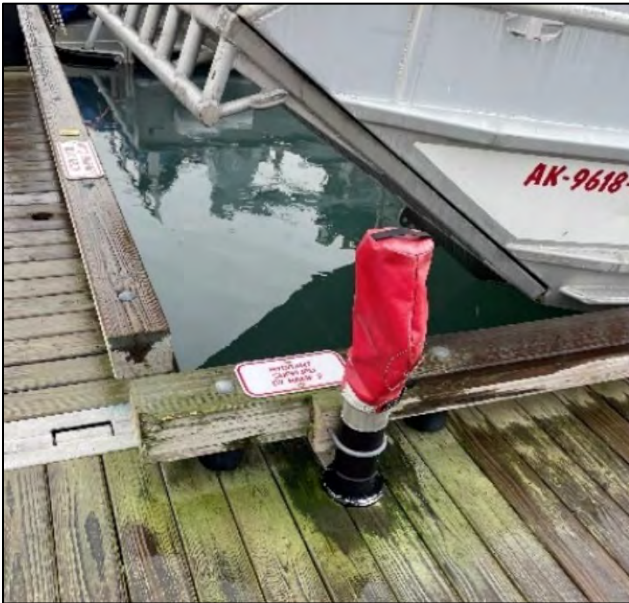
Fire suppression systems include fire extinguishers placed on the floats as well as a dry standpipe fire suppression system with an upland charging station for Fire Department use. According to the National Fire Protection Association (NFPA) 303 “*Fire Protection for Marinas and Boatyards*”, the fire suppression system appears to be inadequate because the above-water piping is HDPE which is not fire-resistant (Figures 2.12 and 2.13). A failure in part of the piping system due to melting during a fire could render the system useless or worse cause delay in fighting a fire. The above-water HDPE pipe should be replaced with metal pipe or it may be possible to install a suitable fireproof cover sleeve.

Figure 2.12: Fire suppression system standpipe/hydrant near J Float

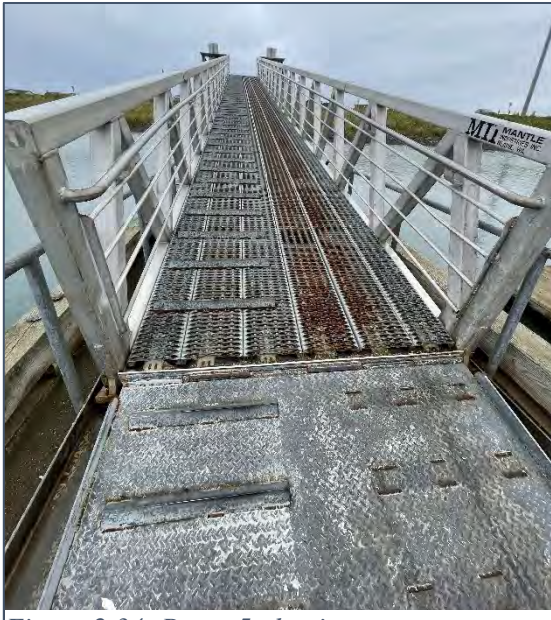
The Ramp 5 approach trestle and gangway have evidence of wear, typical of their age. Steel piles have evidence of corrosion in the tidal zone. Trestle timber treatment is reduced, some minor cracking in pile caps, and decking has evidence of wear. The gangway ramp, at 70-ft long does not meet ADA-guidelines; however, as long as there are sufficient ADA slips (5 total) in the 20-24-ft length available in the harbor (i.e., System 1), this is not required; although it is recommended to replace the ramp with an 80-ft minimum length ADA ramp when the trestle and/or floating docks are replaced. The gangway ramp bottom slide guides have evidence of wear and these as well as the steel floor grating have evidence of corrosion (Figure 2.34). However, there is no visible major damage or defects that immediately affect the capacity of these structures; other than the float on which the gangway ramp lands has low freeboard, as is noted by the timber walers in/near the water especially at the shoreward end (Figure 2.35).

Figure 2.34: Ramp 5 aluminum gangway w steel floor grating.
