Soils Investigation
Lot 2, Homer Public Library No.2
3713 Main Street, Homer Alaska 99603

Completed by:
Homer Public Works Department
Carey Meyer, P.E.
City Engineer

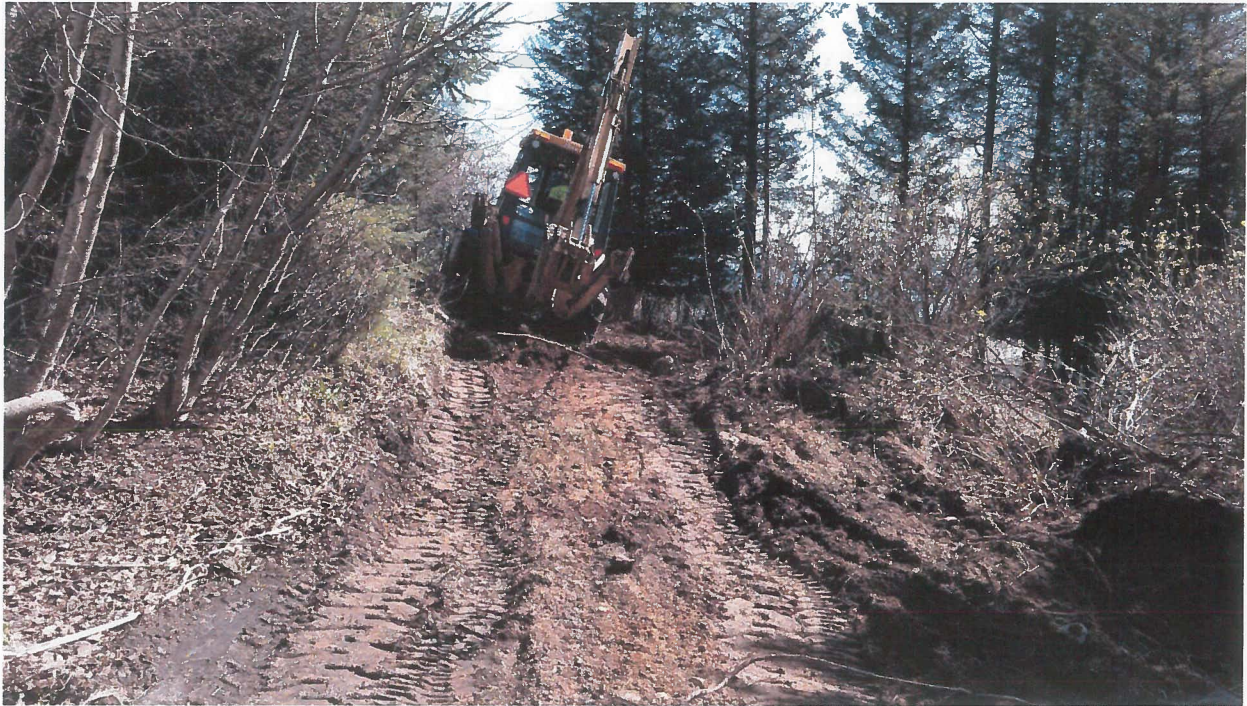
John Deere 410 accessing the site

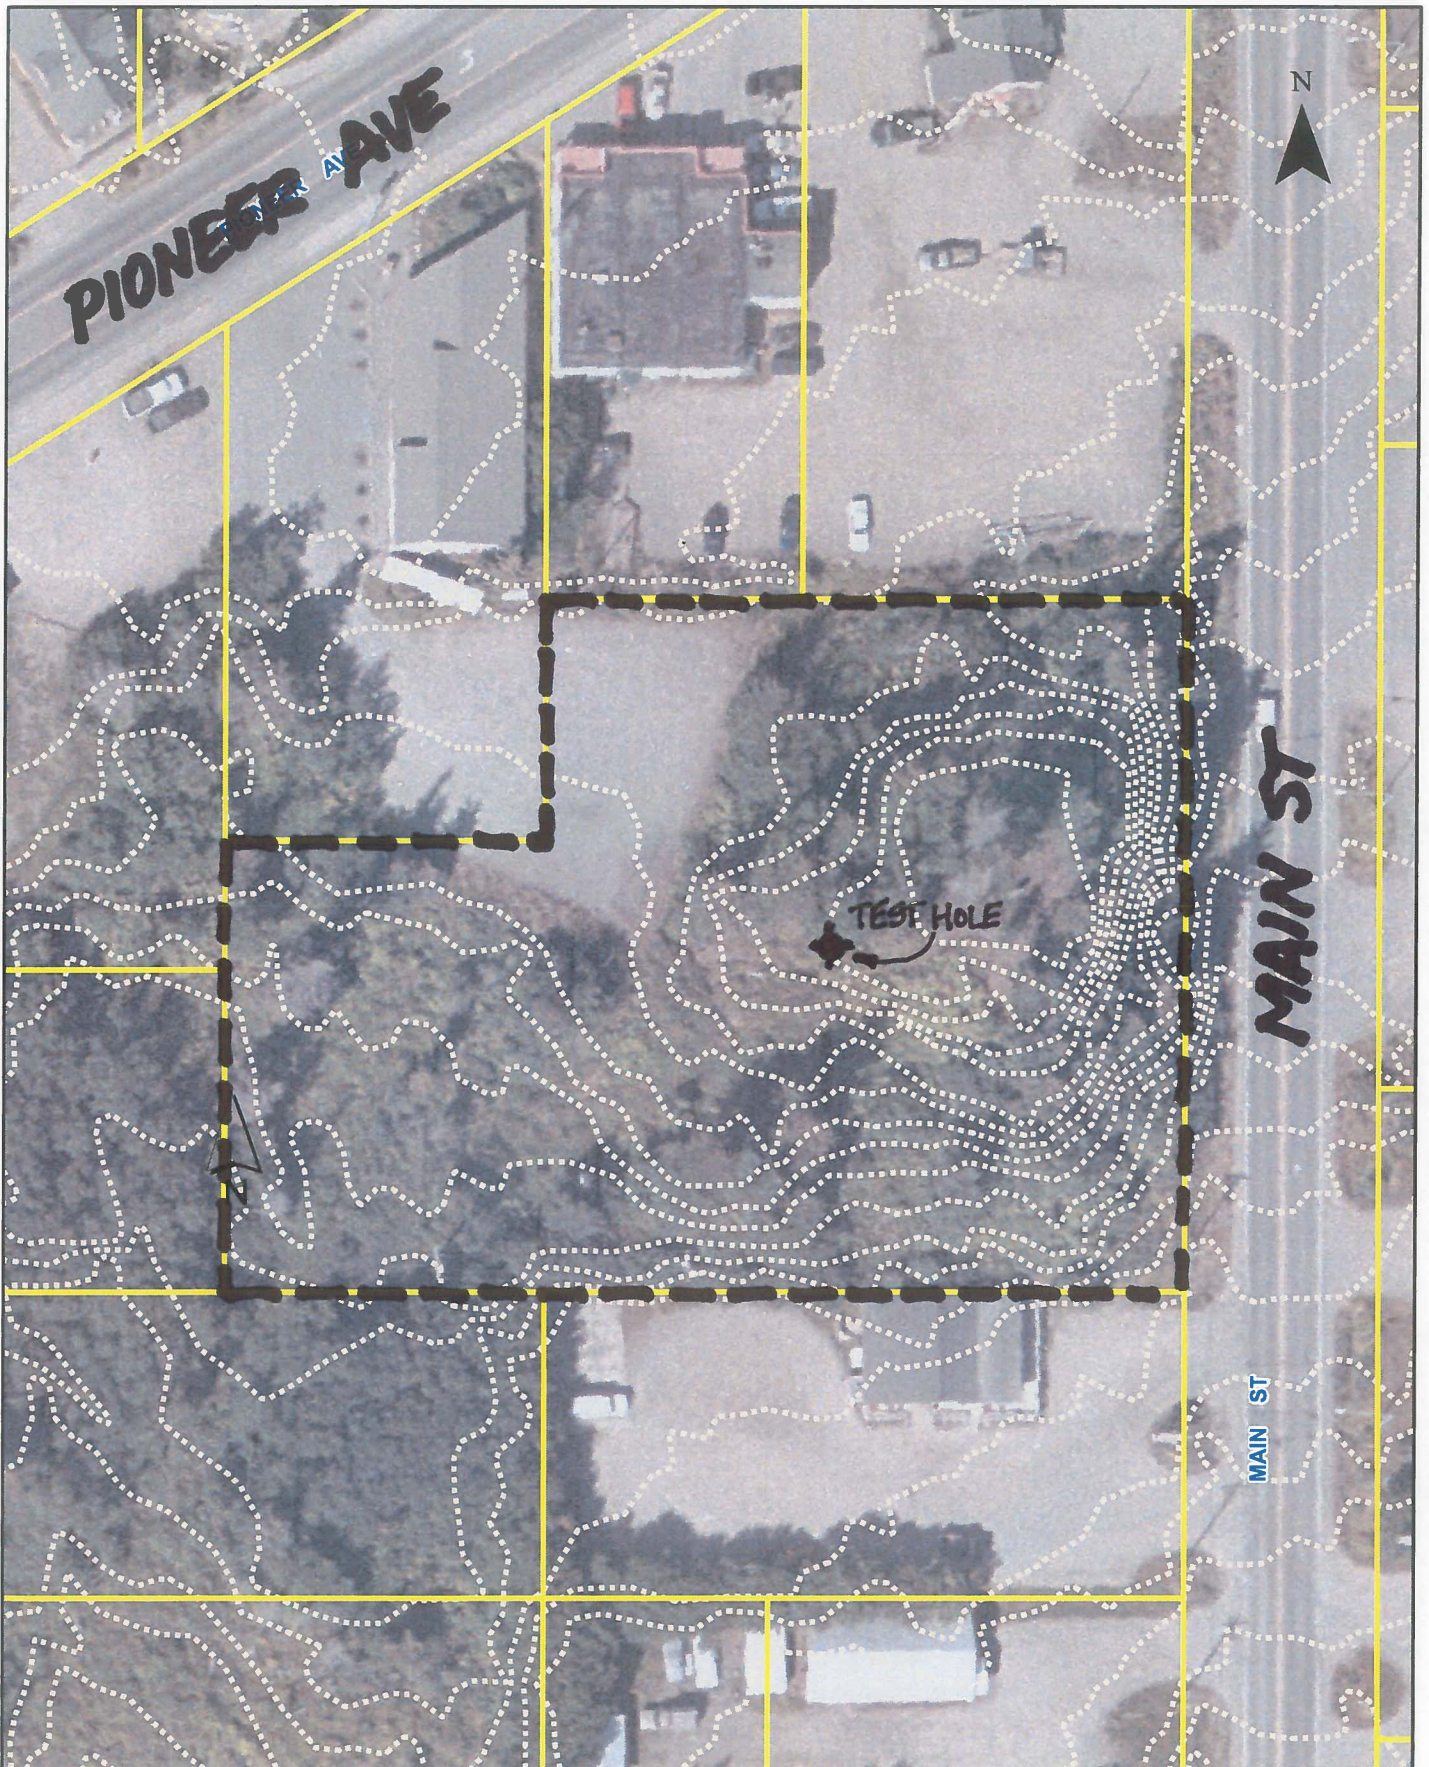
1 inch = 60 feet

The attached map shows the steepness of the property, two foot elevation contours, and the location of the completed test hole.

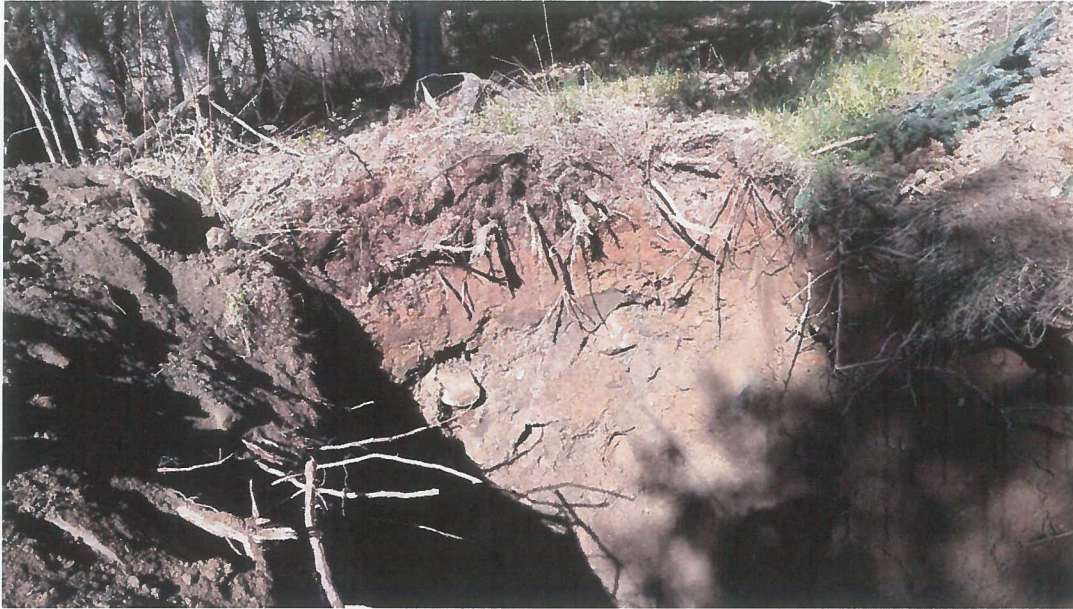
Field Investigation Results: A test hole was completed to a depth of 15 feet. See photos attached. No ground water was encountered. Subsurface soil conditions encountered at the site consisted of surface organics with roots (first 18") and a dark brown loamy soil (second 18").

Shallow soil profile – surface organics

Surface organics, could be re-utilized on-site as topsoil. The soils encountered below the surface organics could be used to fill and flatten the site, but would not be suitable as structural fill. The soils encountered below 9 feet, if undisturbed, appeared able to support residential/light commercial conventional foundation footings.

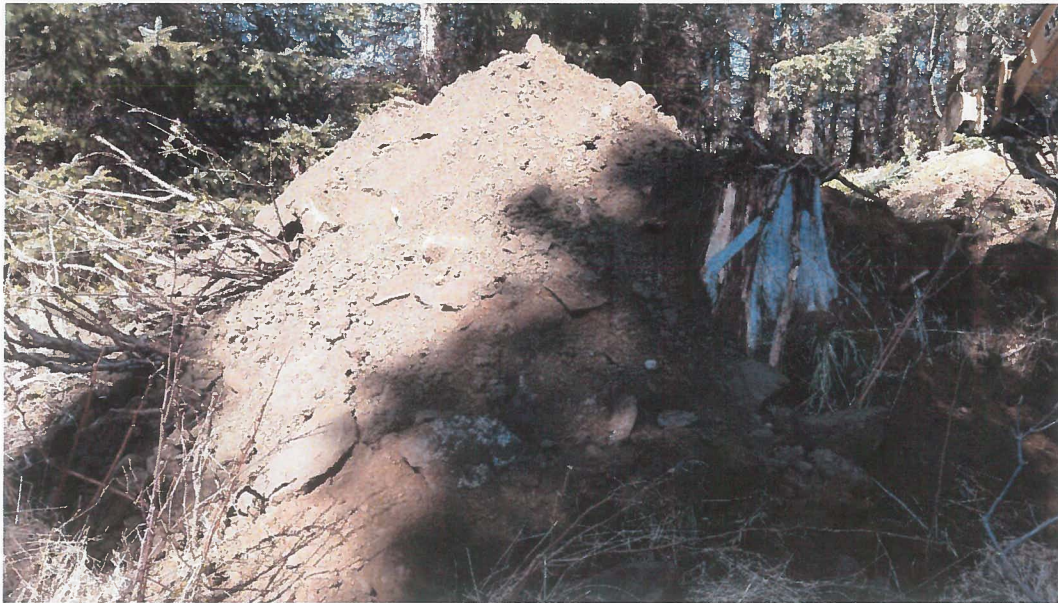
Below this, to a depth of 9 feet was a dense brown, slightly plastic loamy soil with 6" – 8" diameter cobbles (less than 10% by volume, mostly round and durable, but some fractured easily).

Material from 3' to 9' deep

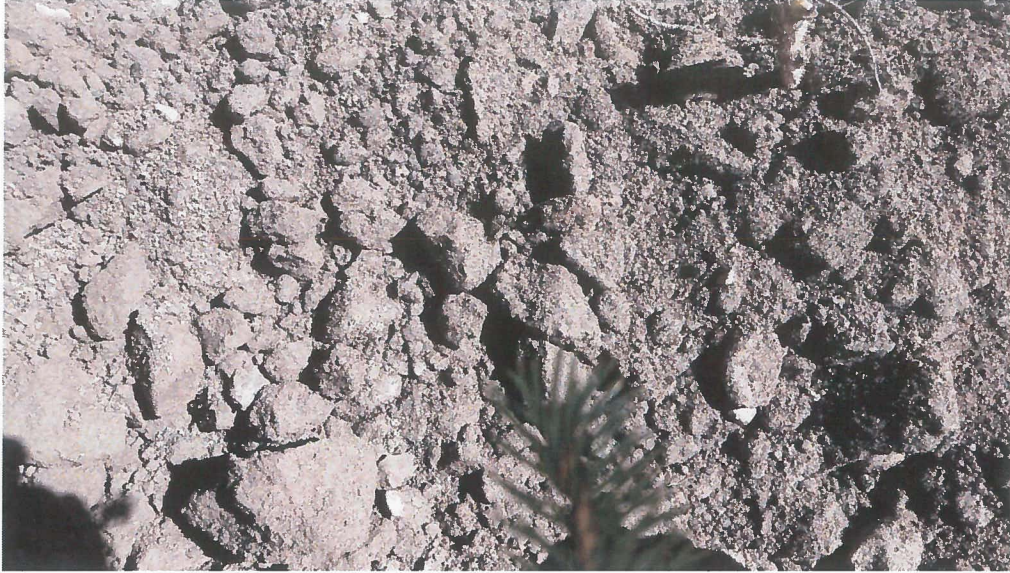
Below 9 feet, a gray dense silt, moderately plastic, with some gravel was encountered. The gravel fractured easily. Excavation stopped at 15 feet; no groundwater was encountered. There was evidence of some thin sand layers.

Material from 9' to 15' -
